Contract #: 04-0120F4Cty: SF/ALA Rte: 80 PM: 13.2/13.9File #: 69.28**WELDING INSPECTION REPORT****Resident Engineer:** Pursell, Gary**Address:** 333 Burma Road**City:** Oakland, CA 94607**Report No:** WIR-015827**Date Inspected:** 23-Jul-2010**Project Name:** SAS Superstructure**OSM Arrival Time:** 1900**Prime Contractor:** American Bridge/Fluor Enterprises, a JV**OSM Departure Time:** 700**Contractor:** Zhenhua Port Machinery Company, Ltd (ZPMC), Changxing Island **Location:** Shanghai, China**CWI Name:** See Below**CWI Present:** Yes No**Inspected CWI report:** Yes No N/A**Rod Oven in Use:** Yes No N/A**Electrode to specification:** Yes No N/A**Weld Procedures Followed:** Yes No N/A**Qualified Welders:** Yes No N/A**Verified Joint Fit-up:** Yes No N/A**Approved Drawings:** Yes No N/A**Approved WPS:** Yes No N/A**Delayed / Cancelled:** Yes No N/A**Bridge No:** 34-0006**Component:** OBG**Summary of Items Observed:**

On this date CALTRANS OSM Quality Assurance (QA) Inspector, Mr. Paul Dawson, arrived on site at the Zhenhua Port Machinery Company (ZPMC) facility at Changxing Island, in Shanghai China, for the purpose of monitoring welding and fabrication of the San Francisco / Oakla

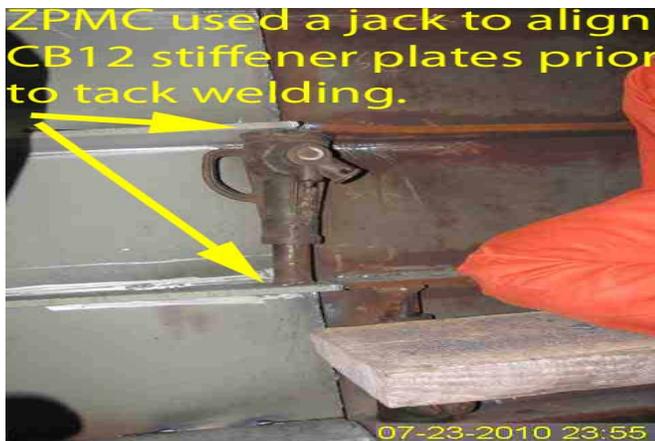
This QA Inspector observed ZPMC welders Mr. Wei Dashuai stencil 051246 and Mr. Xin Meng, stencil 053742 were using flux cored welding process to make tack welds between OBG segment 9DE and cross beam CB12 bottom plates. These temporary plates were installed to allow ZPMC to maintain alignment of these weld joints. This QA Inspector observed ZPMC personnel used a torch to preheat the base material prior to welding and both welders appeared to be certified to make these welds. Items observed on this date appeared to generally comply with applicable contract documents.
