Contract #: 04-0120F4Cty: SF/ALA Rte: 80 PM: 13.2/13.9File #: 69.28**WELDING INSPECTION REPORT****Resident Engineer:** Pursell, Gary**Address:** 333 Burma Road**City:** Oakland, CA 94607**Report No:** WIR-015828**Date Inspected:** 24-Jul-2010**Project Name:** SAS Superstructure**OSM Arrival Time:** 1900**Prime Contractor:** American Bridge/Fluor Enterprises, a JV**OSM Departure Time:** 700**Contractor:** Zhenhua Port Machinery Company, Ltd (ZPMC), Changxing Island **Location:** Shanghai, China**CWI Name:** See Below**CWI Present:** Yes No**Inspected CWI report:** Yes No N/A**Rod Oven in Use:** Yes No N/A**Electrode to specification:** Yes No N/A**Weld Procedures Followed:** Yes No N/A**Qualified Welders:** Yes No N/A**Verified Joint Fit-up:** Yes No N/A**Approved Drawings:** Yes No N/A**Approved WPS:** Yes No N/A**Delayed / Cancelled:** Yes No N/A**Bridge No:** 34-0006**Component:** OBG**Summary of Items Observed:**

OBG Segment Trial Assembly

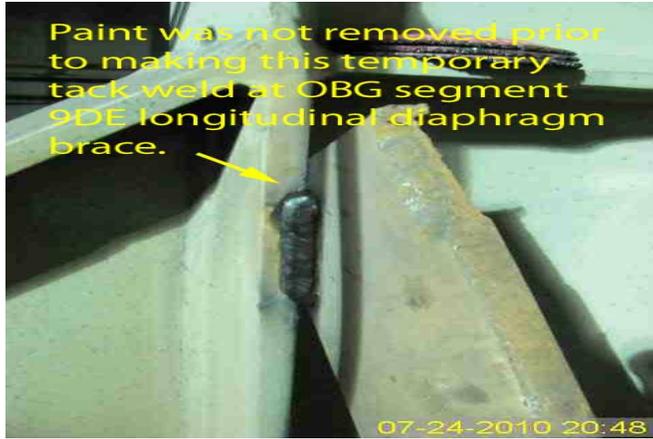
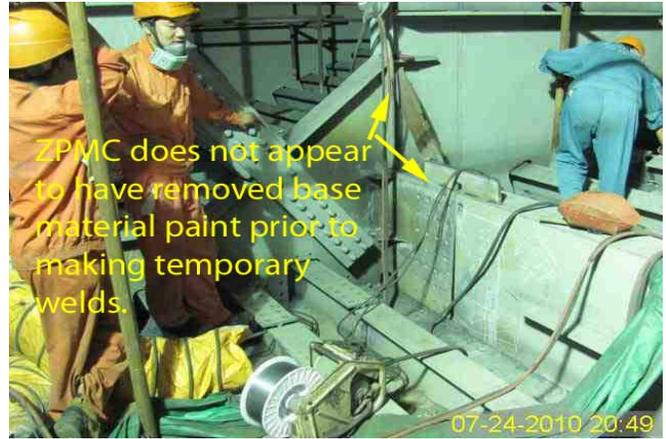
Pan appeared to be certified to make this weld. This QA Inspector observed ZPMC workers did not appear to have removed base material paint from one of the temporary welds that secure this longitudinal diaphragm to OBG segment 9DW. This QA Inspector informed ZPMC CWI Mr. Liu Hua Jie that the paint had not been removed. See the photograph below for additional information. Items observed on this date do not fully appeared to comply with applicable contract documents.
