**DEPARTMENT OF TRANSPORTATION**

Contract #: 04-0120F4Cty: SF/Ala Rte: 80 PM: 13.2/13.9File #: 69.28**WELDING INSPECTION REPORT****Resident Engineer:** Pursell, Gary**Address:** 333 Burma Road**City:** Oakland, CA 94607**Report No:** WIR-015965**Date Inspected:** 23-Jul-2010**Project Name:** SAS Superstructure**OSM Arrival Time:** 1900**Prime Contractor:** American Bridge/Fluor Enterprises, a JV**OSM Departure Time:** 700**Contractor:** Zhenhua Port Machinery Company, Ltd (ZPMC), Changxing Island **Location:** Shanghai, China**CWI Name:** See below**CWI Present:** Yes No**Inspected CWI report:** Yes No N/A**Rod Oven in Use:** Yes No N/A**Electrode to specification:** Yes No N/A**Weld Procedures Followed:** Yes No N/A**Qualified Welders:** Yes No N/A**Verified Joint Fit-up:** Yes No N/A**Approved Drawings:** Yes No N/A**Approved WPS:** Yes No N/A**Delayed / Cancelled:** Yes No N/A**Bridge No:** 34-0006**Component:** Tower and OBG Components**Summary of Items Observed:**

## WELDING INSPECTION REPORT

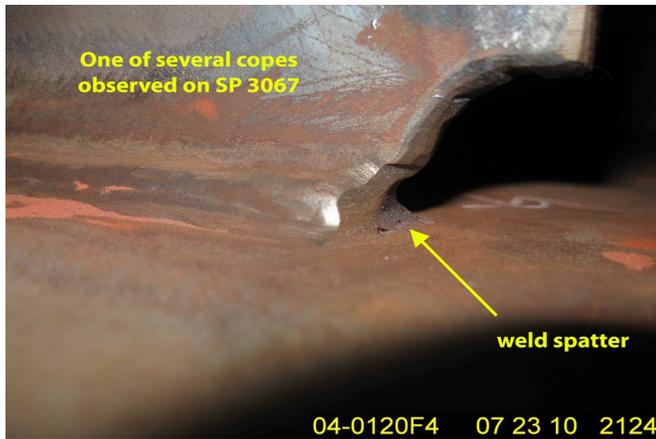
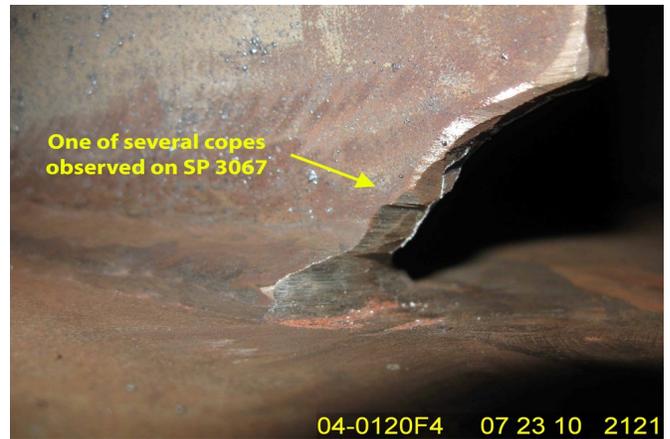
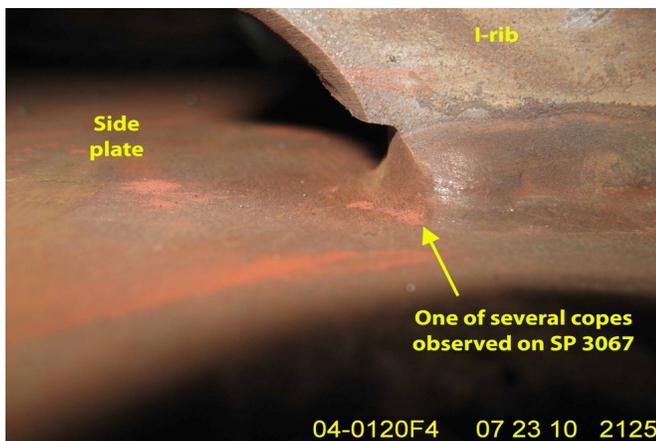
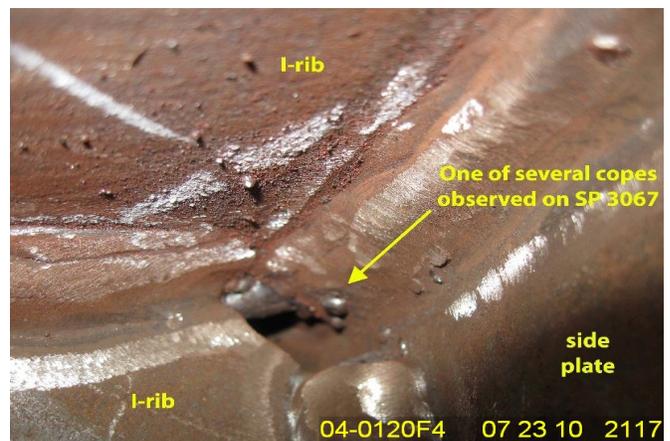
This QA Inspector performed random visual testing (VT) in preparation for MT of approximately 15% of the area previously tested and accepted by ZPMC Quality Control personnel. The member was identified as SP3067-001. This QA Inspector observed several copes that were jagged, gouged, and were covered with weld spatter. See photos below. This QA Inspector informed ZPMC CAWI Liu Dao Feng (CAWI) and showed CAWI the obvious issues. This QA Inspector rejected the VT due to the above noted issues and the MT was not performed.
