Contract #: 04-0120F4Cty: SF/ALA Rte: 80 PM: 13.2/13.9File #: 69.28**WELDING INSPECTION REPORT****Resident Engineer:** Pursell, Gary**Address:** 333 Burma Road**City:** Oakland, CA 94607**Report No:** WIR-016108**Date Inspected:** 27-Jul-2010**Project Name:** SAS Superstructure**OSM Arrival Time:** 1900**Prime Contractor:** American Bridge/Fluor Enterprises, a JV**OSM Departure Time:** 700**Contractor:** Zhenhua Port Machinery Company, Ltd (ZPMC), Changxing Island **Location:** Shanghai, China**CWI Name:** See Below**CWI Present:** Yes No**Inspected CWI report:** Yes No N/A**Rod Oven in Use:** Yes No N/A**Electrode to specification:** Yes No N/A**Weld Procedures Followed:** Yes No N/A**Qualified Welders:** Yes No N/A**Verified Joint Fit-up:** Yes No N/A**Approved Drawings:** Yes No N/A**Approved WPS:** Yes No N/A**Delayed / Cancelled:** Yes No N/A**Bridge No:** 34-0006**Component:** OBG**Summary of Items Observed:**

OBG Segment Trial Assembly

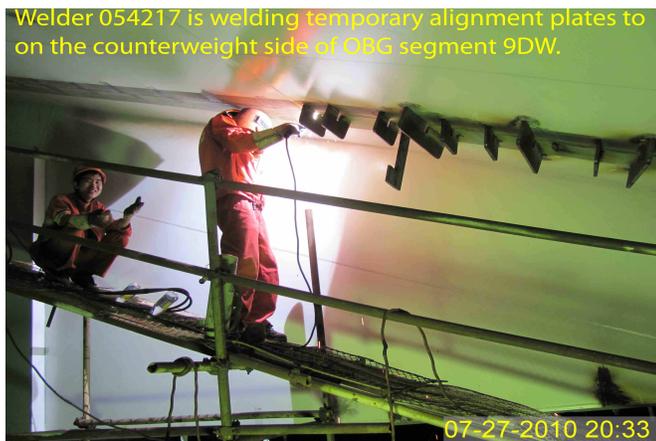
This QA Inspector observed ZPMC welder Mr. Zhu Fachao, stencil 054217 used shielded metal arc process to perform tack welding of temporary plates to maintain alignment of OBG side plate butt weld joint between segments 9DW and 9EW on the cross beam side. This QA Inspector observed Mr. Zhu Fachao appeared to be certified to make these welds and a torch had been used to preheat the base material prior to welding. See the photograph below for additional information. Items observed on this date appeared to comply with applicable contract documents.
