**DEPARTMENT OF TRANSPORTATION**

Contract #: 04-0120F4Cty: SF/ALA Rte: 80 PM: 13.2/13.9File #: 69.28**WELDING INSPECTION REPORT****Resident Engineer:** Pursell, Gary**Address:** 333 Burma Road**City:** Oakland, CA 94607**Report No:** WIR-015950**Date Inspected:** 01-Aug-2010**Project Name:** SAS Superstructure**OSM Arrival Time:** 700**Prime Contractor:** American Bridge/Fluor Enterprises, a JV**OSM Departure Time:** 1900**Contractor:** Zhenhua Port Machinery Company, Ltd (ZPMC), Changxing Island **Location:** Shanghai, China**CWI Name:** Li Yang**CWI Present:** Yes No**Inspected CWI report:** Yes No N/A**Rod Oven in Use:** Yes No N/A**Electrode to specification:** Yes No N/A**Weld Procedures Followed:** Yes No N/A**Qualified Welders:** Yes No N/A**Verified Joint Fit-up:** Yes No N/A**Approved Drawings:** Yes No N/A**Approved WPS:** Yes No N/A**Delayed / Cancelled:** Yes No N/A**Bridge No:** 34-0006**Component:** welder qual**Summary of Items Observed:**

On this date Caltrans OSM Quality Assurance (QA) Inspector, Dan Hernandez was present during the times noted above to observe the fit up, welding and related activities associated with the fabrication of the San Francisco Oakland

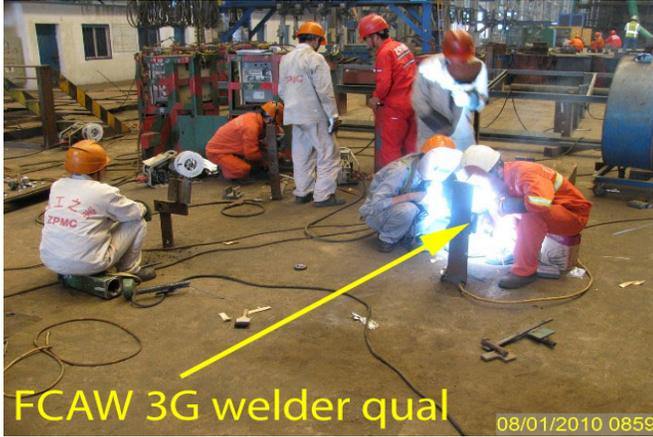
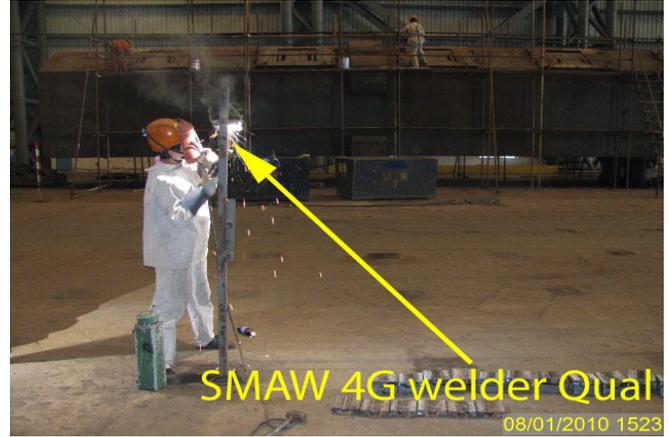
This QA Inspector observed Welder Qualification using the Flux Cored Arc Welding (FCAW) and Shield Metal Arc Welding (SMAW) process for Complete Joint Penetration (CJP) Groove Tests for plate of unlimited thickness in the 3G (vertical) and 4G (overhead) position.

ZPMC QC CWI Li Yang was present during Welder qualification. Test coupons will be sent to ZPMC weld lab for Radiographic Testing and Mechanical Bend Tests.

Visual for CJP test plates and Tack weld Visual and Fracture Testing results were accepted by ZPMC QC unless otherwise noted.
