Contract #: 04-0120F4Cty: SF/ALA Rte: 80 PM: 13.2/13.9File #: 69.28**WELDING INSPECTION REPORT****Resident Engineer:** Pursell, Gary**Address:** 333 Burma Road**City:** Oakland, CA 94607**Report No:** WIR-016094**Date Inspected:** 07-Aug-2010**Project Name:** SAS Superstructure**OSM Arrival Time:** 645**Prime Contractor:** American Bridge/Fluor Enterprises, a JV**OSM Departure Time:** 1845**Contractor:** Zhenhua Port Machinery Company, Ltd (ZPMC), Changxing Island **Location:** Shanghai, China**CWI Name:** Yang Bai Qian.**CWI Present:** Yes No**Inspected CWI report:** Yes No N/A**Rod Oven in Use:** Yes No N/A**Electrode to specification:** Yes No N/A**Weld Procedures Followed:** Yes No N/A**Qualified Welders:** Yes No N/A**Verified Joint Fit-up:** Yes No N/A**Approved Drawings:** Yes No N/A**Approved WPS:** Yes No N/A**Delayed / Cancelled:** Yes No N/A**Bridge No:** 34-0006**Component:** Orthotropic Box Girder (OBG)**Summary of Items Observed:**

Subassembly, Bay 04, 13BW, Deck panel to U-rib.

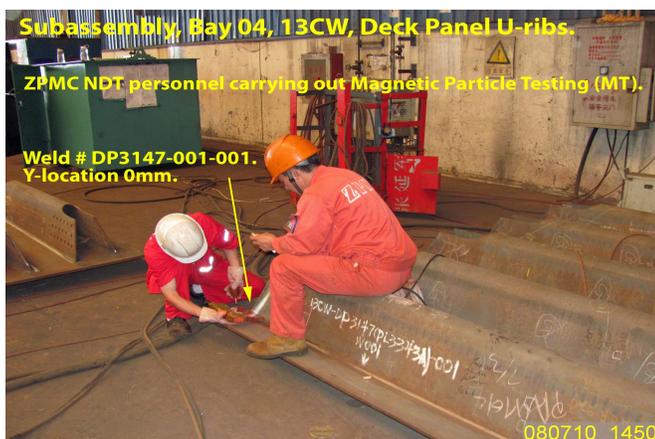
During Random Visual in process Inspection, this QA inspector observed ZPMC NDT personnel “Yuan Tao” carrying out Magnetic Particle Testing (MT) on Deck panel to U-rib welds. Deck Panel identified as DP3147-001. The attached photographs provide additional detail.

FCAW welding of weld complete penetration joint DP3172-001-249, 246, 147, 144; located on subassembly, Bay 09, 14W. Welders are identified as 203805, 059416; ZPMC Quality Control Inspector (QC) is identified as Chen Shigang. The welding variables recorded by Quality Control Inspector (QC) appeared to comply with the Applicable WPS: WPS-B-T-2233-TC-U4B-F. The attached photographs provide additional detail.
