DEPARTMENT OF TRANSPORTATION

Quality Assurance and Source Inspection

Contract #: 04-0120F4Cty: SF/ALA Rte: 80 PM: 13.2/13.9File #: 69.28**WELDING INSPECTION REPORT****Resident Engineer:** Pursell, Gary**Address:** 333 Burma Road**City:** Oakland, CA 94607**Report No:** WIR-016513**Date Inspected:** 24-Aug-2010**Project Name:** SAS Superstructure**OSM Arrival Time:** 700**Prime Contractor:** American Bridge/Fluor Enterprises, a JV**OSM Departure Time:** 1900**Contractor:** Zhenhua Port Machinery Company, Ltd (ZPMC), Changxing Island **Location:** Shanghai, China**CWI Name:** Mr. Xu Le Feng**CWI Present:** Yes No**Inspected CWI report:** Yes No N/A**Rod Oven in Use:** Yes No N/A**Electrode to specification:** Yes No N/A**Weld Procedures Followed:** Yes No N/A**Qualified Welders:** Yes No N/A**Verified Joint Fit-up:** Yes No N/A**Approved Drawings:** Yes No N/A**Approved WPS:** Yes No N/A**Delayed / Cancelled:** Yes No N/A**Bridge No:** 34-0006**Component:** Tower and Orthotropic Box Girder (OBG)**Summary of Items Observed:**

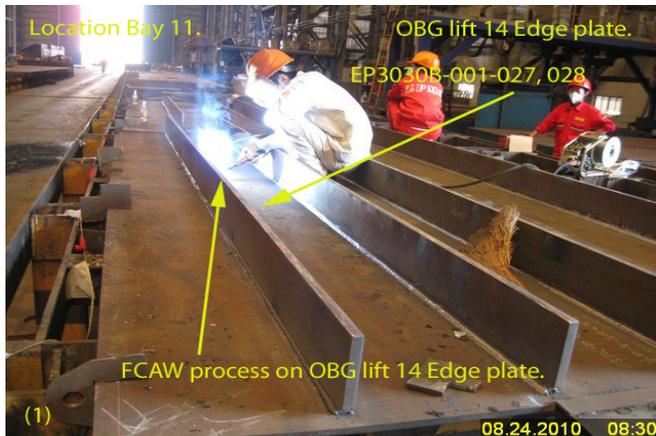
This QA Inspector observed ZPMC qualified welding personnel identified as 040759, Perform Flux core Arc Welding (FCAW) on OBG lift 14 Edge plate, Joint identified as EP3030B-001-027, 028. ZPMC CWI Identified as Yu Dong Ping. The welding parameters as measured using QC's calibrated instrument appeared to be in general compliance with WPS-B-T-2132. For more information see below attached picture number 1.

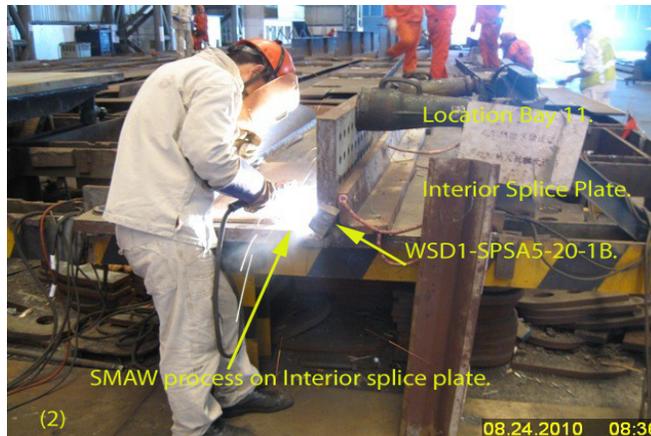
This QA Inspector observed ZPMC qualified welding personnel identified as 202100, Perform Shielded Metal Arc Welding (SMAW) on Interior splice plate, Joint identified as WSD1-SPSA5-20-1B. ZPMC QC Identified as Liu Dao Feng. The welding parameters as measured using QC's calibrated instrument appeared to be in general compliance with WPS-B-T-3212-Tc-U5b-1. For more information see below attached picture number 2.
