DEPARTMENT OF TRANSPORTATION

Quality Assurance and Source Inspection

Contract #: 04-0120F4Cty: SF/ALA Rte: 80 PM: 13.2/13.9File #: 69.28**WELDING INSPECTION REPORT****Resident Engineer:** Siegenthaler, Peter**Address:** 333 Burma Road**City:** Oakland, CA 94607**Report No:** WIR-017438**Date Inspected:** 25-Sep-2010**Project Name:** SAS Superstructure**OSM Arrival Time:** 700**Prime Contractor:** American Bridge/Fluor Enterprises, a JV**OSM Departure Time:** 1900**Contractor:** Zhenhua Port Machinery Company, Ltd (ZPMC), Changxing Island **Location:** Shanghai, China**CWI Name:** Mr. Xu Le Fung.**CWI Present:** Yes No**Inspected CWI report:** Yes No N/A**Rod Oven in Use:** Yes No N/A**Electrode to specification:** Yes No N/A**Weld Procedures Followed:** Yes No N/A**Qualified Welders:** Yes No N/A**Verified Joint Fit-up:** Yes No N/A**Approved Drawings:** Yes No N/A**Approved WPS:** Yes No N/A**Delayed / Cancelled:** Yes No N/A**Bridge No:** 34-0006**Component:** Tower and Orthotropic Box Girder (OBG)**Summary of Items Observed:**

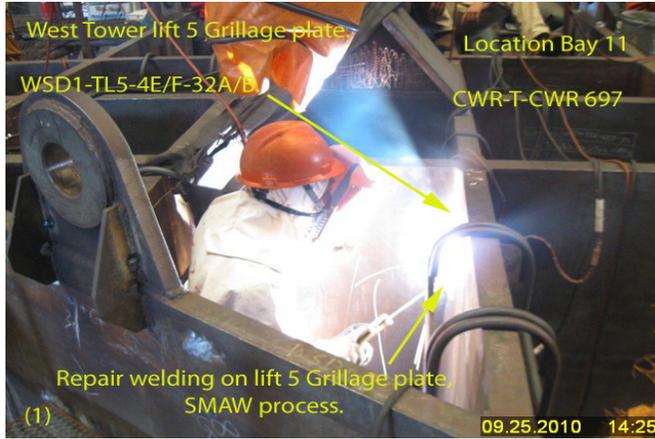
This QA Inspector observed ZPMC qualified welding personnel identified as 037996 Perform Shielded Metal Arc Welding (SMAW) on West Tower lift 5 Grillage plate. Joint identified as WSD1-TL5-4E/F-32A/B. ZPMC QC Identified as Xu Jie with Critical welding repair report CWR-T-CWR697. The welding parameters as measured using QC's calibrated instrument appeared to be in general compliance with WPS-485-SMAW-3G (3F) Repair. For more information see below attached picture number 1.

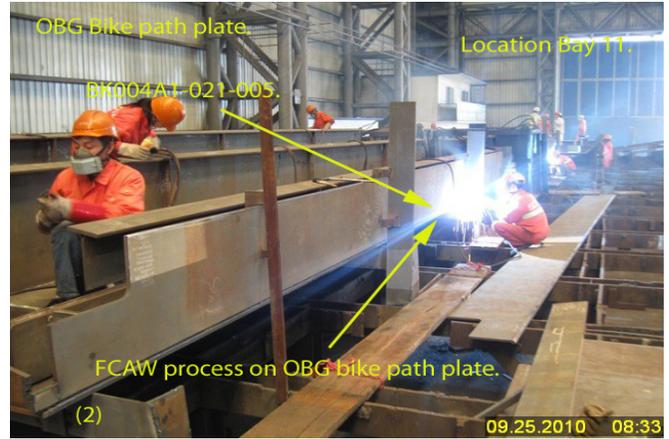
This QA Inspector observed ZPMC qualified welding personnel identified as 053316, Perform Flux Core Arc Welding (FCAW) on OBG bike path stringer plate. Joint identified as BK004A1-021-005. ZPMC QC Identified as Wang Ching Xin. The welding parameters as measured using QC's calibrated instrument appeared to be in general compliance with WPS-B-T-2232-Tc-U4c-F. For more information see below attached picture number 2.
