DEPARTMENT OF TRANSPORTATION

Quality Assurance and Source Inspection

Contract #: 04-0120F4Cty: SF/ALA Rte: 80 PM: 13.2/13.9File #: 69.28**WELDING INSPECTION REPORT****Resident Engineer:** Siegenthaler, Peter**Address:** 333 Burma Road**City:** Oakland, CA 94607**Report No:** WIR-017201**Date Inspected:** 02-Oct-2010**Project Name:** SAS Superstructure**OSM Arrival Time:** 700**Prime Contractor:** American Bridge/Fluor Enterprises, a JV**OSM Departure Time:** 1900**Contractor:** Zhenhua Port Machinery Company, Ltd (ZPMC), Changxing Island **Location:** Shanghai, China**CWI Name:** Mr. Huang min / Mr. Tian Le**CWI Present:** Yes No**Inspected CWI report:** Yes No N/A**Rod Oven in Use:** Yes No N/A**Electrode to specification:** Yes No N/A**Weld Procedures Followed:** Yes No N/A**Qualified Welders:** Yes No N/A**Verified Joint Fit-up:** Yes No N/A**Approved Drawings:** Yes No N/A**Approved WPS:** Yes No N/A**Delayed / Cancelled:** Yes No N/A**Bridge No:** 34-0006**Component:** Orthotropic Box Girder (OBG)**Summary of Items Observed:**

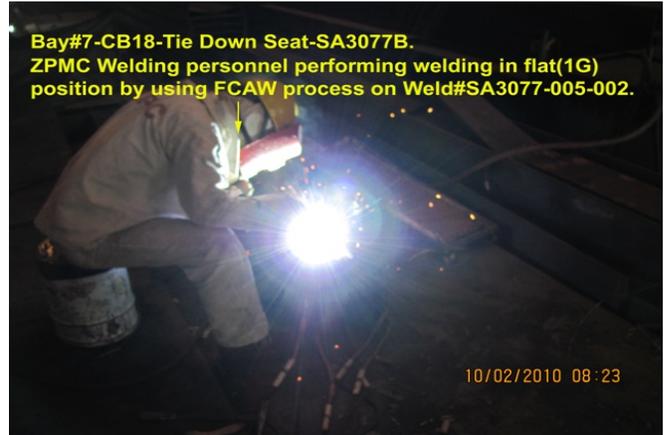
During random in process inspection of OBG member identified as Lift 14 East Floor beam FB3271A, this QA observed a cracked tack weld on weld joint identified as FB3271-001-085. The Y location is 2000mm from North end of the stiffener. The Floor beam web plate is designated as Seismic Performance Critical Material (SPCM) on the approved shop drawing. ZPMC welding personnel were welding this joint from south end of the stiffener. This QA marked the cracked tack and informed ZPMC Quality Control (QC) identified as Mr. Zhan Hai Feng of this issue. Mr. Zhan Hai Feng informed this QA that the cracked tack would be corrected in a manner compliant with the contract documents. Refer the attached photos for reference.

During QA random in-process observations of the fabrication of OBG Cross Beam(CB) CB18 Tie Down Seat SA3077B, this QA observed single pass FCAW groove weld that exceeds the maximum single pass weld size as specified in AWS D1.5 2002. The weld was performed in the flat (1G) position. The single pass groove weld, as measured by this QA, is approximately 25mm. AWS D1.5 specifies the maximum FCAW single pass weld width allowed in this position is 16mm. The weld is a Partial joint penetration (PJP) weld joining the Top Bearing plate (X3734F) to Top Bearing plate(X3734G). The weld is identified as SA3077-005-002. The Tie down Seat Bearing plate's material thickness is 100 mm.

This QA generated an incident report on this date for the above issue, for further information see the incident report and attached photos.
