Quality Assurance and Source Inspection

Contract #: 04-0120F4Cty: SF/ALA Rte: 80 PM: 13.2/13.9File #: 99.28**WELDING INSPECTION REPORT****Resident Engineer:** Siegenthaler, Peter**Address:** 333 Burma Road**City:** Oakland, CA 94607**Report No:** WIR-017426**Date Inspected:** 17-Oct-2010**Project Name:** SAS Superstructure**OSM Arrival Time:** 700**Prime Contractor:** American Bridge/Fluor Enterprises, a JV**OSM Departure Time:** 1900**Contractor:** Zhenhua Port Machinery Company, Ltd (ZPMC)**Location:** Shanghai, China

Orthotropic Box Girder (OBG) at Trial Assembly Areas

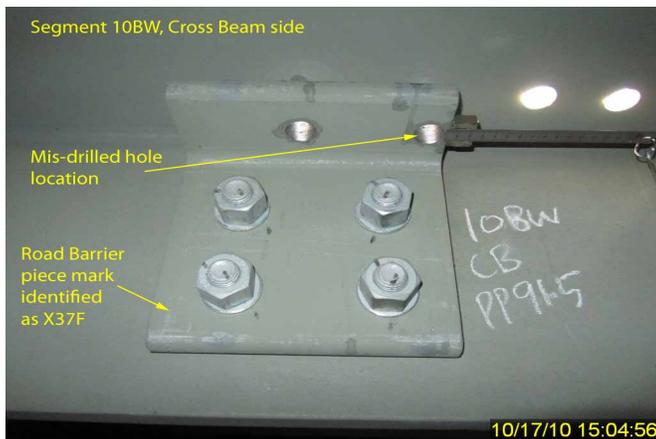
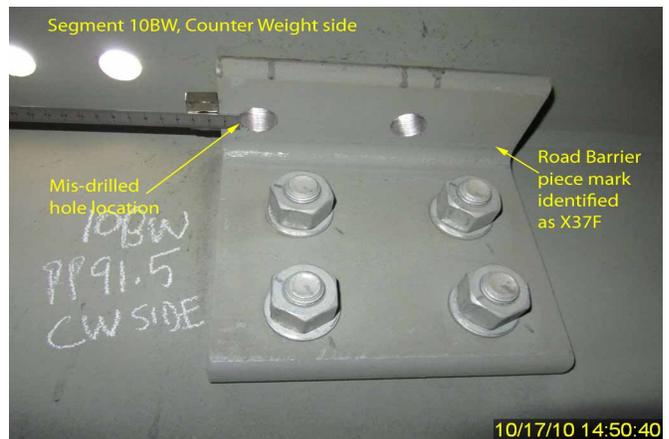
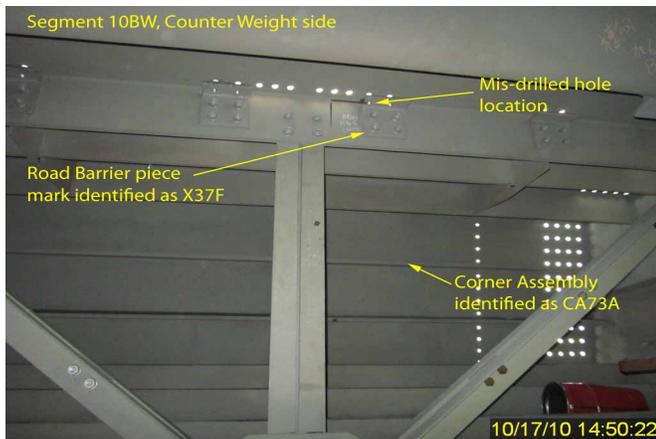
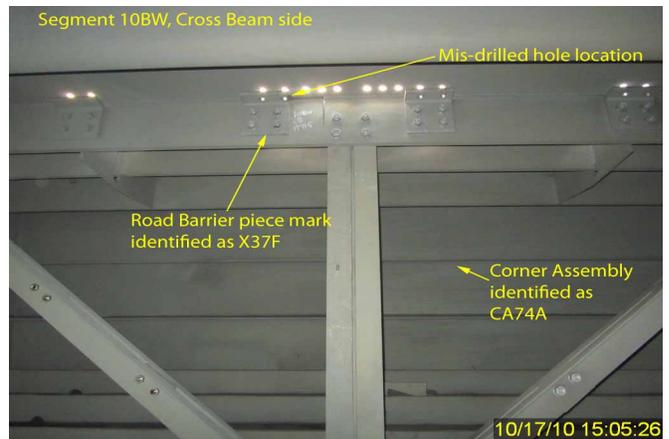
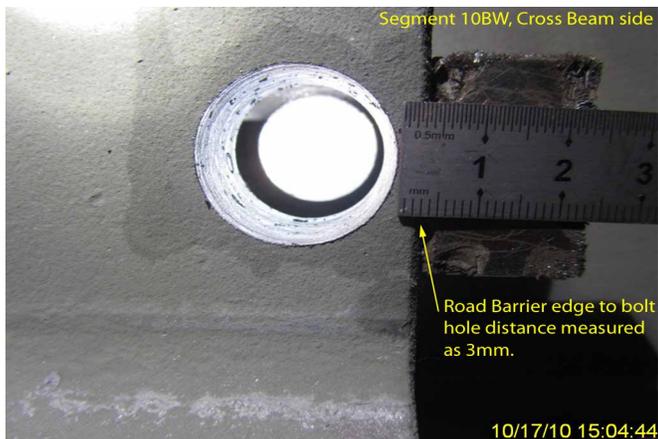
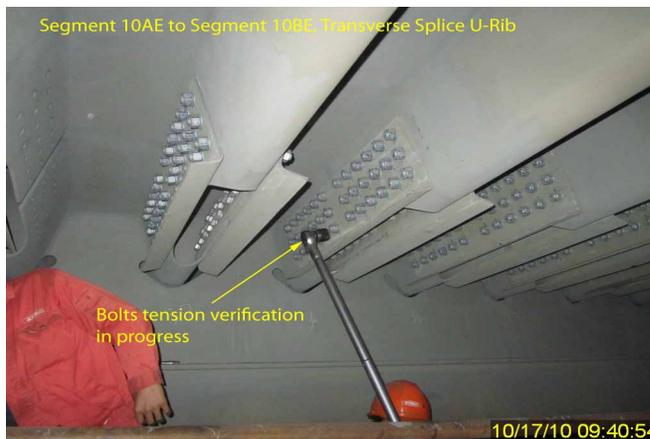
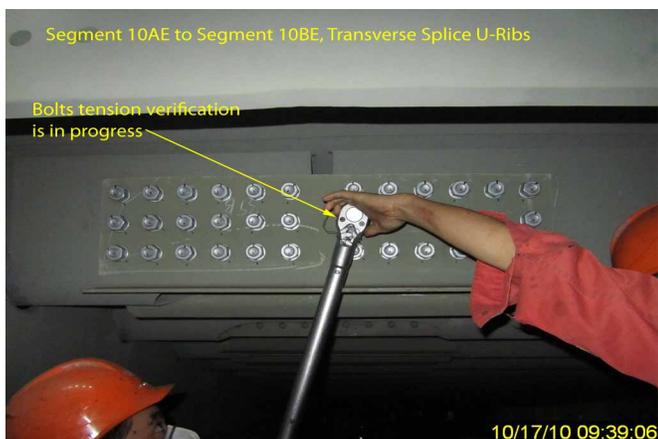
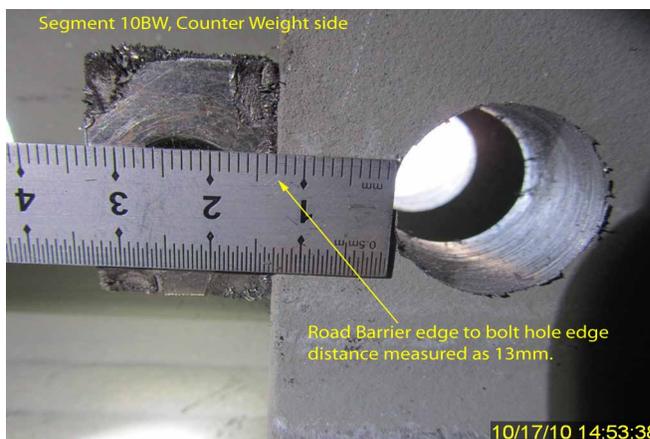
This Quality Assurance (QA) Inspector wrote an Incident Report for the Road Barrier brackets which is installed at deck panel I-Stiffener at corner assembly at Cross Beam and Counter Weight side for mis-drilling the bolt hole, as the edge distance to bolt hole edge does not comply the requirements. The road barrier in question is installed at Segment 10BW at PP 91.5. Please reference the Incident Report # 04-0120F4_TL-15_B278_10-17-2010_Mis Drilled Holes_Segment 10BW_PP 91.5_Road Barrier_CB_CW_Side dated October 17, 2010 for further detail.

This QA Inspector witnessed the final bolt tension verification on bolts connecting the U-Rib to U-Rib at the transverse splice between Panel Points (PP) 88 and PP 89 for Segment 10AE to Segment 10BE. The QA Inspector

verified the bolt tension on a random basis and the results appeared to be in general compliance. The Inspection was performed against Notification No. 00512 dated October 17, 2010.

The bolt sizes used were M22 x 70 RC Lot # DHGM220022 and the final torque value established was 487 N-m.

This QA Inspector witnessed final bolt tension verification on bolts connecting T-Rib to T-Rib for Transverse Splice at Side Panel Cross Beam Side (from work point W6 towards W4), Bottom Panel (from work point W4 towards W3) and Counter Weight side (from work point W3 to W1) between Panel Point (PP) 91 to PP 92 for Segment 10BW to Segment 10CW. Inspected the bolt tensioning on a random basis and found the tension to be in general compliance. Inspection was performed against the Notification No. 00511 Dated October 17, 2010.

The bolt sizes used were M22 x 70 RC Lot # DHGM220038 and the final torque value established was 480 N-m.

This QA Inspector witnessed the final bolt tension verification on bolts connecting the U-Rib to U-Rib at the transverse splice between Panel Points (PP) 91 and PP 92 for Segment 10BW to Segment 10CW. The QA Inspector verified the bolt tension on a random basis and the results appeared to be in general compliance. The Inspection was performed against Notification No. 00511 dated October 17, 2010.

The bolt sizes used were M22 x 80 RC Lot # DHGM220094 and the final torque value established was 470 N-m.

The bolt sizes used were M22 x 85 RC Lot # DHGM220110 and the final torque value established was 356 N-m.
