Contract #: 04-0120F4Cty: SF/ALA Rte: 80 PM: 13.2/13.9File #: 69.28**WELDING INSPECTION REPORT****Resident Engineer:** Siegenthaler, Peter**Address:** 333 Burma Road**City:** Oakland, CA 94607**Report No:** WIR-017558**Date Inspected:** 12-Oct-2010**Project Name:** SAS Superstructure**OSM Arrival Time:** 700**Prime Contractor:** American Bridge/Fluor Enterprises, a JV**OSM Departure Time:** 1900**Contractor:** Zhenhua Port Machinery Company, Ltd (ZPMC), Changxing Island **Location:** Shanghai, China

Bridge No: 34-0006**Component:** Tower**Summary of Items Observed:**

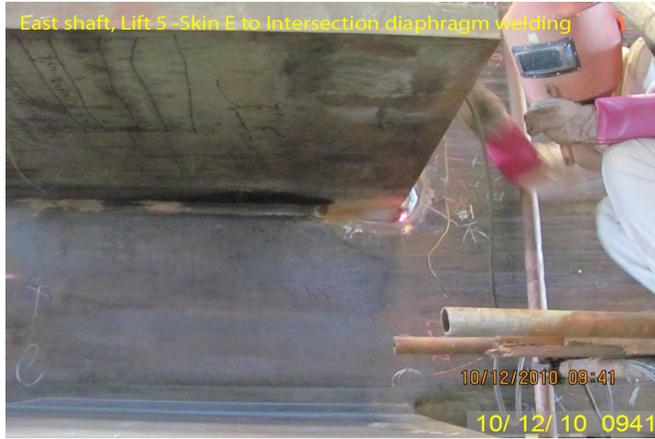
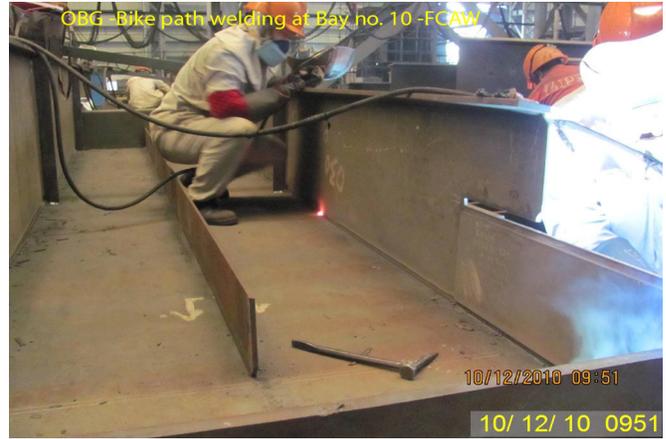
This QA inspector Witnessed 100% MT performed by ZPMC Quality Control personnel. The member is identified as Bike path -OBG Component. The component and weld designation identified as follows:

For further information see below pictures:-
