DEPARTMENT OF TRANSPORTATION

Contract #: 04-0120F4Cty: SF/ALA Rte: 80 PM: 13.2/13.9File #: 99.28**WELDING INSPECTION REPORT****Resident Engineer:** Siegenthaler, Peter**Address:** 333 Burma Road**City:** Oakland, CA 94607**Report No:** WIR-018115**Date Inspected:** 01-Nov-2010**Project Name:** SAS Superstructure**OSM Arrival Time:** 700**Prime Contractor:** American Bridge/Fluor Enterprises, a JV**OSM Departure Time:** 1900**Contractor:** Zhenhua Port Machinery Company, Ltd (ZPMC) Chanxing Island**Location:** Shanghai, China**CWI Name:** Mr. Xu Tao**CWI Present:** Yes No**Inspected CWI report:** Yes No N/A**Rod Oven in Use:** Yes No N/A**Electrode to specification:** Yes No N/A**Weld Procedures Followed:** Yes No N/A**Qualified Welders:** Yes No N/A**Verified Joint Fit-up:** Yes No N/A**Approved Drawings:** Yes No N/A**Approved WPS:** Yes No N/A**Delayed / Cancelled:** Yes No N/A**Bridge No:** 34-0006**Component:** OBG Segment and Bike Path**Summary of Items Observed:**

WELDING INSPECTION REPORT

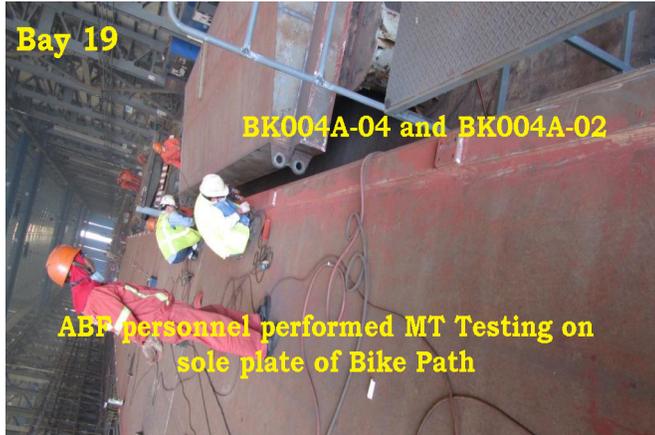
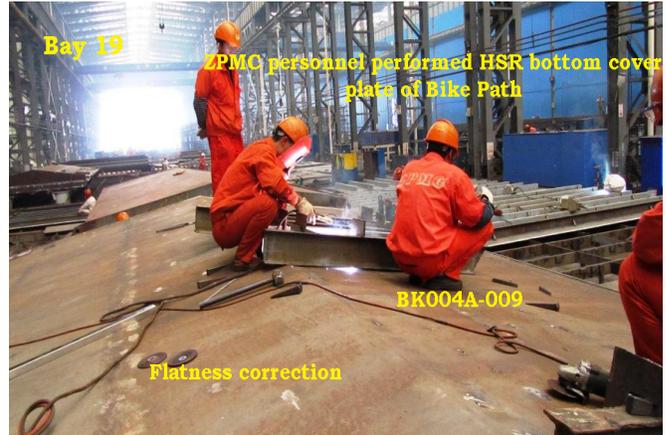
ZPMC personnel performing heat straightening on bottom cover plate of OBG bike path member identified as

BK004A-009-014~021. Distortion appeared to be caused by mishandling of the welding/material. ZPMC Quality Control (QC) inspector identified as Mr. Xu Tao was present to monitor the heat straightening process. The heat straightening appeared to comply with HSR1 (B) number 9501. See the attached pictures.
