**DEPARTMENT OF TRANSPORTATION**

Contract #: 04-0120F4Cty: SF/ALA Rte: 80 PM: 13.2/13.9File #: 99.28**WELDING INSPECTION REPORT****Resident Engineer:** Siegenthaler, Peter**Address:** 333 Burma Road**City:** Oakland, CA 94607**Report No:** WIR-018313**Date Inspected:** 25-Nov-2010**Project Name:** SAS Superstructure**OSM Arrival Time:** 700**Prime Contractor:** American Bridge/Fluor Enterprises, a JV**OSM Departure Time:** 1900**Contractor:** Zhenhua Port Machinery Company, Ltd (ZPMC) Chanxing Island**Location:** Shanghai, China**CWI Name:** Mr. Xu Tao**CWI Present:** Yes No**Inspected CWI report:** Yes No N/A**Rod Oven in Use:** Yes No N/A**Electrode to specification:** Yes No N/A**Weld Procedures Followed:** Yes No N/A**Qualified Welders:** Yes No N/A**Verified Joint Fit-up:** Yes No N/A**Approved Drawings:** Yes No N/A**Approved WPS:** Yes No N/A**Delayed / Cancelled:** Yes No N/A**Bridge No:** 34-0006**Component:** OBG Bike Path**Summary of Items Observed:**

## WELDING INSPECTION REPORT

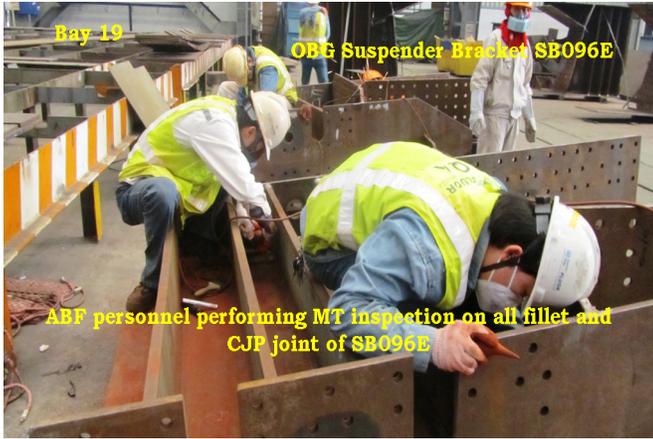
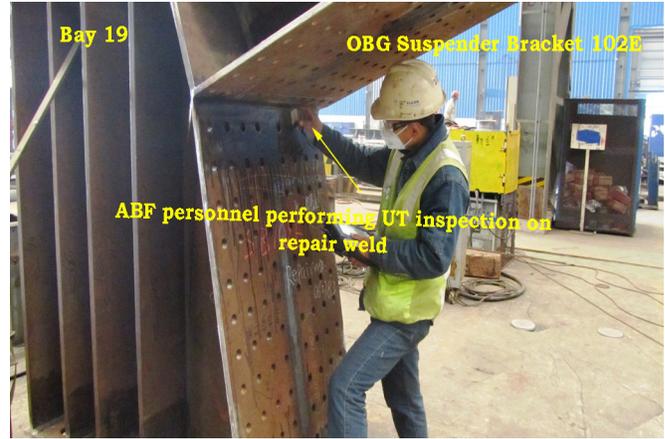
This QA Inspector performed a preliminary random visual inspection on OBG Segment 12BW, after the grit blast of the interior components top side of the deck plates, floor beams, side plates and corner assemblies of this segment panel point PP113 to P115. Areas of visual weld defects that will require welding were taped and will be repaired after the coating is applied. ZPMC QC personnel are aware of these areas and were present during the inspection.
