Contract #: 04-0120F4Cty: SF/ALA Rte: 80 PM: 13.2/13.9File #: 69.28**WELDING INSPECTION REPORT****Resident Engineer:** Siegenthaler, Peter**Address:** 333 Burma Road**City:** Oakland, CA 94607**Report No:** WIR-019550**Date Inspected:** 23-Nov-2010**Project Name:** SAS Superstructure**OSM Arrival Time:** 1900**Prime Contractor:** American Bridge/Fluor Enterprises, a JV**OSM Departure Time:** 700**Contractor:** Zhenhua Port Machinery Company, Ltd (ZPMC), Changxing Island **Location:** Shanghai, China**CWI Name:** See below**CWI Present:** Yes No**Inspected CWI report:** Yes No N/A**Rod Oven in Use:** Yes No N/A**Electrode to specification:** Yes No N/A**Weld Procedures Followed:** Yes No N/A**Qualified Welders:** Yes No N/A**Verified Joint Fit-up:** Yes No N/A**Approved Drawings:** Yes No N/A**Approved WPS:** Yes No N/A**Delayed / Cancelled:** Yes No N/A**Bridge No:** 34-0006**Component:** OBG**Summary of Items Observed:**

WELDING INSPECTION REPORT

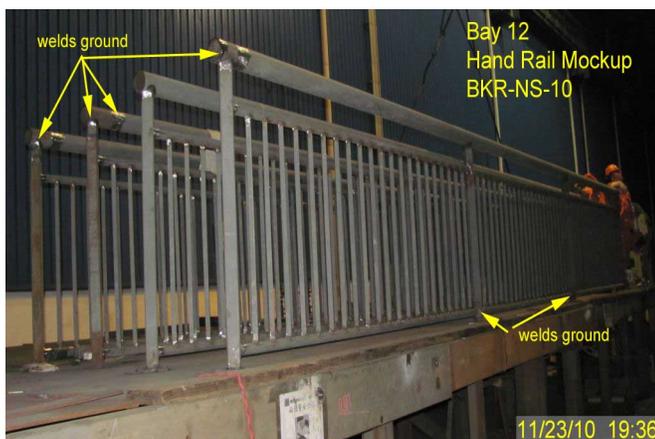
Listed below are the locations that were identified by this QA Inspector. Photo below.

Component; Hand Rail Mockup

PCMK: BKR-NS-10 & 36

Welder: 053869

WPS-B-T-2234
