Quality Assurance and Source Inspection

Contract #: 04-0120F4Cty: SF/ALA Rte: 80 PM: 13.2/13.9File #: 69.28**WELDING INSPECTION REPORT****Resident Engineer:** Siegenthaler, Peter**Address:** 333 Burma Road**City:** Oakland, CA 94607**Report No:** WIR-019054**Date Inspected:** 02-Jan-2011**Project Name:** SAS Superstructure**OSM Arrival Time:** 700**Prime Contractor:** American Bridge/Fluor Enterprises, a JV**OSM Departure Time:** 1900**Contractor:** Zhenhua Port Machinery Company, Ltd (ZPMC), Changxing Island **Location:** Shanghai, China**CWI Name:** Li Yang**CWI Present:** Yes No**Inspected CWI report:** Yes No N/A**Rod Oven in Use:** Yes No N/A**Electrode to specification:** Yes No N/A**Weld Procedures Followed:** Yes No N/A**Qualified Welders:** Yes No N/A**Verified Joint Fit-up:** Yes No N/A**Approved Drawings:** Yes No N/A**Approved WPS:** Yes No N/A**Delayed / Cancelled:** Yes No N/A**Bridge No:** 34-0006**Component:** OBG Segment**Summary of Items Observed:**

OBG # TRIAL ASSEMBLY YARD (11BW)

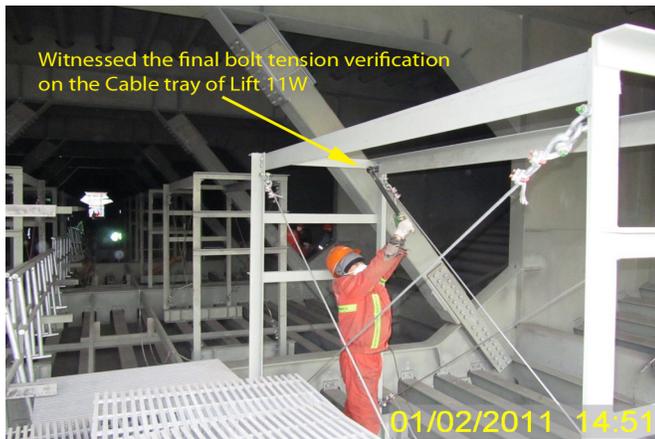
This QA Inspector witnessed the final bolt tension verification on the Cable tray of Lift 11W. The torque wrench S/N was XO2-114. The QA Inspector witnessed 10% of the bolts on a random basis and found the tensioning of the bolts appeared to be in general compliance with the contract specifications. The Segment, panel point and bolt size designations were as follows:

For additional information please reference the pictures below:
