DEPARTMENT OF TRANSPORTATION

Contract #: 04-0120F4Cty: SF/ALA Rte: 80 PM: 13.2/13.9File #: 69.28**WELDING INSPECTION REPORT****Resident Engineer:** Siegenthaler, Peter**Address:** 333 Burma Road**City:** Oakland, CA 94607**Report No:** WIR-019530**Date Inspected:** 26-Jan-2011**Project Name:** SAS Superstructure**OSM Arrival Time:** 7000**Prime Contractor:** American Bridge/Fluor Enterprises, a JV**OSM Departure Time:** 1900**Contractor:** Zhenhua Port Machinery Company, Ltd (ZPMC), Changxing Island **Location:** Shanghai, China**CWI Name:** Li Yang**CWI Present:** Yes No**Inspected CWI report:** Yes No N/A**Rod Oven in Use:** Yes No N/A**Electrode to specification:** Yes No N/A**Weld Procedures Followed:** Yes No N/A**Qualified Welders:** Yes No N/A**Verified Joint Fit-up:** Yes No N/A**Approved Drawings:** Yes No N/A**Approved WPS:** Yes No N/A**Delayed / Cancelled:** Yes No N/A**Bridge No:** 34-0006**Component:** Orthotropic Box Girder (OBG)**Summary of Items Observed:**

WELDING INSPECTION REPORT

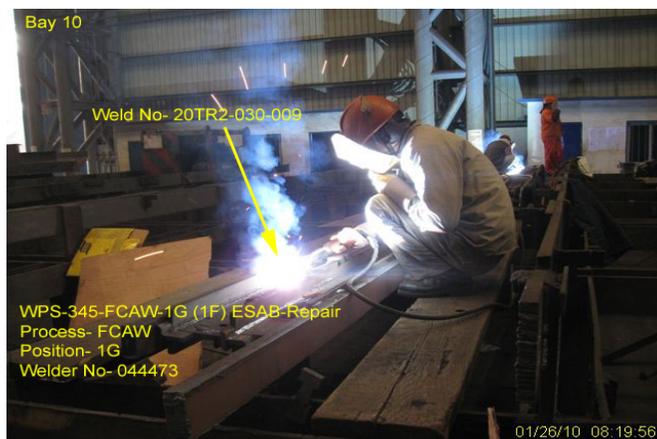
This QA Inspector observed ZPMC qualified welding personnel identified as 044473 perform Flux Core Arc Welding (FCAW), weld joint identified as 20TR2-030-009; located On Orthotropic Box Girder (OBG) Traveler rail CJP Weld; The Critical Welding Repair Report (WRR) was B-WR14292. ZPMC Quality Control (QC) is identified as Mr. Li Jun. The welding variables recorded by QC appeared to comply with applicable WPS-345-FCAW-1G (1F) ESAB-Repair. See attached photo for further details.

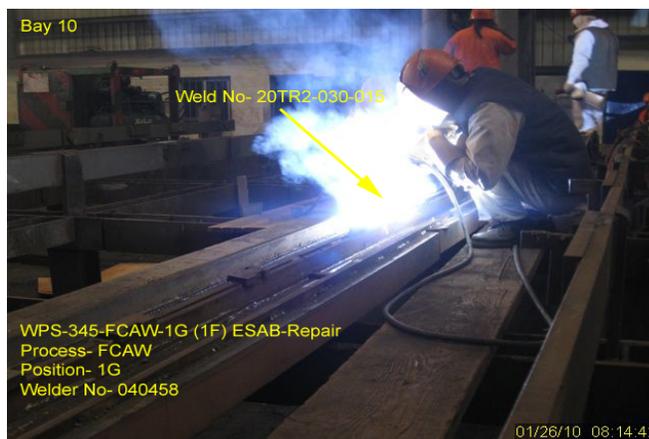
rail CJP Weld; The Critical Welding Repair Report (WRR) was B-WR14294. ZPMC Quality Control (QC) is identified as Mr. Li Jun. The welding variables recorded by QC appeared to comply with applicable WPS-345-FCAW-1G (1F) ESAB-Repair. See attached photo for further details.
