DEPARTMENT OF TRANSPORTATION

Quality Assurance and Source Inspection

Contract #: 04-0120F4Cty: SF/ALA Rte: 80 PM: 13.2/13.9File #: 69.28**WELDING INSPECTION REPORT****Resident Engineer:** Siegenthaler, Peter**Address:** 333 Burma Road**City:** Oakland, CA 94607**Report No:** WIR-019619**Date Inspected:** 30-Jan-2011**Project Name:** SAS Superstructure**OSM Arrival Time:** 700**Prime Contractor:** American Bridge/Fluor Enterprises, a JV**OSM Departure Time:** 1900**Contractor:** Zhenhua Port Machinery Company, Ltd (ZPMC), Changxing Island **Location:** Shanghai, China**CWI Name:** Mr. Qiu wen**CWI Present:** Yes No**Inspected CWI report:** Yes No N/A**Rod Oven in Use:** Yes No N/A**Electrode to specification:** Yes No N/A**Weld Procedures Followed:** Yes No N/A**Qualified Welders:** Yes No N/A**Verified Joint Fit-up:** Yes No N/A**Approved Drawings:** Yes No N/A**Approved WPS:** Yes No N/A**Delayed / Cancelled:** Yes No N/A**Bridge No:** 34-0006**Component:** Orthotropic Box Girder (OBG)**Summary of Items Observed:**

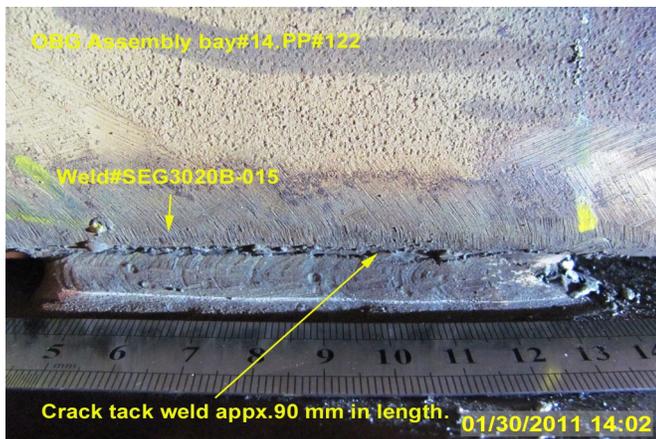
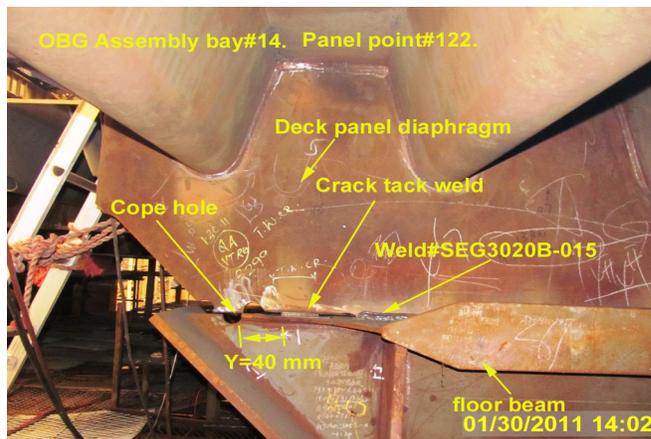
ZPMC Grinder was performing flush grinding for the bevel cut area on deck panel diaphragm identified as DP3117A-X4080K. Refer the attached photos for reference.

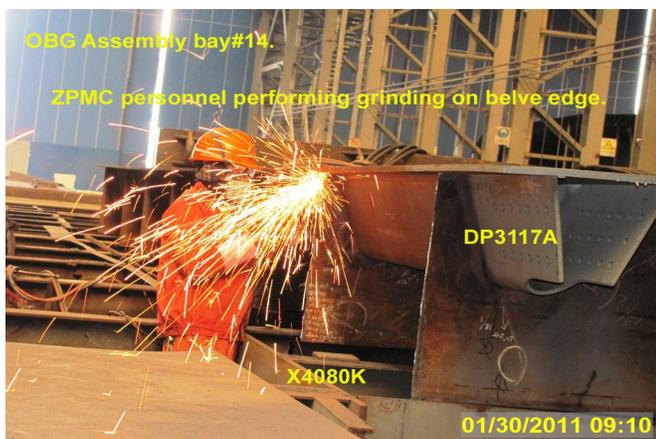
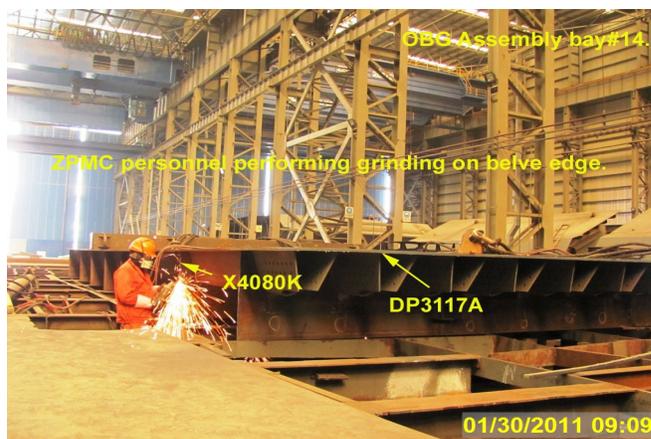
During random in process inspection of member identified as Deck panel diaphragm this QA observed a cracked tack weld on weld joint identified as SEG3014B-015. This QA marked the cracked tack and informed ZPMC Quality Control (QC) identified as Mr. Qui wen of this issue. Mr. Qui wen informed this QA that the cracked tack would be corrected in a manner compliant with the contract documents prior to start the welding. Refer the attached photos for reference.
