DEPARTMENT OF TRANSPORTATION

Quality Assurance and Source Inspection

Contract #: 04-0120F4Cty: SF/Ala Rte: 80 PM: 13.2/13.9File #: 69.28**WELDING INSPECTION REPORT****Resident Engineer:** Siegenthaler, Peter**Address:** 333 Burma Road**City:** Oakland, CA 94607**Report No:** WIR-020202**Date Inspected:** 24-Jan-2011**Project Name:** SAS Superstructure**OSM Arrival Time:** 1900**Prime Contractor:** American Bridge/Fluor Enterprises, a JV**OSM Departure Time:** 700**Contractor:** Zhenhua Port Machinery Company, Ltd (ZPMC), Changxing Island **Location:** Shanghai, China**CWI Name:** See below**CWI Present:** Yes No**Inspected CWI report:** Yes No N/A**Rod Oven in Use:** Yes No N/A**Electrode to specification:** Yes No N/A**Weld Procedures Followed:** Yes No N/A**Qualified Welders:** Yes No N/A**Verified Joint Fit-up:** Yes No N/A**Approved Drawings:** Yes No N/A**Approved WPS:** Yes No N/A**Delayed / Cancelled:** Yes No N/A**Bridge No:** 34-0006**Component:** OBG Components**Summary of Items Observed:**

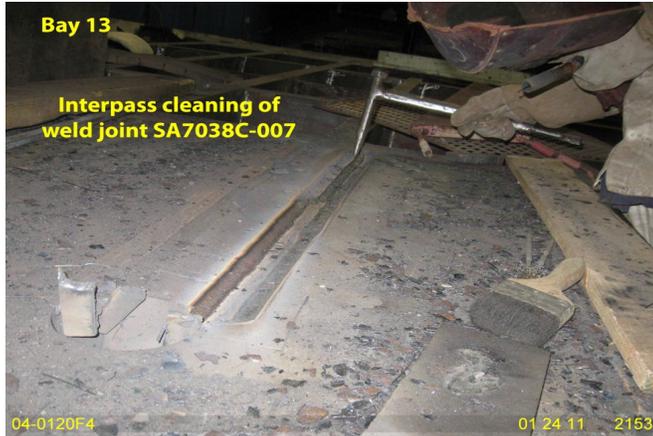
FCAW welding of weld joint SA7038C-007 located on OBG segment 13 grillage. Welder was identified as 066733. QC was identified as QC1. Assisting QC1 at this location and appearing to be monitoring the welding operation and recording data was QCA1, who was not a CWI. Weld variables recorded by QCA1 appeared to comply with WPS-B-T-2231-ESAB as verbally identified by QCA1. See photo below.
