Contract #: 04-0120F4Cty: SF/ALA Rte: 80 PM: 13.2/13.9File #: 69.28**WELDING INSPECTION REPORT****Resident Engineer:** Siegenthaler, Peter**Address:** 333 Burma Road**City:** Oakland, CA 94607**Report No:** WIR-019849**Date Inspected:** 01-Feb-2011**Project Name:** SAS Superstructure**OSM Arrival Time:** 700**Prime Contractor:** American Bridge/Fluor Enterprises, a JV**OSM Departure Time:** 1900**Contractor:** Zhenhua Port Machinery Company, Ltd (ZPMC), Changxing Island **Location:** Shanghai, China**CWI Name:** Mr. Qiu wen**CWI Present:** Yes No**Inspected CWI report:** Yes No N/A**Rod Oven in Use:** Yes No N/A**Electrode to specification:** Yes No N/A**Weld Procedures Followed:** Yes No N/A**Qualified Welders:** Yes No N/A**Verified Joint Fit-up:** Yes No N/A**Approved Drawings:** Yes No N/A**Approved WPS:** Yes No N/A**Delayed / Cancelled:** Yes No N/A**Bridge No:** 34-0006**Component:** Orthotropic Box Girder (OBG)**Summary of Items Observed:**

This CALTRANS OSM Quality Assurance Inspector (QA) Surendra Prabhu was present during the times noted above for observations relative to the fabrication of the Self Anchored Suspension (SAS) Superstructure being performed by Zhenhua Por

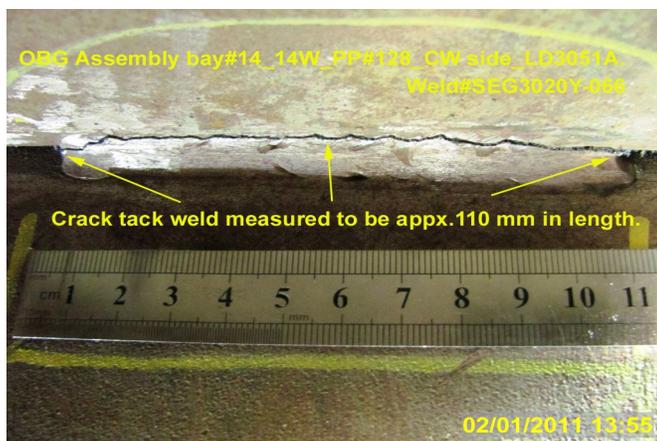
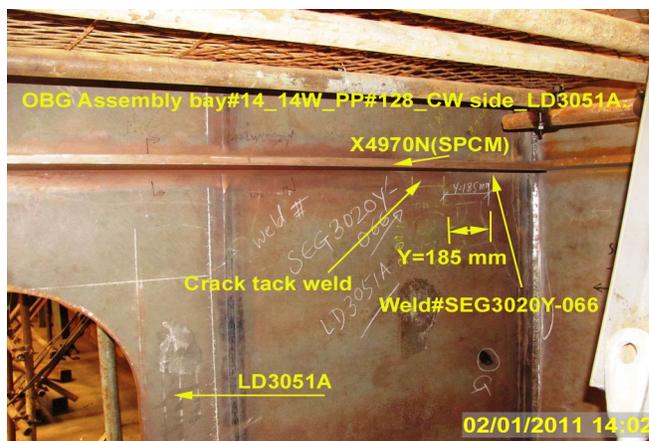
During random in process inspection of member identified as 14 West Panel Point(PP)#128 longitudinal diaphragm LD3051A, this QA observed a cracked tack weld on weld joint identified as SEG3020Y-066. This weld is joining to LD3051A to stiffener plate (X4970N). The “Y” location is approximately 185 mm from nearest end of the stiffener plate. The “Y” location is measured from PP#128 side as shown on the picture below. This QA marked the cracked tack and informed ZPMC Quality Control (QC) identified as Mr. Wang xiang pin of this issue. Mr. Wang xiang pin informed this QA that the cracked tack would be corrected in a manner compliant with the contract documents prior to start the welding. Refer the attached photos for reference.
