Contract #: 04-0120F4Cty: SF/ALA Rte: 80 PM: 13.2/13.9File #: 99.28**WELDING INSPECTION REPORT****Resident Engineer:** Siegenthaler, Peter**Address:** 333 Burma Road**City:** Oakland, CA 94607**Report No:** WIR-020545**Date Inspected:** 09-Feb-2011**Project Name:** SAS Superstructure**OSM Arrival Time:** 700**Prime Contractor:** American Bridge/Fluor Enterprises, a JV**OSM Departure Time:** 1900**Contractor:** Zhenhua Port Machinery Company, Ltd (ZPMC)**Location:** Shanghai, China

Orthotropic Box Girder (OBG) at Bay # 14

WELDING INSPECTION REPORT

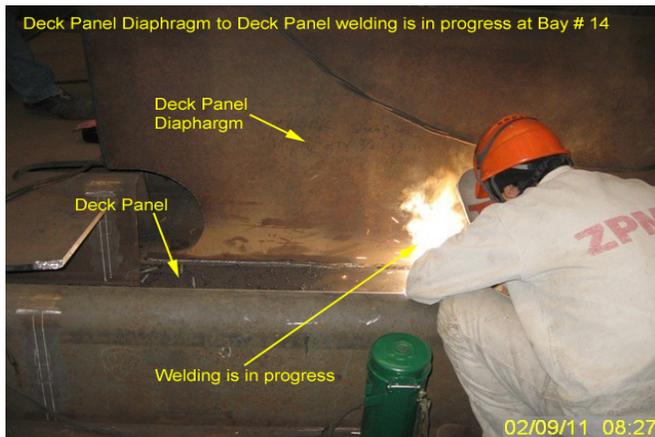
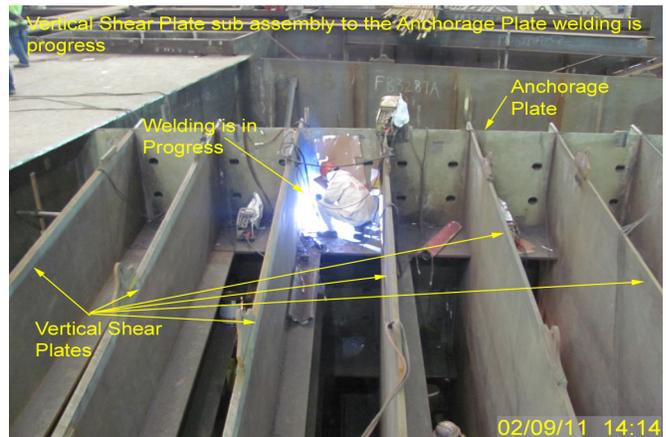
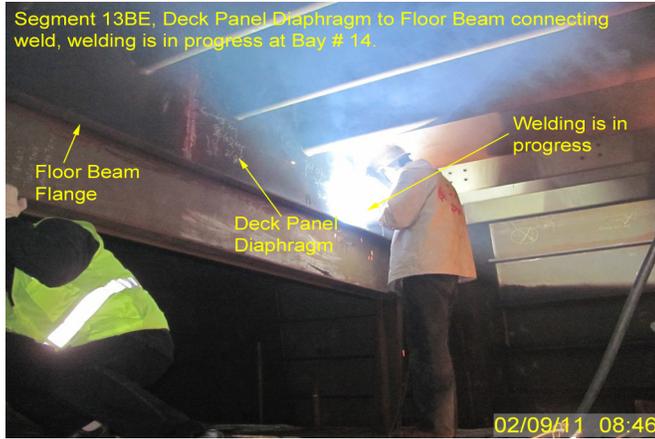
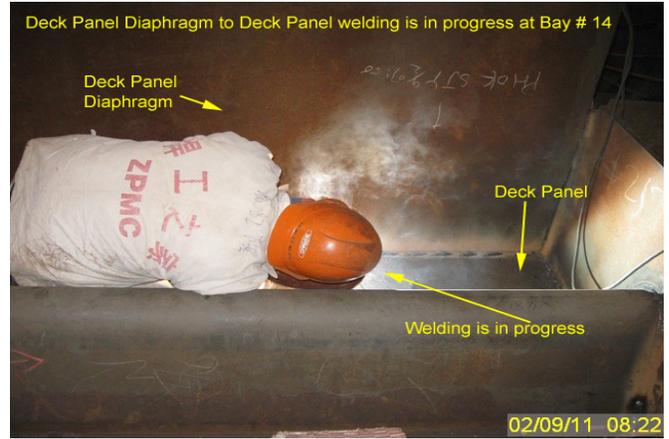
This QA Inspector observed the in-process welding by Shielded Metal Arc Welding (SMAW) process on a Complete Joint Penetration (CJP) groove weld. The Weld joint was designated as DP3173-001-019. The welder identification was 037779 and observed welding in the 2G(Horizontal) position using approved Welding Procedure Specification WPS-B-P-2212-Tc-U4b-FCM-1. The piece mark was identified as the weld connecting the Deck Panel Diaphragm to Deck Panel.

This QA Inspector observed the in-process welding by Shielded Metal Arc Welding (SMAW) process on a Complete Joint Penetration (CJP) groove weld. The Weld joint was designated as DP3174-001-018. The welder identification was 037780 and observed welding in the 2G(Horizontal) position using approved Welding Procedure Specification WPS-B-P-2212-Tc-U4b-FCM-1. The piece mark was identified as the weld connecting the Deck Panel Diaphragm to Deck Panel.

This QA Inspector observed the in-process welding by Flux Cored Arc Welding (FCAW) process on a Complete Joint Penetration (CJP) groove weld. The Weld joint was designated as Seg3019BB-047. The welder identification was 067877 and observed welding in the 3G (Vertical) position using approved Welding Procedure Specification WPS-B-T-2233-ESAB. The piece mark was identified as the weld connecting the Vertical Shear Plate sub

assembly identified as SA3359A to Anchorage Plate AP3031A.

This QA Inspector observed the in-process welding by Flux Cored Arc Welding (FCAW) process on a Complete Joint Penetration (CJP) groove weld. The Weld joint was designated as Seg3009B-006. The welder identification was 066881 and observed welding in the 2G (Horizontal) position using approved Welding Procedure Specification WPS-B-T-2232-ESAB. The piece mark was identified as the weld connecting the Floor Beam to Deck Panel Diaphragm.
