Contract #: 04-0120F4Cty: SF/ALA Rte: 80 PM: 13.2/13.9File #: 69.28**WELDING INSPECTION REPORT****Resident Engineer:** Siegenthaler, Peter**Address:** 333 Burma Road**City:** Oakland, CA 94607**Report No:** WIR-020799**Date Inspected:** 14-Feb-2011**Project Name:** SAS Superstructure**OSM Arrival Time:** 700**Prime Contractor:** American Bridge/Fluor Enterprises, a JV**OSM Departure Time:** 1900**Contractor:** Zhenhua Port Machinery Company, Ltd (ZPMC), Changxing Island **Location:** Shanghai, China**CWI Name:** Zhou Zhong Hai**CWI Present:** Yes No**Inspected CWI report:** Yes No N/A**Rod Oven in Use:** Yes No N/A**Electrode to specification:** Yes No N/A**Weld Procedures Followed:** Yes No N/A**Qualified Welders:** Yes No N/A**Verified Joint Fit-up:** Yes No N/A**Approved Drawings:** Yes No N/A**Approved WPS:** Yes No N/A**Delayed / Cancelled:** Yes No N/A**Bridge No:** 34-0006**Component:** OBG Segments**Summary of Items Observed:**

Segment 12BW/12CW

WELDING INSPECTION REPORT

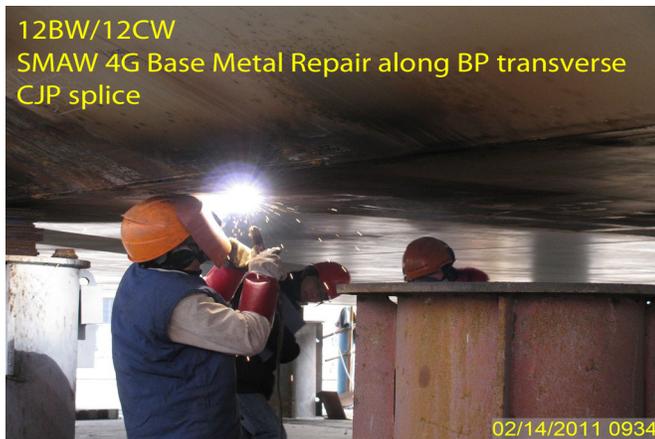
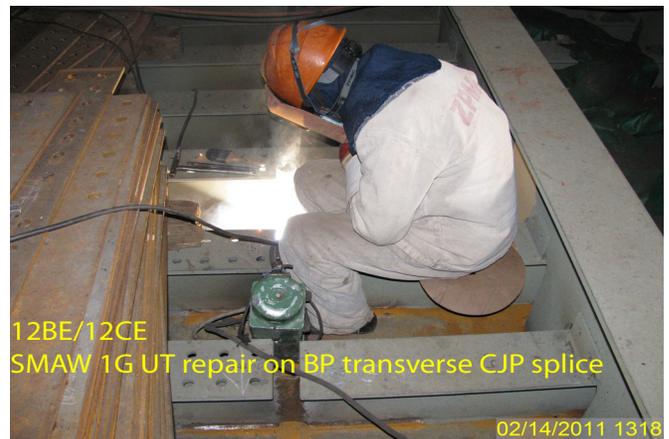
This QA Inspector observed Base Metal Repair using the Shielded Metal Arc Welding (SMAW) process at locations of removed fit up plates along the exterior of the Bottom Plate transverse CJP splice. The welder is identified as #202316 and was observed welding in the 4G (overhead) position using approved Welding Procedure Specification WPS-345-SMAW-4G (4F)-FCM-repair-1 for CWR2126.

This QA Inspector observed Shielded Metal Arc Welding (SMAW) in progress of a UT repair on a Complete Joint Penetration (CJP) weld joint. The Weld joint is designated OBE12C-001, Bottom Plate transverse splice. The welder is identified as #050289 and was observed welding in the 1G (flat) position using approved Welding Procedure Specification WPS-345-SMAW-1G (1F)-FCM-repair-1 for WR20190.

This QA Inspector observed Shielded Metal Arc Welding (SMAW) in progress of a fillet weld joint. The Weld joint is designated DP3012-001-016, Deck Plate I-rib hold back weld. The welder is identified as #040378 and was observed welding in the 4F (overhead) position using approved Welding Procedure Specification WPS-B-T-4114-1.

This QA Inspector observed grit blasting in progress of the FL3 Bottom Panel exterior.
