DEPARTMENT OF TRANSPORTATION

Contract #: 04-0120F4Cty: SF/ALA Rte: 80 PM: 13.2/13.9File #: 69.28**WELDING INSPECTION REPORT****Resident Engineer:** Siegenthaler, Peter**Address:** 333 Burma Road**City:** Oakland, CA 94607**Report No:** WIR-021520**Date Inspected:** 06-Mar-2011**Project Name:** SAS Superstructure**OSM Arrival Time:** 1500**Prime Contractor:** American Bridge/Fluor Enterprises, a JV**OSM Departure Time:** 300**Contractor:** Zhenhua Port Machinery Company, Ltd (ZPMC), Changxing Island **Location:** Shanghai, China**CWI Name:** Geng Wei**CWI Present:** Yes No**Inspected CWI report:** Yes No N/A**Rod Oven in Use:** Yes No N/A**Electrode to specification:** Yes No N/A**Weld Procedures Followed:** Yes No N/A**Qualified Welders:** Yes No N/A**Verified Joint Fit-up:** Yes No N/A**Approved Drawings:** Yes No N/A**Approved WPS:** Yes No N/A**Delayed / Cancelled:** Yes No N/A**Bridge No:** 34-0006**Component:** OBG Segment Assembly**Summary of Items Observed:**

OBG Segment 13AW / Bay 14

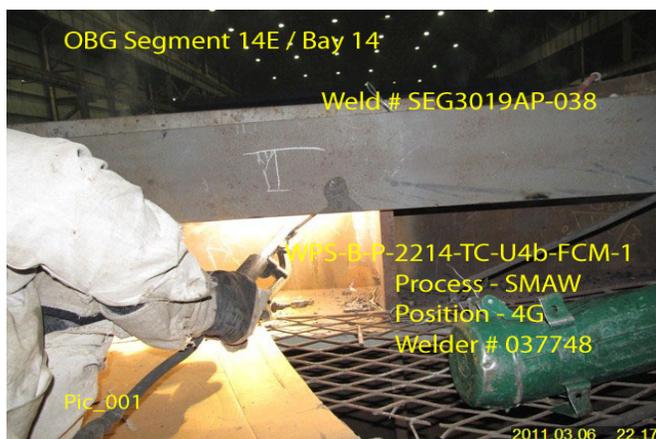
Shielded Metal Arc Welding (SMAW) in the 4G position of weld # SEG3019AP-038. The welder is identified as 037748. ZPMC Quality Control (QC) is identified as Zhong Yang Gang. The welding variables recorded by QC appeared to comply with WPS-B-P-2214-TC-U4b-FCM-1. See attached photograph Pic_001.
