Contract #: 04-0120F4Cty: SF/ALA Rte: 80 PM: 13.2/13.9File #: 69.28**WELDING INSPECTION REPORT**

Report No: WIR-021672
Date Inspected: 05-Mar-2011

Project Name: SAS Superstructure **OSM Arrival Time:** 1900
Prime Contractor: American Bridge/Fluor Enterprises, a JV **OSM Departure Time:** 700
Contractor: Zhenhua Port Machinery Company, Ltd (ZPMC), Changxing Island **Location:** Shanghai, China

OBG Bay 14

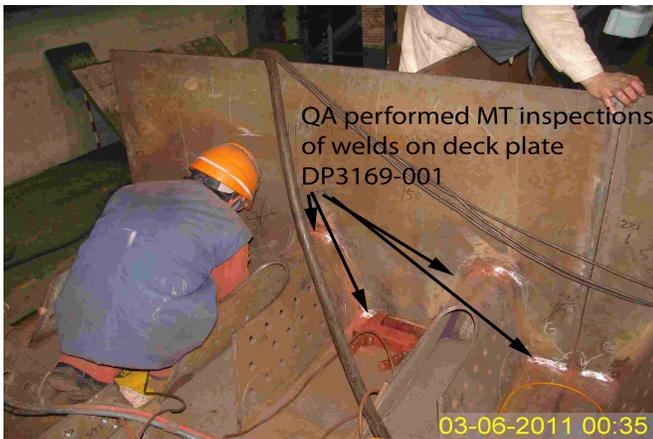
QA performed magnetic particle (MT) inspections of segment 14W deck plate welds DP3169-001-133, 138~141, 146~149, 122~129, 164, 169~172, 177~180, 013, 266, 185, 268, NWIT (NDT Inspection Notification Sheet) 8466 item #2. The NWIT listed above indicates welds DP3169-001-131, 132, 162 and 163 are also presented for MT inspections. This QA Inspector observed these welds have not been completed and it appears that ZPMC will complete these welds once the adjacent deck plate is welded to DP3169-001. This QA Inspector observed weld DP3169-001-164 was visually unacceptable due to weld overlap at the toe of the weld. This QA Inspector showed this weld overlap to ZPMC QA Inspectors and one of the ZPMC workers used an electric rotary file to remove the weld overlap. For additional information on these inspections see this QA Inspector's TL6028 magnetic particle test report and the photographs below.
