Contract #: 04-0120F4Cty: SF/ALA Rte: 80 PM: 13.2/13.9File #: 69.28**WELDING INSPECTION REPORT****Resident Engineer:** Siegenthaler, Peter**Address:** 333 Burma Road**City:** Oakland, CA 94607**Report No:** WIR-021823**Date Inspected:** 16-Mar-2011**Project Name:** SAS Superstructure**OSM Arrival Time:** 700**Prime Contractor:** American Bridge/Fluor Enterprises, a JV**OSM Departure Time:** 1900**Contractor:** Zhenhua Port Machinery Company, Ltd (ZPMC), Changxing Island **Location:** Shanghai, China**CWI Name:** Zho Zhong Hai**CWI Present:** Yes No**Inspected CWI report:** Yes No N/A**Rod Oven in Use:** Yes No N/A**Electrode to specification:** Yes No N/A**Weld Procedures Followed:** Yes No N/A**Qualified Welders:** Yes No N/A**Verified Joint Fit-up:** Yes No N/A**Approved Drawings:** Yes No N/A**Approved WPS:** Yes No N/A**Delayed / Cancelled:** Yes No N/A**Bridge No:** 34-0006**Component:** Orthotropic Box Girder (OBG)**Summary of Items Observed:**

OBG # TRIAL ASSEMBLY YARD**WELDING:****Segment 12CW**

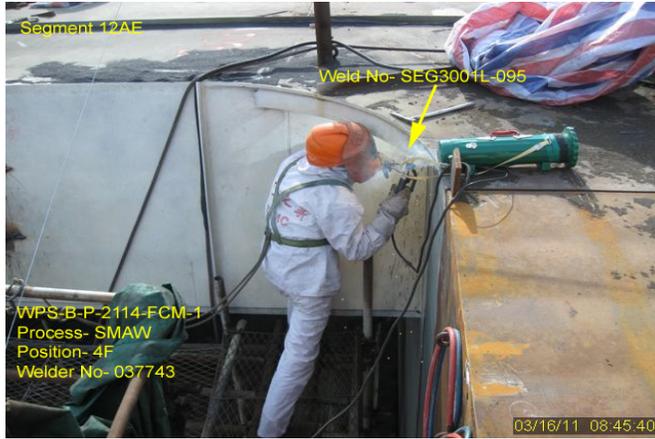
This QA Inspector observed ZPMC qualified welding personnel identified as 057333 perform Shielded Metal Arc Welding (SMAW), weld joint identified as FB3095-001-065; located On Orthotropic Box Girder (OBG) Floor Beam to Stiffener Hold Back Fillet Weld; ZPMC Quality Control (QC) is identified as Mr. Wang Zhu. This QA Inspector observed the base material appears to have been preheated by a torch prior to welding. ZPMC Quality Control (QC) Mr. Wang Zhu was onsite monitoring the welding variables. The welding variables recorded by QC appeared to comply with applicable WPS-B-P-2114-FCM-1. See attached photo for further details.
