Contract #: 04-0120F4Cty: SF/ALA Rte: 80 PM: 13.2/13.9File #: 99.28**WELDING INSPECTION REPORT****Resident Engineer:** Siegenthaler, Peter**Address:** 333 Burma Road**City:** Oakland, CA 94607**Report No:** WIR-021839**Date Inspected:** 17-Mar-2011**Project Name:** SAS Superstructure**OSM Arrival Time:** 700**Prime Contractor:** American Bridge/Fluor Enterprises, a JV**OSM Departure Time:** 1900**Contractor:** Zhenhua Port Machinery Company, Ltd (ZPMC), Changxing Island**Location:** Shanghai**CWI Name:** Tian Lei, Liu Fa Wen**CWI Present:** Yes No**Inspected CWI report:** Yes No N/A**Rod Oven in Use:** Yes No N/A**Electrode to specification:** Yes No N/A**Weld Procedures Followed:** Yes No N/A**Qualified Welders:** Yes No N/A**Verified Joint Fit-up:** Yes No N/A**Approved Drawings:** Yes No N/A**Approved WPS:** Yes No N/A**Delayed / Cancelled:** Yes No N/A**Bridge No:** 34-0006**Component:** OBG**Summary of Items Observed:**

# WELDING INSPECTION REPORT

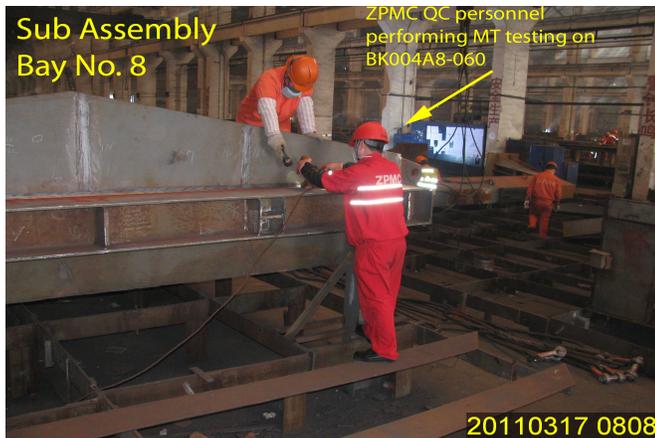
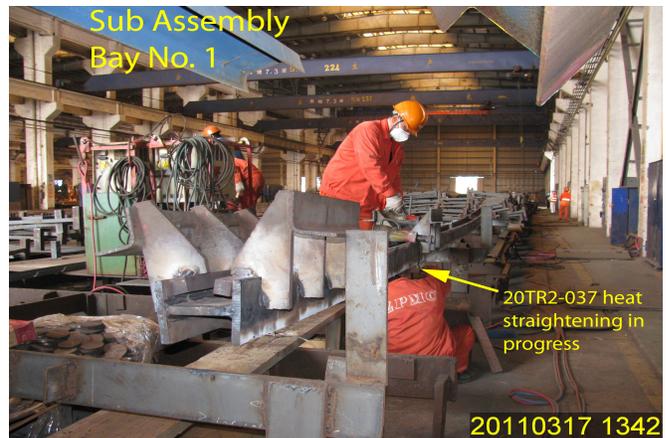
SMAW welding of complete joint penetration welds located on Bike Path component identified as BK004A5-062 weld no.(s) 002, 003, 006, & 008. Welder is identified as welder no. 040673. The welding variables recorded by ZPMC QC identified as Liu Fa Wen appeared to comply with applicable WPS(s) WPS-B-P-2211-TC-U4b.

SMAW welding of complete joint penetration welds located on Bike Path component identified as BK004A5-062 weld no.(s) 112, 115, 118, 121, 122, 125, 128, & 131. Welder is identified as welder no. 069493. The welding variables recorded by ZPMC QC identified as Liu Fa Wen appeared to comply with applicable WPS(s) WPS-B-P-2213-B-U2.
