DEPARTMENT OF TRANSPORTATION

Contract #: 04-0120F4Cty: SF/ALA Rte: 80 PM: 13.2/13.9File #: 69.28**WELDING INSPECTION REPORT****Resident Engineer:** Siegenthaler, Peter**Address:** 333 Burma Road**City:** Oakland, CA 94607**Report No:** WIR-022037**Date Inspected:** 17-Mar-2011**Project Name:** SAS Superstructure**OSM Arrival Time:** 700**Prime Contractor:** American Bridge/Fluor Enterprises, a JV**OSM Departure Time:** 1900**Contractor:** Zhenhua Port Machinery Company, Ltd (ZPMC), Changxing Island **Location:** Shanghai, China

OBG Assembly bay- 14.

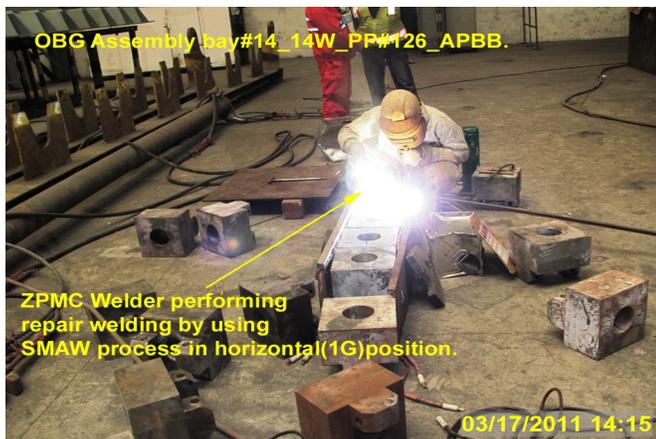
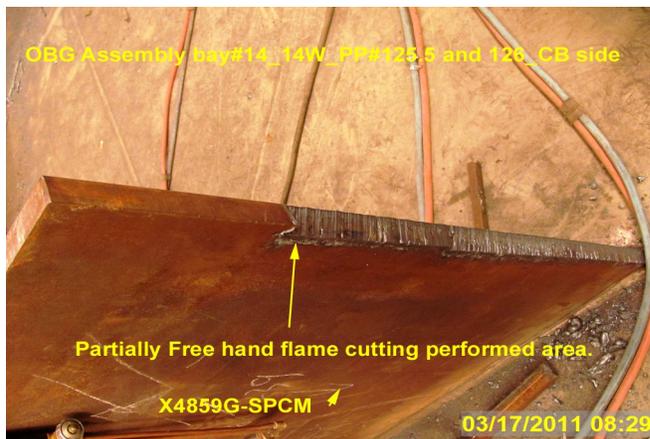
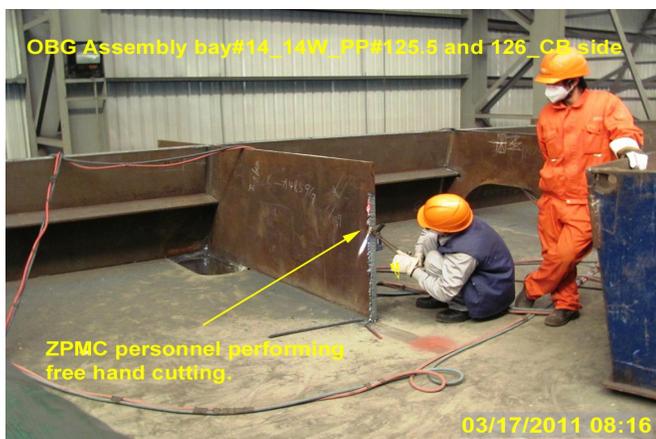
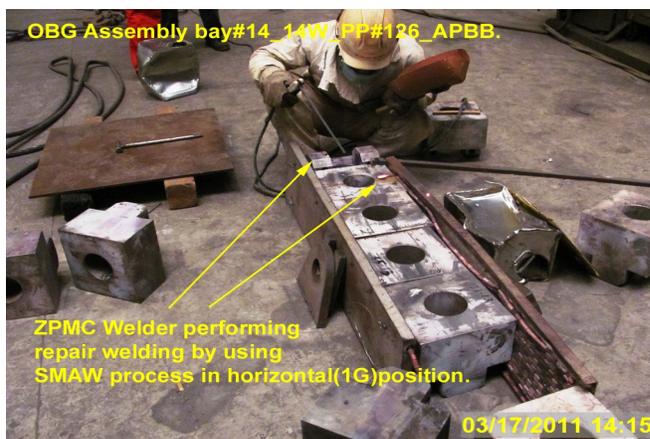
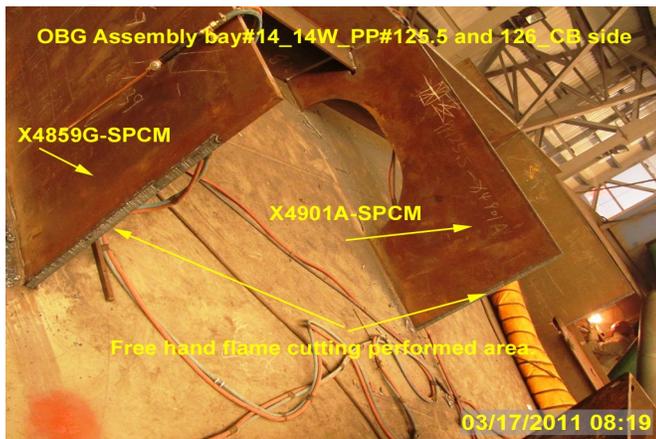
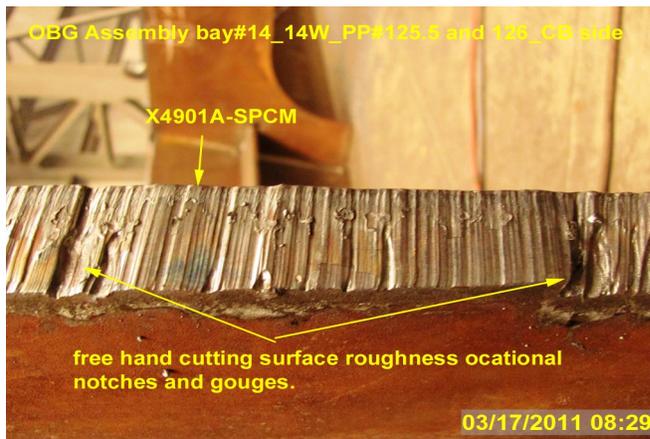
SMAW repair welding of Anchor plate bearing block (APBB) Casting blocks identified as APBB1-094-2,065-13, 108-7,065-6 and 121-13. Welder is identified as 067765. ZPMC Quality Control (QC) is identified as Mr. Shi lei. The welding variables recorded by QC personnel observed appeared to comply with WPS:
WPS-casting-SMAW-1G-repair-1. The repair welding was being performed as per Critical Welding Repair Report (CWR) No: B-CWR2857. These blocks was previously rejected by ZPMC QC MT Technicians personnel and recorded on MT report B787-MT-37137. See attached photos for further details.

During Quality Assurance random in-process observations of the fabrication of OBG Lift 14 west deck panel diaphragms X4901A and X4859G at Panel point no.125.5 and 126 Cross beam side, this QA observed ZPMC personnel have performed Free Hand Flame Cutting for more than 300mm in length. Access to the areas being cut were not restricted due to cross sectional geometry and or position in so far as mechanical guides could not be used. The approximate cut length as measured by this QA was 900mm. The deck panel diaphragm plates are identified as X4901A and X4859G. The deck panel diaphragm are designated as Seismic Performance Critical Material (SPCM) on the approved drawing. The affected CJP weld joints are identified as SEG3020R-015 and SEG3020T-278. The deck panel diaphragm plate materials mentioned above are 25 mm in thickness. This QA informed to ZPMC QC identified as Mr. Zhulin and CWI identified as An Qing xiang. ZPMC QC and CWI informed this QA Inspector that in future free hand cutting work shall be performed as per the contract documents and AB/F submitted procedure identified as ABF Free Hand Flame Cutting Procedure, Dated 01-27-09. See attached photos for further details. This QA Inspector also informed to shop Lead QA Inspector of this issue. This QA Inspector did not generate an Incident Report for the above issue as per the shop Lead QA Inspector's instructions.
