**DEPARTMENT OF TRANSPORTATION**

Contract #: 04-0120F4Cty: SF/ALA Rte: 80 PM: 13.2/13.9File #: 99.28**WELDING INSPECTION REPORT****Resident Engineer:** Siegenthaler, Peter**Address:** 333 Burma Road**City:** Oakland, CA 94607**Report No:** WIR-022159**Date Inspected:** 21-Mar-2011**Project Name:** SAS Superstructure**OSM Arrival Time:** 700**Prime Contractor:** American Bridge/Fluor Enterprises, a JV**OSM Departure Time:** 1900**Contractor:** Zhenhua Port Machinery Company, Ltd (ZPMC) Chanxing Island**Location:** Shanghai, China**CWI Name:** Mr. ZHU ZHONG HAI**CWI Present:** Yes No**Inspected CWI report:** Yes No N/A**Rod Oven in Use:** Yes No N/A**Electrode to specification:** Yes No N/A**Weld Procedures Followed:** Yes No N/A**Qualified Welders:** Yes No N/A**Verified Joint Fit-up:** Yes No N/A**Approved Drawings:** Yes No N/A**Approved WPS:** Yes No N/A**Delayed / Cancelled:** Yes No N/A**Bridge No:** 34-0006**Component:** OBG Segment**Summary of Items Observed:**

## WELDING INSPECTION REPORT

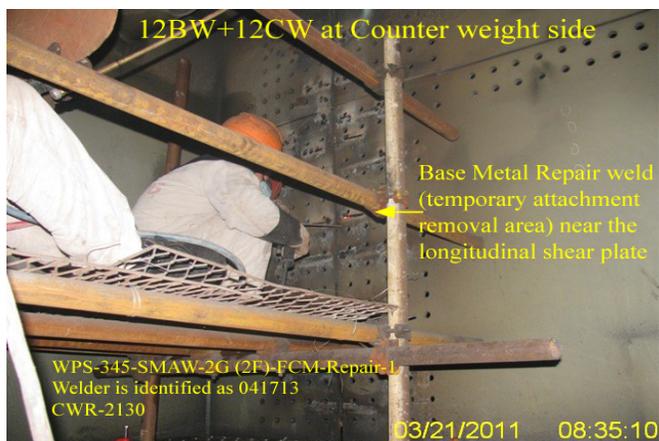
ZPMC welding personnel performing Shielded Metal Arc Welding of Base Metal Repair weld (temporary attachment removal area) near the longitudinal shear plate located on 12BW+12CW at counter weight side. The location near the weld is longitudinal shear plate to deck plate & bottom plate. The welder is identified as 041713. ZPMC QC Mr. ZHOU PENG was onsite monitoring the welding variables. The inprocess Shielded Metal Arc Welding appears to be progressing in compliance with WPS-345-SMAW-2G (2F)-FCM-Repair-1. The weld repair report number is named as CWR-2130. Further weld detail mention in attached picture.
