Contract #: 04-0120F4Cty: SF/ALA Rte: 80 PM: 13.2/13.9File #: 69.28**WELDING INSPECTION REPORT****Resident Engineer:** Siegenthaler, Peter**Address:** 333 Burma Road**City:** Oakland, CA 94607**Report No:** WIR-023195**Date Inspected:** 28-Apr-2011**Project Name:** SAS Superstructure**OSM Arrival Time:** 700**Prime Contractor:** American Bridge/Fluor Enterprises, a JV**OSM Departure Time:** 1900**Contractor:** Zhenhua Port Machinery Company, Ltd (ZPMC), Changxing Island **Location:** Shanghai, China**CWI Name:** Liu Hua Jie/Geng wei**CWI Present:** Yes No**Inspected CWI report:** Yes No N/A**Rod Oven in Use:** Yes No N/A**Electrode to specification:** Yes No N/A**Weld Procedures Followed:** Yes No N/A**Qualified Welders:** Yes No N/A**Verified Joint Fit-up:** Yes No N/A**Approved Drawings:** Yes No N/A**Approved WPS:** Yes No N/A**Delayed / Cancelled:** Yes No N/A**Bridge No:** 34-0006**Component:** OBG**Summary of Items Observed:**

OBG Trial Assembly

WELDING INSPECTION REPORT

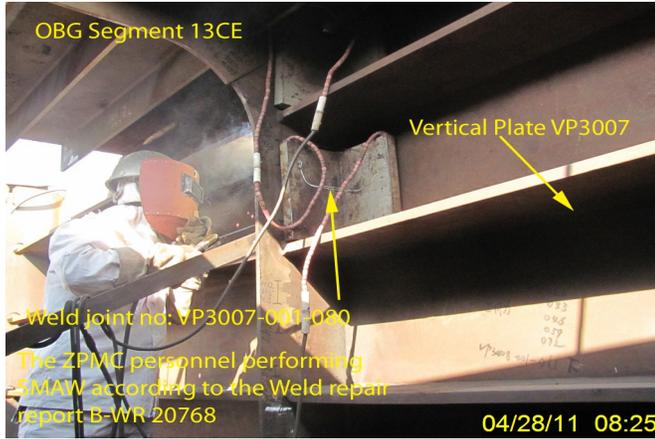
SMAW welding of weld joint No: VP3007-001-080 located on OBG Segment 13CE Vertical plate stiffener. Welder is identified as #066258. ZPMC QC is identified as Mr. Wang Xu. Welding was performed with the weld repair report BWR-20768. The welding variables recorded by QC appeared to comply with the WPS-345-SMAW-3G(3F)-FCM-Repair-1. Please see the attached picture.

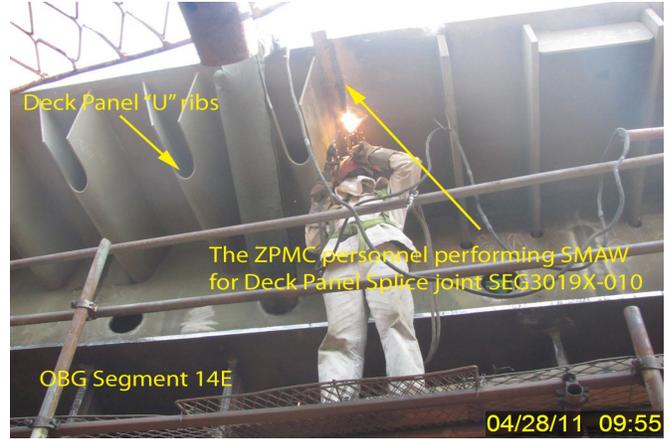
SMAW in the 4G position for the OBG Segment 14E Deck panel splice. The weld joint was designated as: SEG3019X-010. The welder is identified as #067656. ZPMC CWI is identified as Mr. Lv Li Qing. The welding variables recorded by QC appear to comply with WPS-B-P-2214-B-U2-FCM-1. Please see the attached picture.
