Contract #: 04-0120F4Cty: SF/ALA Rte: 80 PM: 13.2/13.9File #: 69.28**WELDING INSPECTION REPORT****Resident Engineer:** Siegenthaler, Peter**Address:** 333 Burma Road**City:** Oakland, CA 94607**Report No:** WIR-024030**Date Inspected:** 20-Apr-2011**Project Name:** SAS Superstructure**OSM Arrival Time:** 700**Prime Contractor:** American Bridge/Fluor Enterprises, a JV**OSM Departure Time:** 1900**Contractor:** Zhenhua Port Machinery Company, Ltd (ZPMC), Changxing Island **Location:** Shanghai, China**CWI Name:** Xu Le Feng**CWI Present:** Yes No**Inspected CWI report:** Yes No N/A**Rod Oven in Use:** Yes No N/A**Electrode to specification:** Yes No N/A**Weld Procedures Followed:** Yes No N/A**Qualified Welders:** Yes No N/A**Verified Joint Fit-up:** Yes No N/A**Approved Drawings:** Yes No N/A**Approved WPS:** Yes No N/A**Delayed / Cancelled:** Yes No N/A**Bridge No:** 34-0006**Component:** TOWER Components**Summary of Items Observed:**

WELDING INSPECTION REPORT

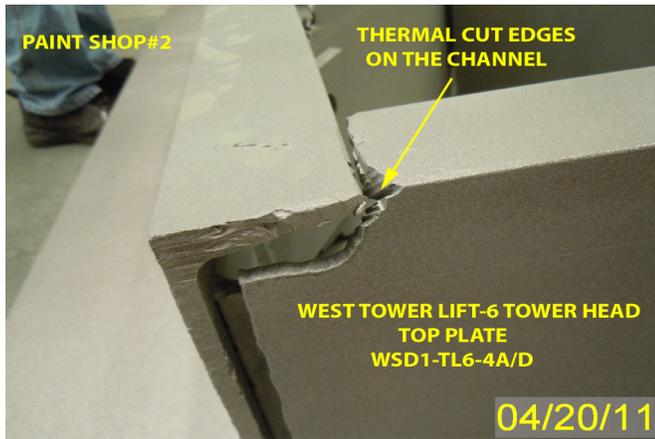
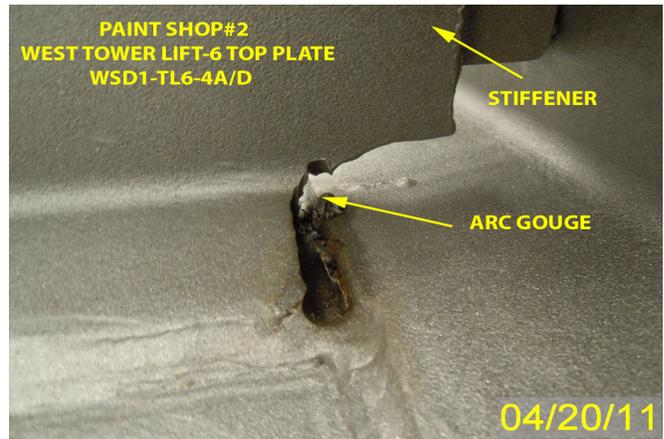
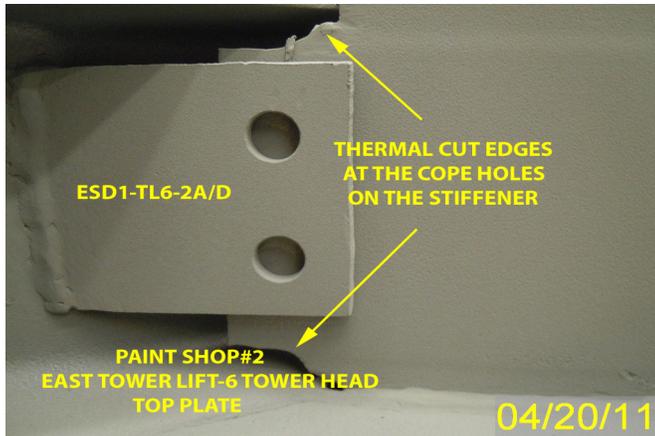
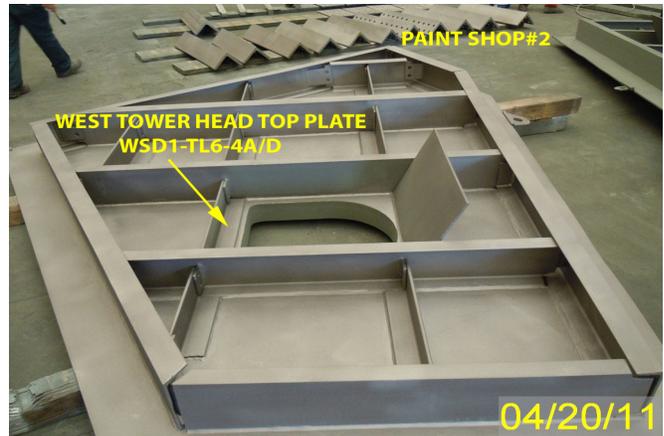
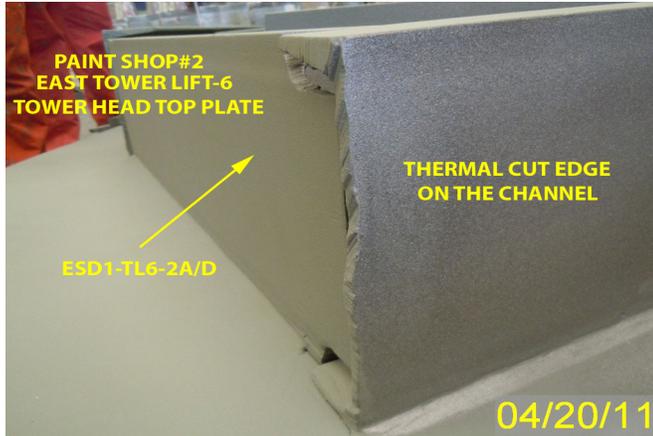
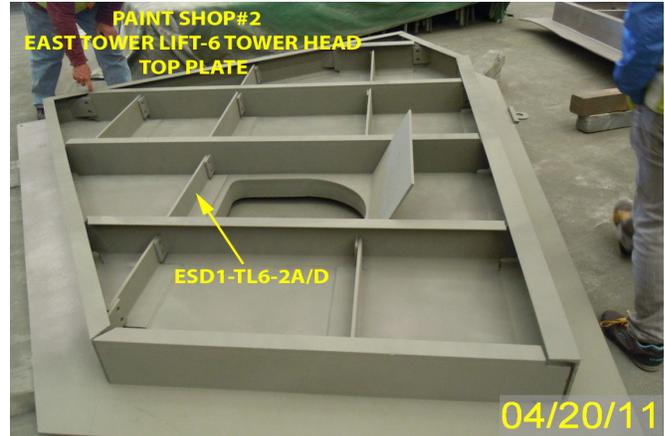
During the Caltrans Quality Assurance (QA) in-process observation on Lift-6 tower head top plates of East and West shafts, this QA Inspector discovered the following issue:

- ZPMC personnel proceeded with blasting in preparation for coating prior to component being Green Tagged.
- During the random visual inspection this QA inspector observed arc gouges in the base metal and thermal cut edges that require repair.
- The components identified as:-
 1. East tower top plate – ESD1-TL6-2A/D
 2. West tower top plate – WSD1-TL6-4A/D
- These members are Non-Seismic Performance Critical Member's (SPCM).
- These components are located at Paint shop # 2.
