**DEPARTMENT OF TRANSPORTATION**

Office of Structural Materials

Contract #: 04-0120F4Cty: SF/ALA Rte: 80 PM: 13.2/13.9File #: 99.28**WELDING INSPECTION REPORT****Resident Engineer:** Siegenthaler, Peter**Address:** 333 Burma Road**City:** Oakland, CA 94607**Report No:** WIR-026341**Date Inspected:** 21-Apr-2011**Project Name:** SAS Superstructure**OSM Arrival Time:** 1500**Prime Contractor:** American Bridge/Fluor Enterprises, a JV**OSM Departure Time:** 300**Contractor:** Zhenhua Port Machinery Company, Ltd (ZPMC) Changxing Island **Location:** Shanghai, China**CWI Name:** Lv Li Qing**CWI Present:** Yes No**Inspected CWI report:** Yes No N/A**Rod Oven in Use:** Yes No N/A**Electrode to specification:** Yes No N/A**Weld Procedures Followed:** Yes No N/A**Qualified Welders:** Yes No N/A**Verified Joint Fit-up:** Yes No N/A**Approved Drawings:** Yes No N/A**Approved WPS:** Yes No N/A**Delayed / Cancelled:** Yes No N/A**Bridge No:** 34-0006**Component:** OBG**Summary of Items Observed:**

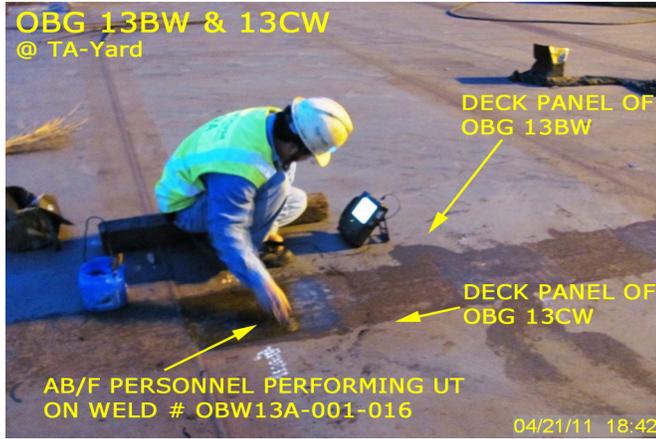
During random in process observations of OBG Segment 13BW, this QA inspector observed AB/F personnel performing Ultrasonic Testing on weld joint identified as OBW13A-001-016 located on deck panel to deck panel of OBG Segment 13BW & 13CW. This QA performed Visual Testing (VT) of the joint and found that appeared to be in general compliance with the applicable contract documents. For more details please see attached photo below:
