Contract #: 04-0120F4Cty: SF/ALA Rte: 80 PM: 13.2/13.9File #: 69.28**WELDING INSPECTION REPORT****Resident Engineer:** Siegenthaler, Peter**Address:** 333 Burma Road**City:** Oakland, CA 94607**Report No:** WIR-023714**Date Inspected:** 15-May-2011**Project Name:** SAS Superstructure**OSM Arrival Time:** 700**Prime Contractor:** American Bridge/Fluor Enterprises, a JV**OSM Departure Time:** 1900**Contractor:** Zhenhua Port Machinery Company, Ltd (ZPMC), Changxing Island **Location:** Shanghai, China**CWI Name:** Zhu Zhong Hai**CWI Present:** Yes No**Inspected CWI report:** Yes No N/A**Rod Oven in Use:** Yes No N/A**Electrode to specification:** Yes No N/A**Weld Procedures Followed:** Yes No N/A**Qualified Welders:** Yes No N/A**Verified Joint Fit-up:** Yes No N/A**Approved Drawings:** Yes No N/A**Approved WPS:** Yes No N/A**Delayed / Cancelled:** Yes No N/A**Bridge No:** 34-0006**Component:** Orthotropic Box Girder (OBG)**Summary of Items Observed:**

OBG # TRIAL ASSEMBLY YARD**WELDING:****Segment 13AE**

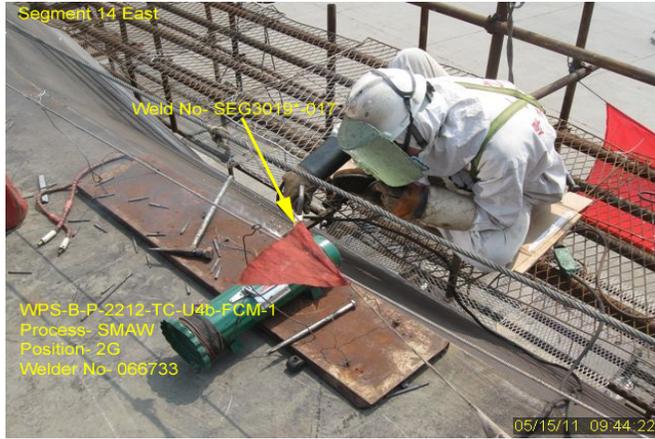
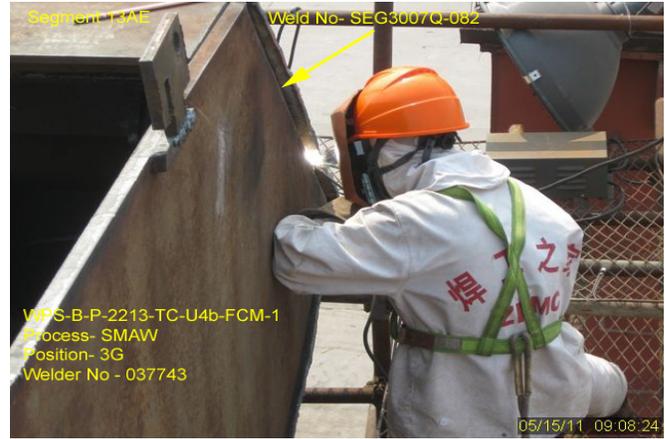
This QA Inspector observed ZPMC qualified welding personnel identified as 037743 perform Shielded Metal Arc Welding (SMAW), weld joint identified as SEG3007Q-082 ; located On Orthotropic Box Girder (OBG) X3490A to AH3150A CJP Weld; ZPMC Quality Control (QC) is identified as Mr. Zhang Yong Yong. This QA Inspector observed the base material appears to have been preheated by an electrical heating element prior to welding. ZPMC Quality Control (QC) Mr. Zhang Yong Yong was onsite monitoring the welding variables. The welding variables recorded by QC appeared to comply with applicable WPS-B-P-2213-TC-U4b-FCM-1. See attached photo for further details.

Welding (SMAW), weld joint identified as SEG3019*-017; located On Orthotropic Box Girder (OBG) Deck Plate to Deck Plate CJP Weld; ZPMC Quality Control (QC) is identified as Mr. Zhang Lin. This QA Inspector observed the base material appears to have been preheated by an electrical heating element prior to welding. ZPMC Quality Control (QC) Mr. Zhang Lin was onsite monitoring the welding variables. The welding variables recorded by QC appeared to comply with applicable WPS-B-P-2212-TC-U4b-FCM-1. See attached photo for further details.

This QA Inspector observed ZPMC qualified welding personnel identified as 068567 perform Flux Cored Arc Welding (FCAW), weld joint identified as SEG3007Q-072; located On Orthotropic Box Girder (OBG) SP3071C to I-Rib CJP Weld; ZPMC Quality Control (QC) is identified as Mr. Zhong Yong Yong. This QA Inspector observed the base material appears to have been preheated by an electrical heating element prior to welding. ZPMC Quality Control (QC) Mr. Zhong Yong Yong was onsite monitoring the welding variables. The welding variables recorded by QC appeared to comply with applicable WPS-B-T-2233-ESAB. See attached photo for further details.
