DEPARTMENT OF TRANSPORTATION

Quality Assurance and Source Inspection

Contract #: 04-0120F4Cty: SF/Ala Rte: 80 PM: 13.2/13.9File #: 69.28**WELDING INSPECTION REPORT****Resident Engineer:** Siegenthaler, Peter**Address:** 333 Burma Road**City:** Oakland, CA 94607**Report No:** WIR-023744**Date Inspected:** 11-May-2011**Project Name:** SAS Superstructure**OSM Arrival Time:** 1900**Prime Contractor:** American Bridge/Fluor Enterprises, a JV**OSM Departure Time:** 700**Contractor:** Zhenhua Port Machinery Company, Ltd (ZPMC), Changxing Island **Location:** Shanghai, China**CWI Name:** See below**CWI Present:** Yes No**Inspected CWI report:** Yes No N/A**Rod Oven in Use:** Yes No N/A**Electrode to specification:** Yes No N/A**Weld Procedures Followed:** Yes No N/A**Qualified Welders:** Yes No N/A**Verified Joint Fit-up:** Yes No N/A**Approved Drawings:** Yes No N/A**Approved WPS:** Yes No N/A**Delayed / Cancelled:** Yes No N/A**Bridge No:** 34-0006**Component:** OBG Components**Summary of Items Observed:**

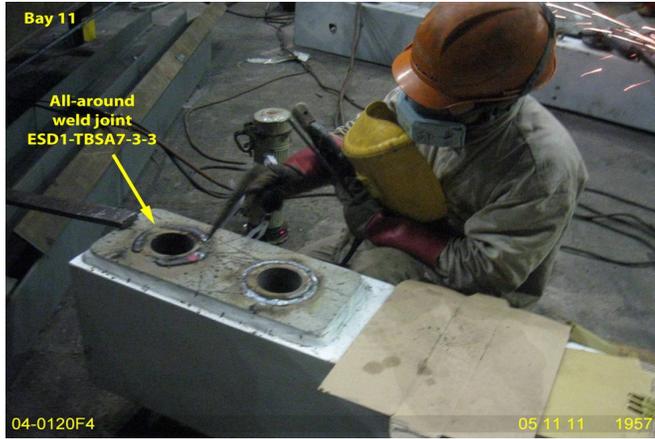
SMAW welding of weld joints ESD1-TBSA7-3-3, 4, 5, 6, 37, 38, 39, 40 located on PCMK East Tower, lift 7 and NSD1-TBSA7-3-3, 4, 5, 6, 37, 38, 39, 40 located on PCMK North Tower, lift 7. Welder was identified as 041271. QC was identified as ZPMC CWI Zhu Feng (QC1). Assisting QC1 at this location and appearing to be monitoring the welding operation and recording data was ZPMC QC Wang Chuang Xin (QCA1), who was not a CWI. Weld variables recorded by QCA1 appeared to comply with WPS-B-P-2212 as verbally identified by QCA1. See photo below of ZPMC welder 041271 cleaning the previous pass of weld joint ESD1-TBSA7-3-3.
