Contract #: 04-0120F4Cty: SF/ALA Rte: 80 PM: 13.2/13.9File #: 69.28**WELDING INSPECTION REPORT****Resident Engineer:** Siegenthaler, Peter**Address:** 333 Burma Road**City:** Oakland, CA 94607**Report No:** WIR-024034**Date Inspected:** 27-May-2011**Project Name:** SAS Superstructure**OSM Arrival Time:** 700**Prime Contractor:** American Bridge/Fluor Enterprises, a JV**OSM Departure Time:** 1900**Contractor:** Zhenhua Port Machinery Company, Ltd (ZPMC), Changxing Island **Location:** Shanghai, China

Orthotropic Box Girder (OBG) at Trial Assembly Areas

## WELDING INSPECTION REPORT

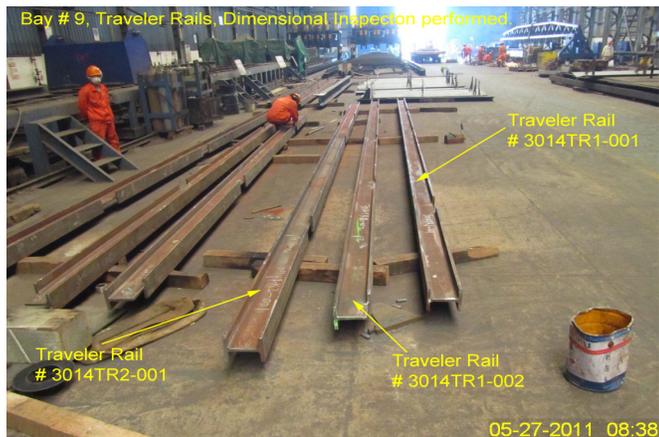
This QA Inspector performed Dimension Control Inspection on the following Traveler Rails against the Inspection Notification # 09257 at Bay # 9.

The following measurements were performed and found dimensions are in compliance with the contract document.
