Contract #: 04-0120F4Cty: SF/ALA Rte: 80 PM: 13.2/13.9File #: 69.28**WELDING INSPECTION REPORT****Resident Engineer:** Siegenthaler, Peter**Address:** 333 Burma Road**City:** Oakland, CA 94607**Report No:** WIR-024901**Date Inspected:** 27-Jun-2011**Project Name:** SAS Superstructure**OSM Arrival Time:** 700**Prime Contractor:** American Bridge/Fluor Enterprises, a JV**OSM Departure Time:** 1900**Contractor:** Zhenhua Port Machinery Company, Ltd (ZPMC), Changxing Island **Location:** Shanghai, China**CWI Name:** An Qing Xiang**CWI Present:** Yes No**Inspected CWI report:** Yes No N/A**Rod Oven in Use:** Yes No N/A**Electrode to specification:** Yes No N/A**Weld Procedures Followed:** Yes No N/A**Qualified Welders:** Yes No N/A**Verified Joint Fit-up:** Yes No N/A**Approved Drawings:** Yes No N/A**Approved WPS:** Yes No N/A**Delayed / Cancelled:** Yes No N/A**Bridge No:** 34-0006**Component:** OBG**Summary of Items Observed:**

BLAST SHOP 1, OBG 14E

OBG SEGMENT 14W

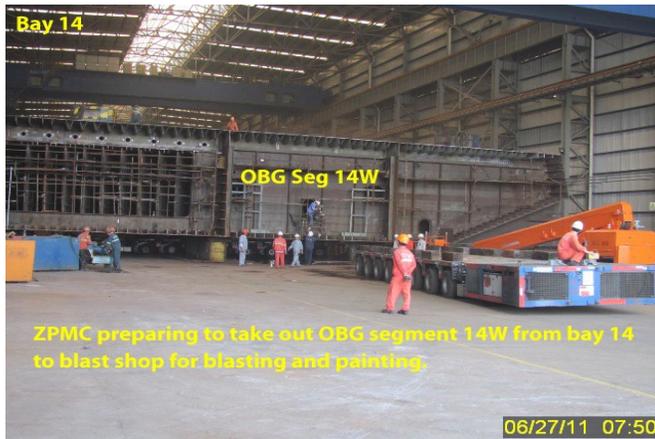
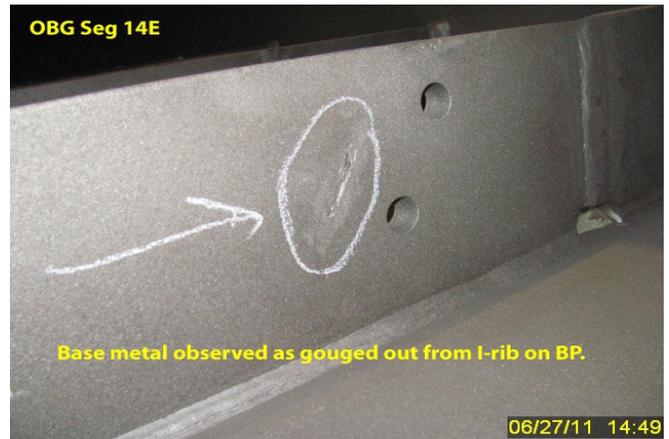
This QA Inspector performed Blast inspection on base metal, fillet welds and complete joint penetration (CJP) welds from panel point (PP) 125 to PP128.3 on internal surface of side panel, floor beam and bottom panel of OBG segment 14East on cross beam side. During inspection, several non conforming discontinuities such as weld spatter, deep gouges and arc strikes were observed. These areas were marked up for repair. All information regarding this marked on weld map and submitted to Lead QA Inspector. See attached photos for additional information.

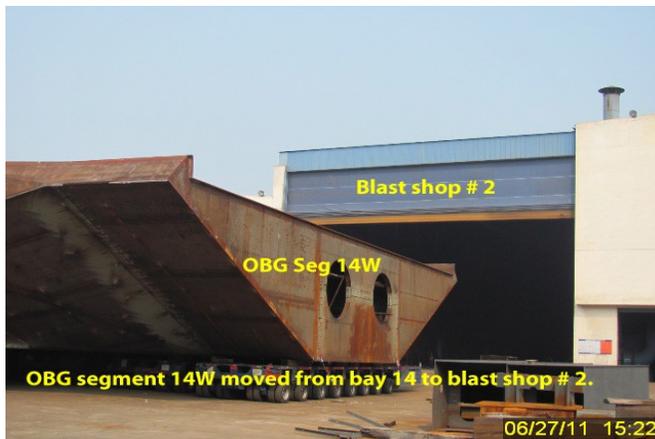
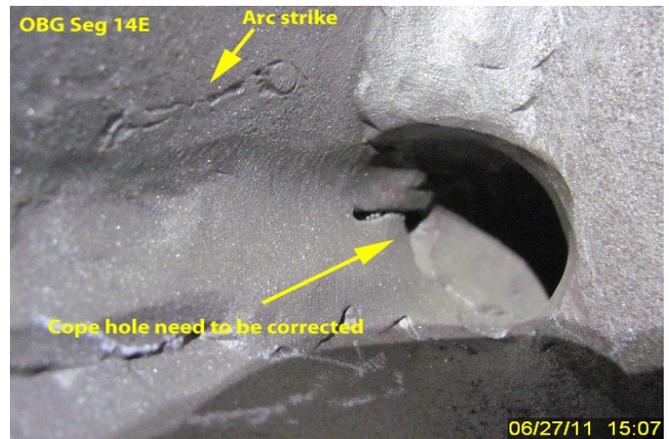
During random in process inspection this QA Inspector observed that ZPMC personnel moved the OBG segment 14W from bay 14 to blast shop # 2 for blasting and painting. See attached photos for additional information.
