**DEPARTMENT OF TRANSPORTATION**

Contract #: 04-0120F4Cty: SF/ALA Rte: 80 PM: 13.2/13.9File #: 69.28**WELDING INSPECTION REPORT****Resident Engineer:** Siegenthaler, Peter**Address:** 333 Burma Road**City:** Oakland, CA 94607**Report No:** WIR-025061**Date Inspected:** 03-Jul-2011**Project Name:** SAS Superstructure**OSM Arrival Time:** 700**Prime Contractor:** American Bridge/Fluor Enterprises, a JV**OSM Departure Time:** 1900**Contractor:** Zhenhua Port Machinery Company, Ltd (ZPMC), Changxing Island **Location:** Shanghai, China**CWI Name:** An Qing Xiang**CWI Present:** Yes No**Inspected CWI report:** Yes No N/A**Rod Oven in Use:** Yes No N/A**Electrode to specification:** Yes No N/A**Weld Procedures Followed:** Yes No N/A**Qualified Welders:** Yes No N/A**Verified Joint Fit-up:** Yes No N/A**Approved Drawings:** Yes No N/A**Approved WPS:** Yes No N/A**Delayed / Cancelled:** Yes No N/A**Bridge No:** 34-0006**Component:** OBG**Summary of Items Observed:**

**BLAST SHOP 4, OBG 13AW**

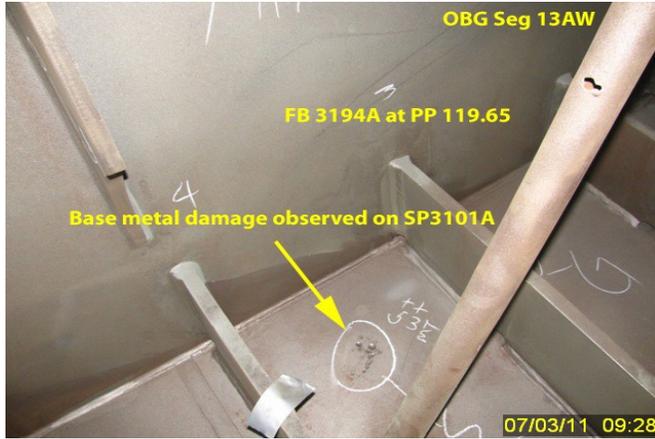
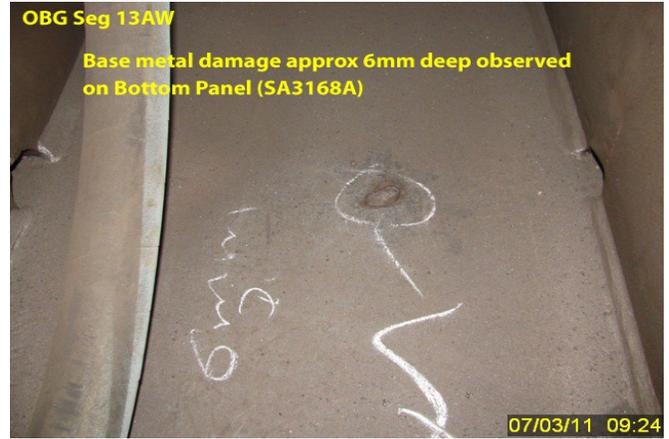
This QA Inspector performed Blast inspection on base metal, fillet welds and complete joint penetration (CJP) welds from panel point (PP) 119+1500 to PP 120.5 on internal surface of floor beam, side panel and bottom panel of OBG segment 13AW at cable side section. During inspection, several non conforming discontinuities such as weld spatter, deep gouges, arc strikes and improper temporary attachment removal were observed. These areas were marked up for repair. All information regarding this marked on weld map and submitted to Lead QA Inspector. See attached photos for additional information.
