Contract #: 04-0120F4Cty: SF/ALA Rte: 80 PM: 13.2/13.9File #: 83.25B**QUALITY ASSURANCE -- NON-CONFORMANCE REPORT****Location:** SAS Superstructure**Report No:** NCR-001121**Prime Contractor:** American Bridge/Fluor Enterprises, a JV**Date:** 29-Apr-2013**Submitting Contractor:** Certified Coating Company**NCR #:** CCC-0009**Type of problem:**

<b>Welding</b>	<b>Concrete</b>	<b>Other</b>	
<b>Welding</b>	<b>Curing</b>	<b>Procedural</b>	<b>Bridge No:</b> 34-0006
<b>Joint fit-up</b>	<b>Coating</b>	<b>Other</b>	<b>Component:</b> Cable System - Suspender Brackets
<b>Procedural</b>	<b>Procedural</b>	<b>Description:</b> Mixing of paint

**Reference Description:** Improper measuring of materials**Description of Non-Conformance:**

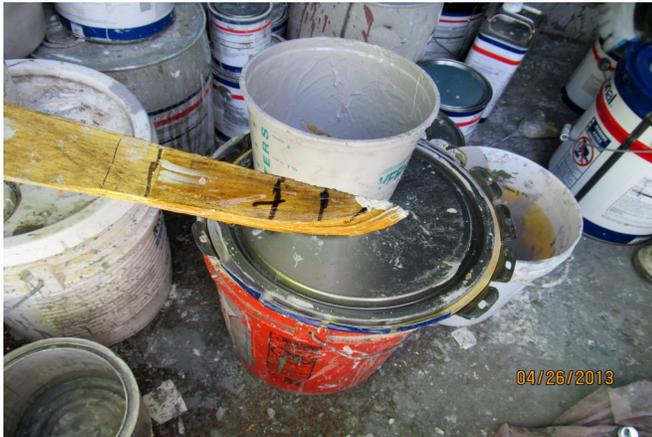
C.C.C. was measuring a partial kit of Intercure 200 HS primer utilizing a broken piece of wood.

Mix paint in complete units as supplied, as required by the manufacturer.  
Provide a procedure for ensuring that the proper volumes of the components are attained and QC documentation to be completed if the Contractor wishes to pursue the mixing of partial kits. Only mix complete kits until the mixing of partial kits has been accepted.

Post signs with instructions for mixing. Assign a designated individual for mixing and provide the proper documentation for each mix.

Certified Coatings Company Inc. in a letter dated 5/7/2013 responded to this issue by posting signs with specific instructions on mixing of coatings. At the paint mixing station one individual has been assigned to document properly each mix of coatings with batch #'s and time of mix. Mixing of coatings can only be initiated with the permission and supervision of a Supervisor or Quality Control personnel.

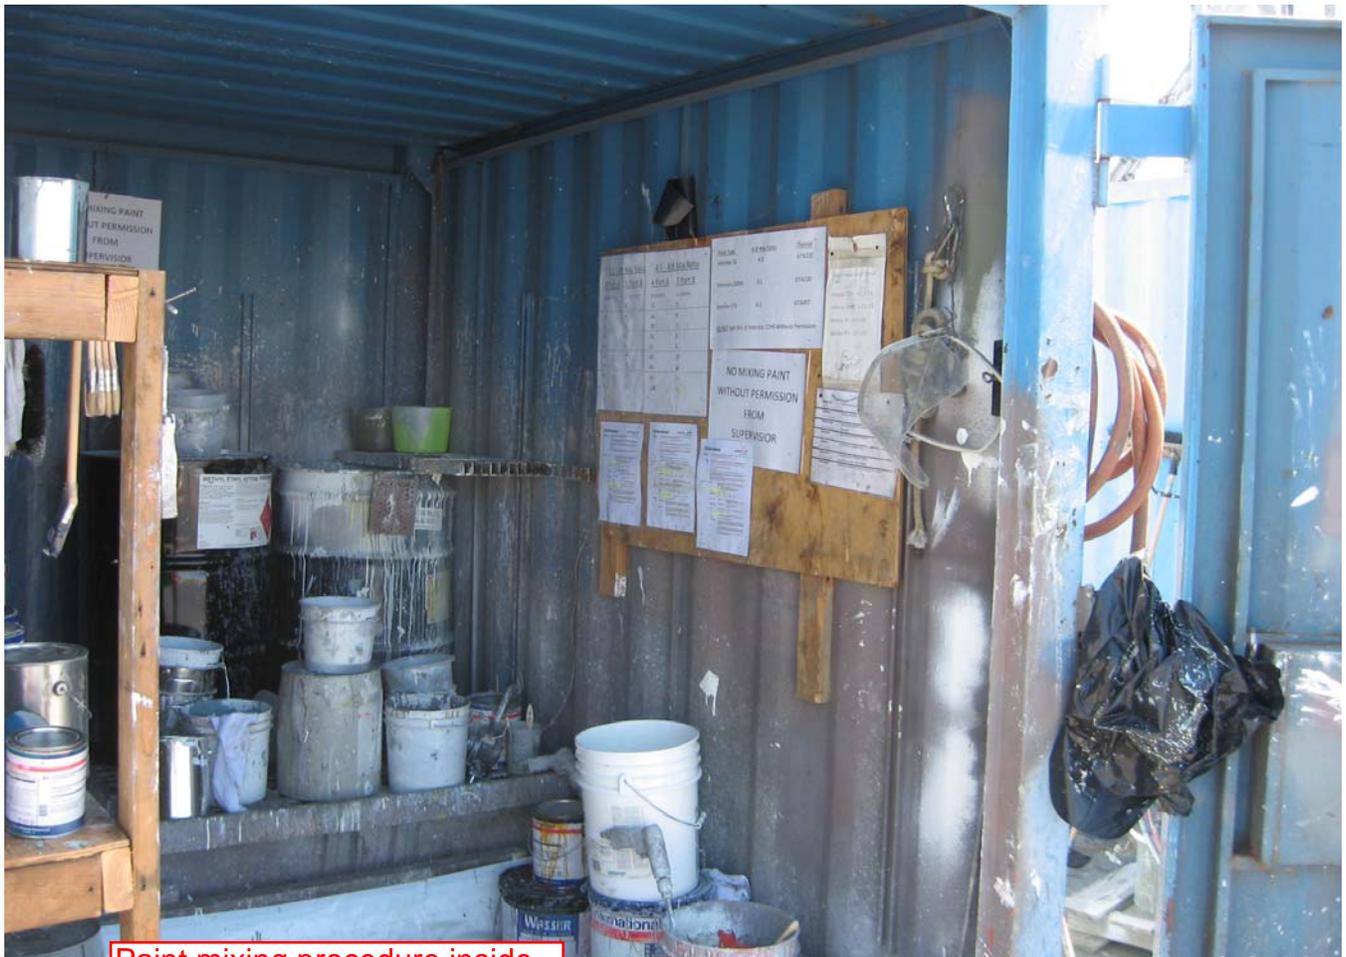
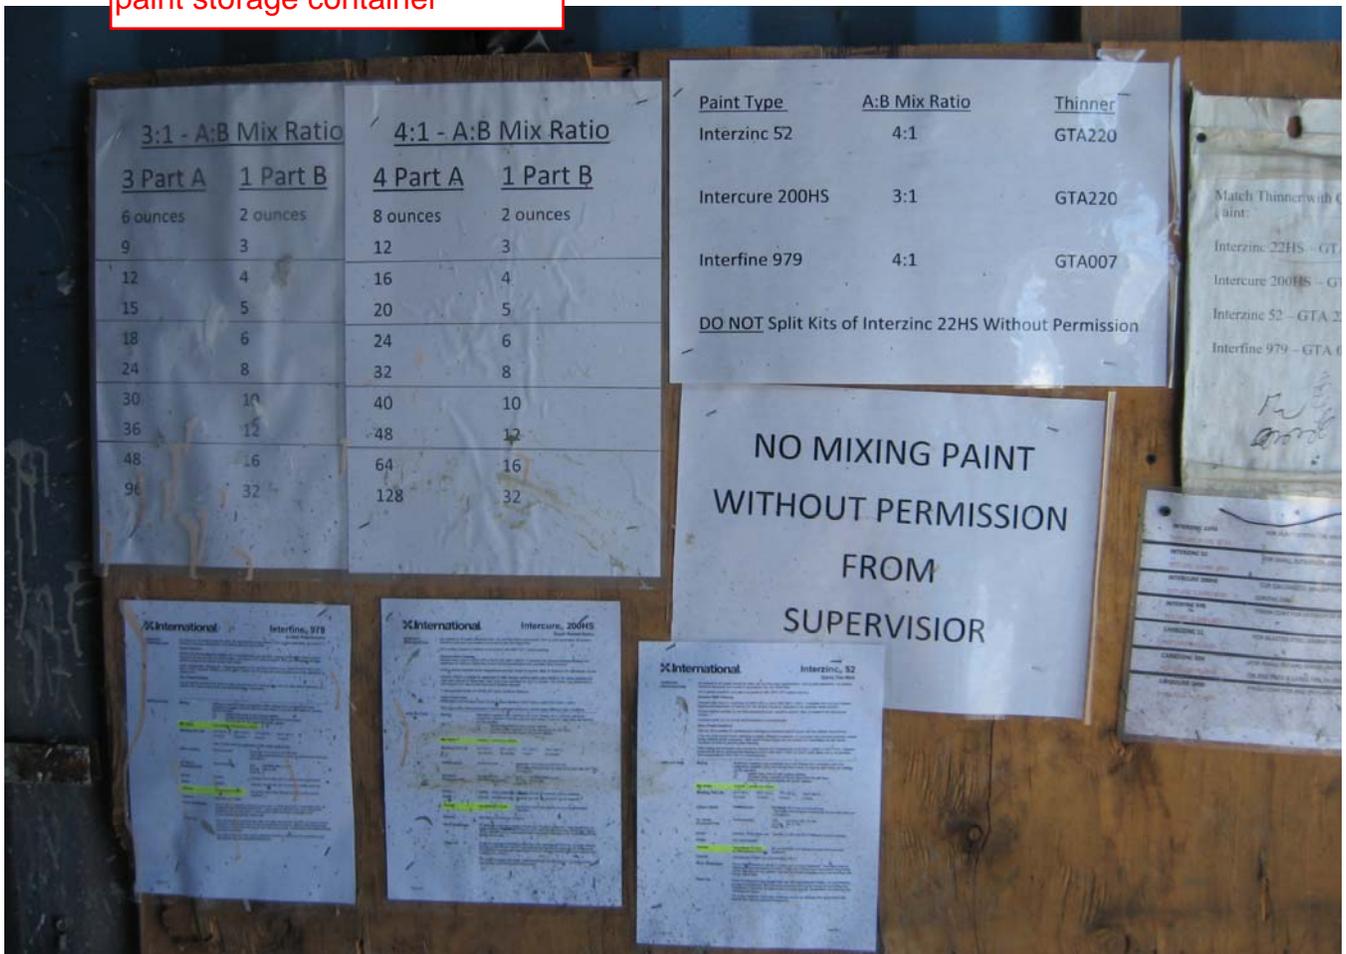
Paint mixing procedure inside paint storage container

In response to Non-Conformance Report CCC-009, Letter ABF-CCC-LTR- 000390, we have taken steps to insure that paint is mixed correctly in the future. With the exception of supervisors, no one is allowed to mix paint without permission and the supervision of a supervisor or QC. All painters are being trained in proper mixing procedures for each type of paint. Mixing data for all of the various types of paint has been posted in the mixing area.
