Contract #: 04-0120F4Cty: SF/ALA Rte: 80 PM: 13.2/13.9File #: 69.25B**QUALITY ASSURANCE -- NON-CONFORMANCE REPORT****Location:** Changxing Island, Shanghai, PRC**Report No:** NCR-000265**Prime Contractor:** American Bridge/Fluor Enterprises, a JV**Date:** 30-Apr-2009**Submitting Contractor:** Zhenhua Port Machinery Company, Ltd (ZPMC), Changxing Island**NCR #:** ZPMC-0239**Type of problem:**

**Reference Description:** Bike Path Assemblies Fabricated Without Submitted Welding Sequences/Processes**Description of Non-Conformance:**

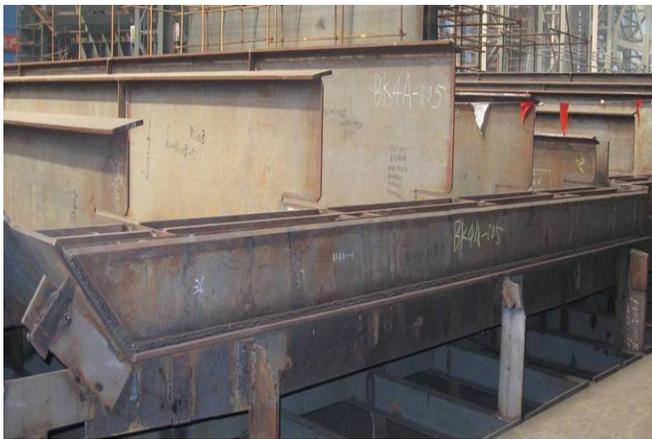
It has been observed that ZPMC personnel have started the fabrication of bike path assemblies prior to submitting details of the welding sequences and processes used. A total of 14 bike path assemblies have been fabricated at this time.

Contractor has provided the fabrication procedure through an RFI discussion. Reference RFI 1690R3 for the latest fabrication sequence.

Fabricate and inspect according to the latest procedure.
