Contract #: 04-0120F4Cty: SF/ALA Rte: 80 PM: 13.2/13.9File #: 69.25B**QUALITY ASSURANCE -- NON-CONFORMANCE REPORT****Location:** Changxing Island, Shanghai, P.R. China**Report No:** NCR-000312**Prime Contractor:** American Bridge/Fluor Enterprises, a JV**Date:** 06-Jun-2009**Submitting Contractor:** Zhenhua Port Machinery Company, Ltd (ZPMC), Changxing Island**NCR #:** ZPMC-0286**Type of problem:****Welding****Concrete****Other****Welding****Curing****Procedural****Bridge No:** 34-0006**Joint fit-up****Coating****Other****Component:** OBG Crossbeam CB3**Procedural****Procedural****Description:****Reference Description:** Improper Match Marking, Crossbeam CB3**Description of Non-Conformance:**

Job Name: SAS Superstructure
Document No: 05.03.06-000273

Reference Description: Improper Match Marking, Crossbeam CB3

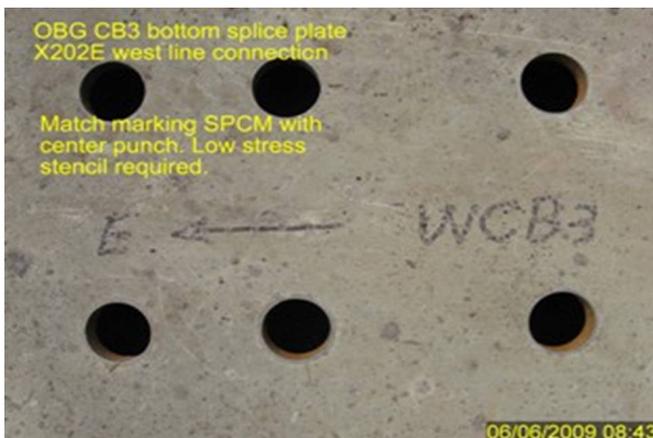
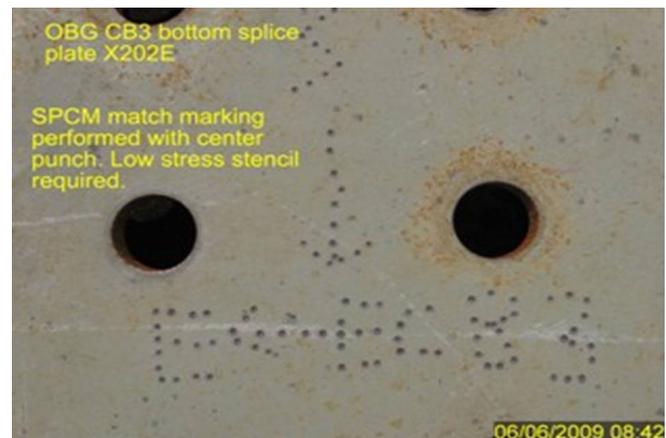
Caltrans Quality Assurance (QA) Inspector observed that the Contractor appears to have stenciled match marking identification numbers on two SPCM splice plates using a center punch rather than the required low stress stencil. Both parts are identified as X202E. Both plates are part of OBG crossbeam CB3. They connect the bottom panel of the crossbeam to the east and west lines.

AWS D1.5 2002 Section 12.4.6: "When heat numbers and other identification markings are applied by die stamping, low-stress dies shall be used."

The proposed resolution is not acceptable. Per the response to RFI-1894, a repair is required. Please submit the required Critical Weld Repair (CWR) report for the base metal repair, and provide documentation that the repair is acceptable. The Department will review the Contractor's proposal to close Non-Conformance ZPMC-0286 at that time.

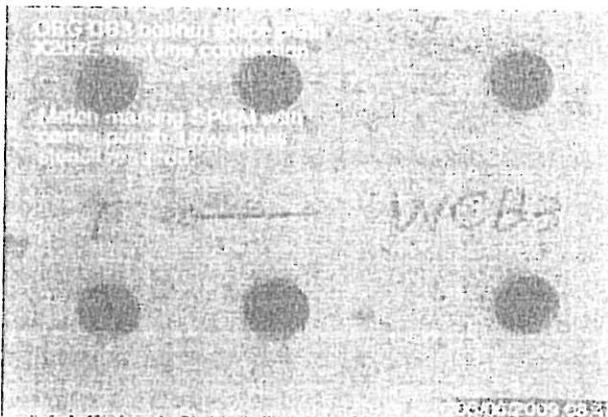
Caltrans Quality Assurance (QA) Inspector observed that the Contractor appears to have stenciled match marking identification numbers on two SPCM splice plates using a center punch rather than the required low stress stencil. Both parts are identified as X202E. Both plates are part of OBG crossbeam CB3. They connect the bottom panel of the crossbeam to the east and west lines.

AWS D1.5 2002 Section 12.4.6: "When heat numbers and other identification markings are applied by die stamping, low-stress dies shall be used."

ABF has instructed ZPMC to grind off the punch marks, weld repair if necessary and submit a report documenting the repair. ZPMC will submit the necessary inspection reports at a later date to close this NCR.

The proposed resolution is acceptable. The Department has verified that the unacceptable punch marks were ground sufficiently to satisfy the code requirement. The Department concurs that Non-Conformance ZPMC-0286 is closed.

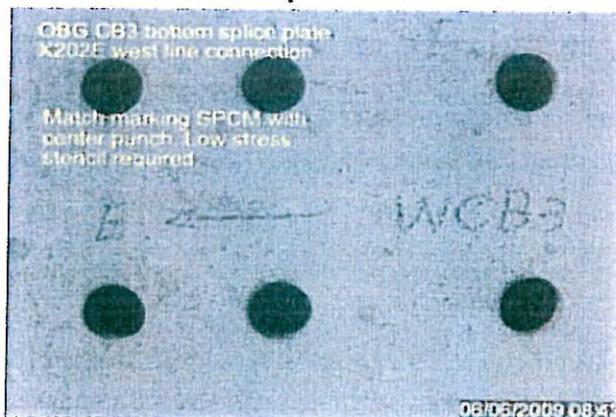
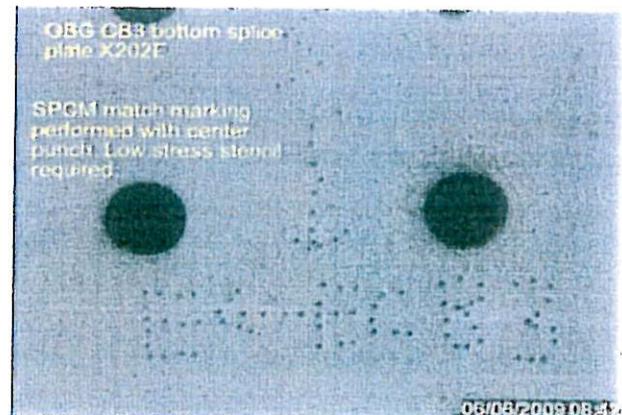
Caltrans Quality Assurance (QA) Inspector observed that the Contractor appears to have stenciled match marking identification numbers on two SPCM splice plates using a center punch rather than the required low stress stencil. Both parts are identified as X202E. Both plates are part of OBG crossbeam CB3. They connect the bottom panel of the crossbeam to the east and west lines.

AWS D1.5 2002 Section 12.4.6: "When heat numbers and other identification markings are applied by die stamping, low-stress dies shall be used."

Contractor has acknowledged that this item must be addressed, and the item was added to the Master Punchlist.

Work was completed and item was cleared on Master Punchlist by Caltrans on 6-2-2009. Submittal of documentation by Contractor being tracked on Documentation Punchlist.
