Contract #: 04-0120F4Cty: SF/ALA Rte: 80 PM: 13.2/13.9File #: 69.25B**QUALITY ASSURANCE -- NON-CONFORMANCE REPORT****Location:** Changxing Island, Shanghai, PRC**Report No:** NCR-000335**Prime Contractor:** American Bridge/Fluor Enterprises, a JV**Date:** 24-Jun-2009**Submitting Contractor:** Zhenhua Port Machinery Company, Ltd (ZPMC), Changxing Island**NCR #:** ZPMC-0309**Type of problem:**

**Reference Description:** Missed linear indications in tack welds of West Tower, Lift 4, Skin E**Description of Non-Conformance:**

**Subject:** NCR No. ZPMC-0309

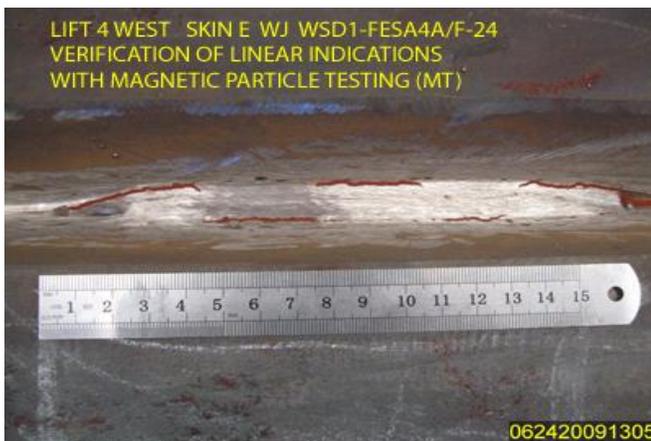
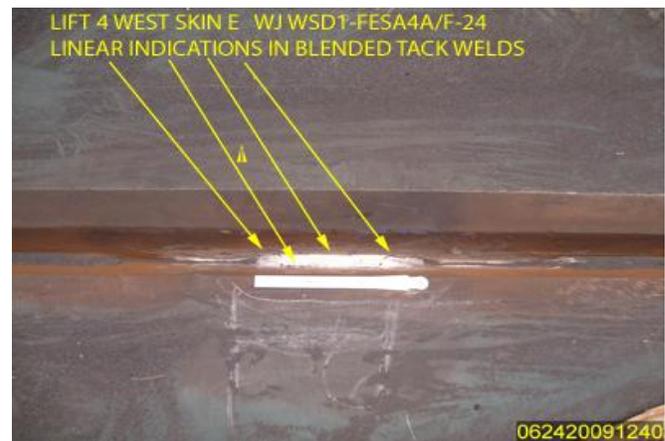
During random visual inspection of West Tower, Lift 4, Skin E, QA observed linear indications in the tack welds of weld joints WSD1-FESA4-A/F-24 and WSD1-FESA4-A/F-3A. The indications in the tack welds were verified with Magnetic Particle Testing (MT). These tack welds were previously accepted by ZPMC QC MT technicians.

Repair affected tack welds.

The affected welds have been repaired and a NDT report indicating sound welds has been submitted. The welds have been verified by QA.

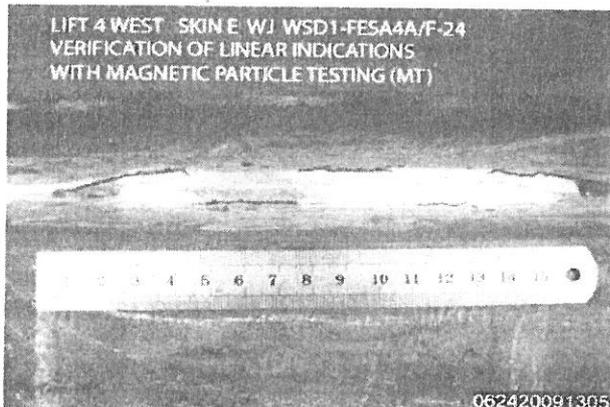
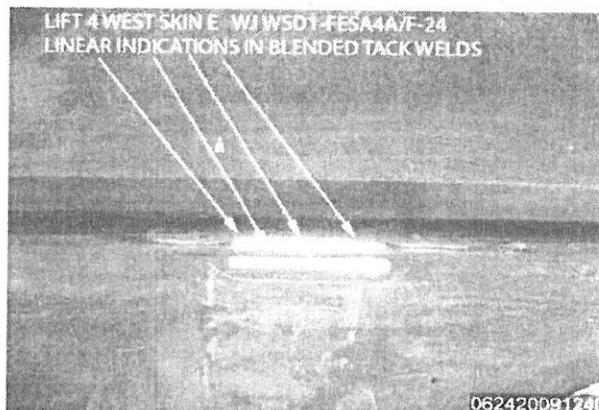
During random visual inspection of West Tower, Lift 4, Skin E, QA observed linear indications in the tack welds of weld joints WSD1-FESA4-A/F-24 and WSD1-FESA4-A/F-3A. The indications in the tack welds were verified with Magnetic Particle Testing (MT). These tack welds were previously accepted by ZPMC QC MT technicians.
