Contract #: 04-0120F4
 Cty: SF/ALA Rte: 80 PM: 13.2/13.9
 File #: 69.25B

QUALITY ASSURANCE -- NON-CONFORMANCE REPORT

Reference Description: Linear indications on tack welds of West Shaft, Lift 4, Skin D

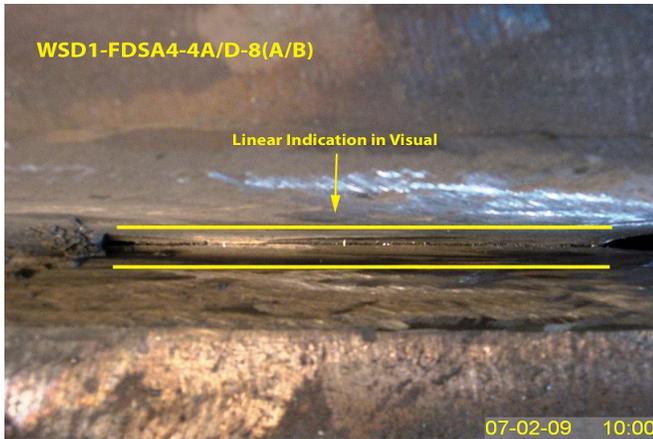
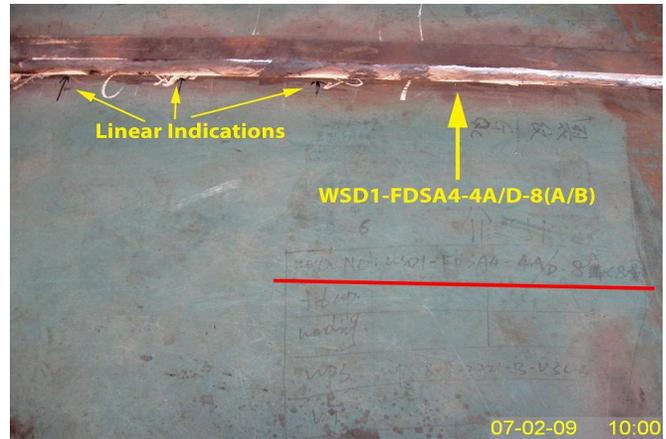
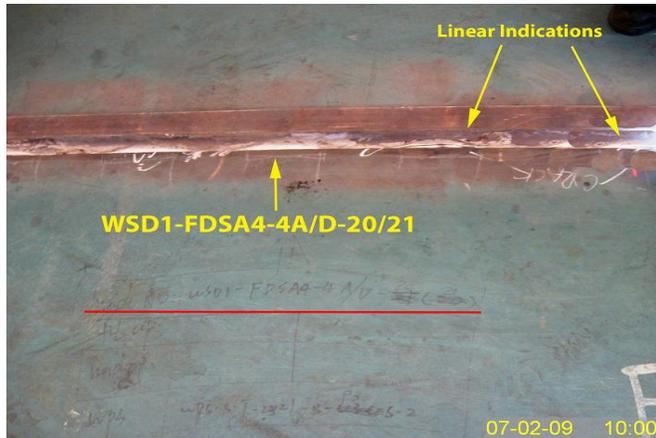
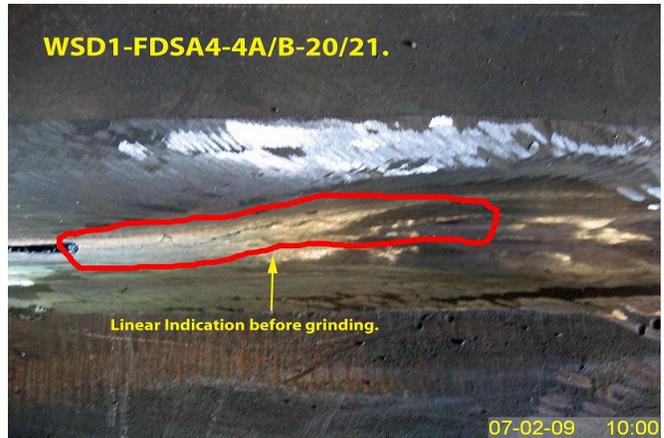
During in process Visual Inspection, QA discovered five linear indications on the tack welds of West Shaft, Lift 4, Skin D at weld joints WSD1-FDSA4-4A/D-8A/B and WSD1-FDSA4-4A/D-20/21. These welds were previously visually accepted by ZPMC QC personnel.

The proposed resolution is acceptable. The welding inspectors have received additional training, and tests have been administered to ZPMC technicians to demonstrate their ability to detect indications. Also, the welds in question have been accepted by MT as shown in the attached documents. The Department concurs that Non-Conformance ZPMC-0317 is closed.

Repair affected tack welds.

The affected welds have been repaired and a NDT report indicating sound welds has been submitted. The welds have been verified by QA.

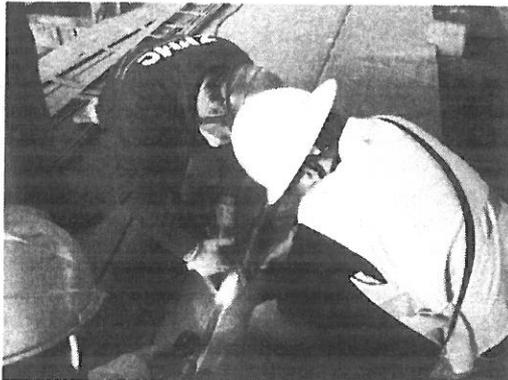
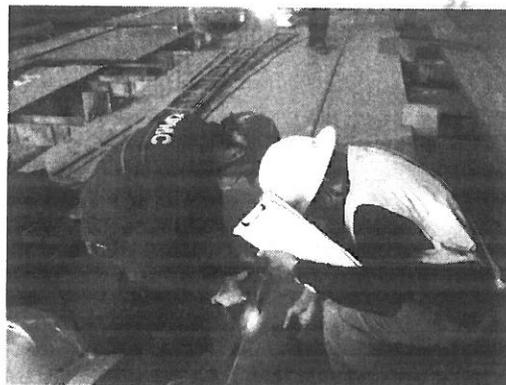
**REPORT OF MAGNETIC PARTICLE EXAMINATION T787-MT-4841, T787-MT-4908
PHOTOES**

About this situation we ZPMC at the first time remove the cracks and did the MT work to make sure remove them , and we informed CT people to witness them before welding .

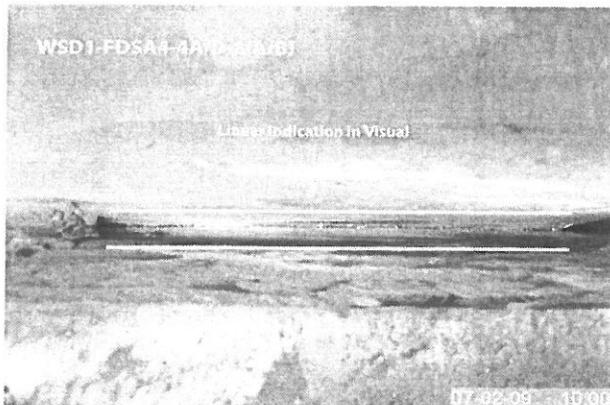
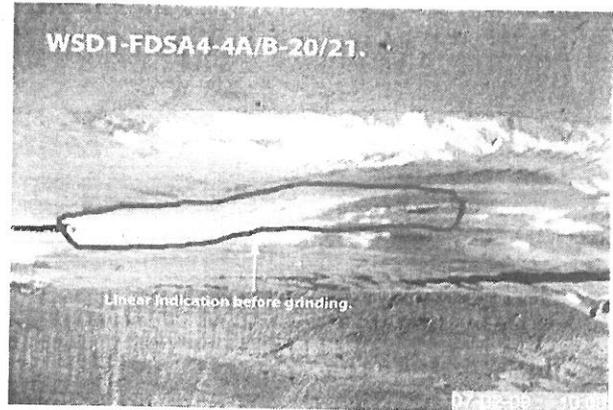
During in process Visual Inspection, QA discovered five linear indications on the tack welds of West Shaft, Lift 4, Skin D at weld joints WSD1-FDSA4-4A/D-8A/B and WSD1-FDSA4-4A/D-20/21. These welds were previously visually accepted by ZPMC QC personnel.
