Contract #: 04-0120F4Cty: SF/ALA Rte: 80 PM: 13.2/13.9File #: 69.25B**QUALITY ASSURANCE -- NON-CONFORMANCE REPORT****Location:** Changxing Island**Report No:** NCR-000370**Prime Contractor:** American Bridge/Fluor Enterprises, a JV**Date:** 28-Jun-2009**Submitting Contractor:** Zhenhua Port Machinery Company, Ltd (ZPMC), Changxing Island**NCR #:** ZPMC-0344**Type of problem:****Welding****Concrete****Other****Welding****Curing****Procedural****Bridge No:** 34-0006**Joint fit-up****Coating****Other****Component:** OBG 1AAE & 1AAW**Procedural****Procedural****Description:****Reference Description:** End Plates**Description of Non-Conformance:**

Job Name: SAS Superstructure

Report No: NCR-000370

Heat Straightening Report (HSR)

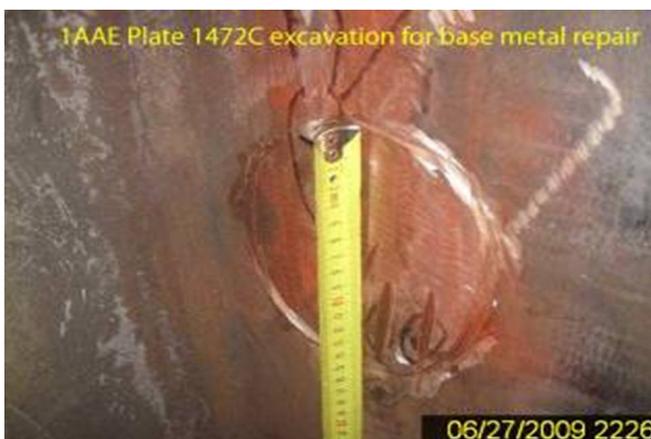
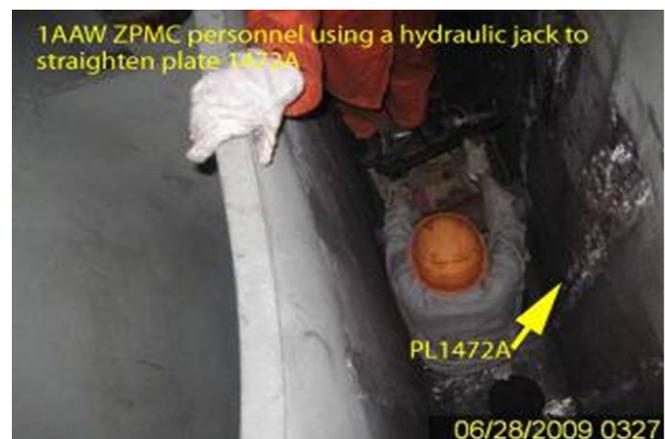
During random visual observations of Heat Straightening of OBG Segment 1AAW end plates as directed by HSR(B)-298. The Quality Assurance (QA) Inspector observed ZPMC personnel using two (2) hydraulic jacks with a high amount of pressure (excessive hydraulic force) to correct deformation in end plate 1472A. The HSR(B)-298 states "Jacking shall not be used to plastically deform the plates. The jack shall only be used as a fixture."

It is also noted that ZPMC personnel have mechanically ground a 2mm deep by 150 mm diameter circle in the base material of 1AAE End Plate 1472C. It appears ZPMC was attempting to straighten the deformed end plate.

Propose a resolution for the identified non-conformance with revised procedures to prevent future occurrences.,A response for the resolution of this issue is expected within 14 days.

The proposed resolution is acceptable. The heat straightening report is included, and all of the affected welds have been accepted by VT, MT, and UT as shown in the attached documents. The Department concurs that Non-Conformance ZPMC-0344 is closed.

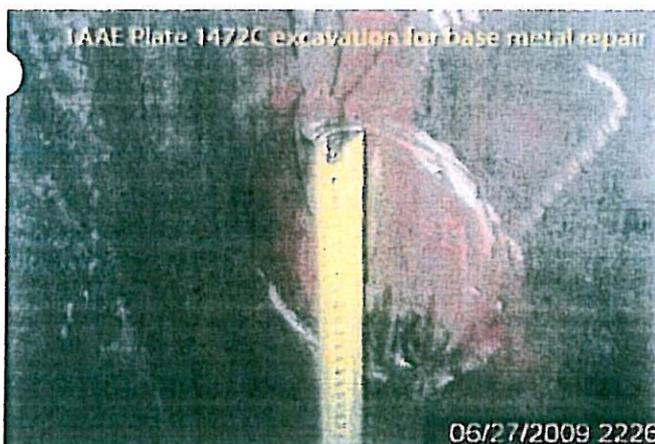
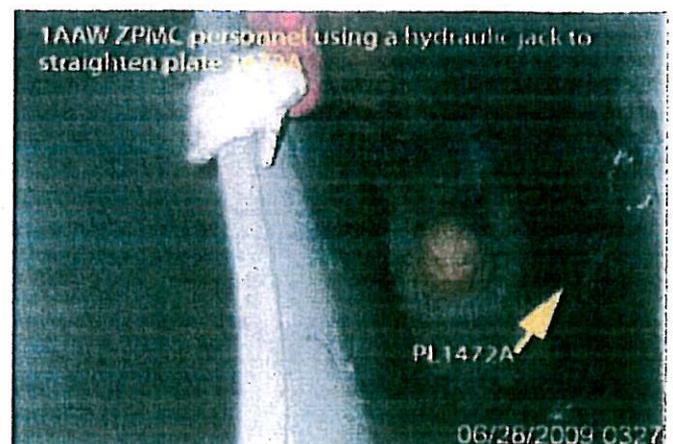
During random visual observations of Heat Straightening of OBG Segment 1AAW end plates as directed by HSR(B)-298. The Quality Assurance (QA) Inspector observed ZPMC personnel using two (2) hydraulic jacks with a high amount of pressure (excessive hydraulic force) to correct deformation in end plate 1472A. The HSR(B)-298 states "Jacking shall not be used to plastically deform the plates. The jack shall only be used as a fixture."

It is also noted that ZPMC personnel have mechanically ground a 2mm deep by 150 mm diameter circle in the base material of 1AAE End Plate 1472C. It appears ZPMC was attempting to straighten the deformed end plate.

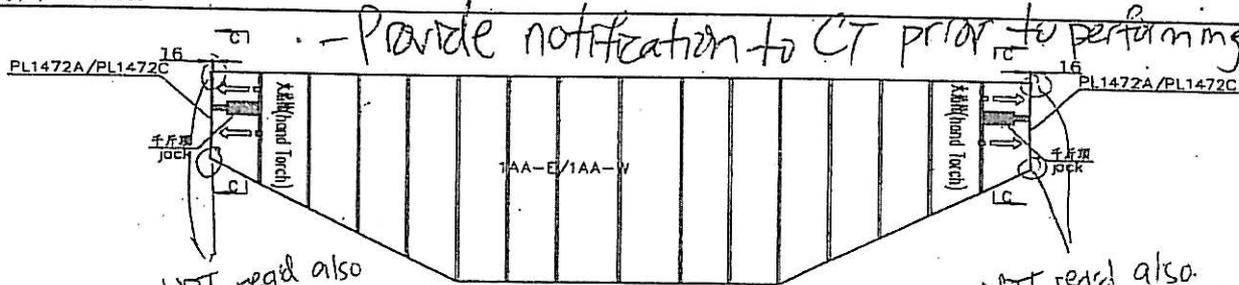
简图 Sketch

Cause原因: Welding distortion 焊接变形

注: 最大变形量约16mm, 校火厚度20~100mm.
NOTE: the max deformation is about 16mm, heat straightening the width is 20~100mm.-E.T.
2009.6.26

Jacking shall not be used to plastically deform the flange. The Jack shall only be used as a fixture.

After finishing heat straightening, the weld of the treat area shall perform NDT according to the approved shop drawing. 不能使用千斤顶进行塑性变形。千斤顶只能用作固定装置，校火后需按照图纸上的要求对热影响区域进行 NDT 检测。

Increase the flange anti-deformation allowance during the course of fit-up, and Control the welding parameters according to associated WPS. 在装配的过程中增加反变形量。根据相关WPS控制焊接参数。
