QUALITY ASSURANCE -- NON-CONFORMANCE REPORT

Report No: NCR-000390

Reference Description: Missed MT Indications by QC on OBG Segment 1AW

Job Name: SAS Superstructure

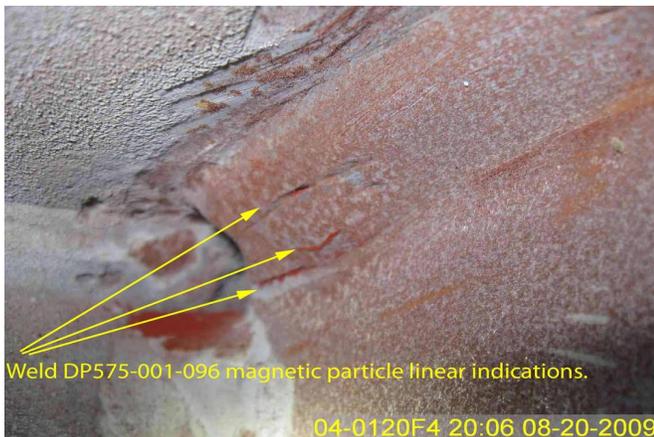
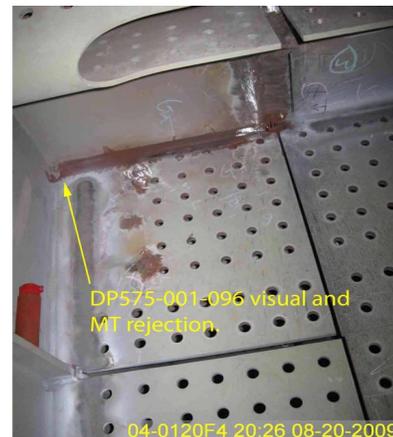
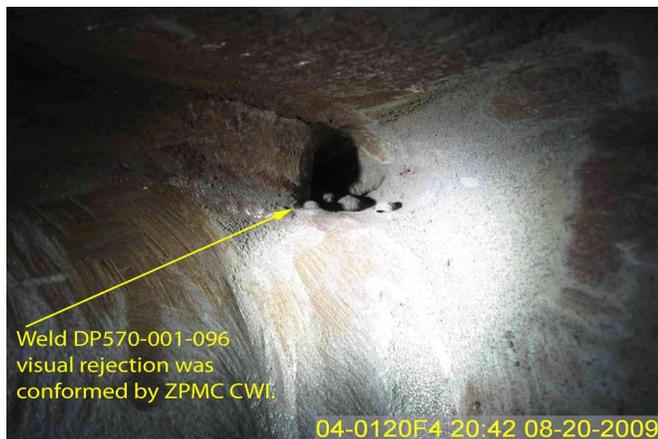
During random Visual Inspections and Magnetic Particle Testing (MT) of welds at panel point 10, Segment 1AW, this Caltrans Quality Assurance (QA) Inspector observed the following: Weld DP575-001-096 has multiple magnetic particle linear indications and is visually rejected; weld DP570-001-096 is visually rejected.

ZPMC CWI Mr. Yumin Xu agreed that both welds listed above are visually unacceptable due to weld contour and spatter. These inspections were performed as requested by ZPMC NDT Inspection Notification Sheet 004018 which indicates ZPMC has accepted the visual and magnetic particle inspections of these welds. See the photographs below for additional information.

Submit a repair procedure to the engineer for approval.

ABF has submitted ZPMC's NDT reports in the weld Data Base showing that the welds in question are in conformance with Contract requirements.
