Contract #: 04-0120F4
 Cty: SF/ALA Rte: 80 PM: 13.2/13.9
 File #: 69.25B

QUALITY ASSURANCE -- NON-CONFORMANCE REPORT

Report No: NCR-000417

Reference Description: Unapproved freehand thermal cutting on West Tower base-end bevel preparation

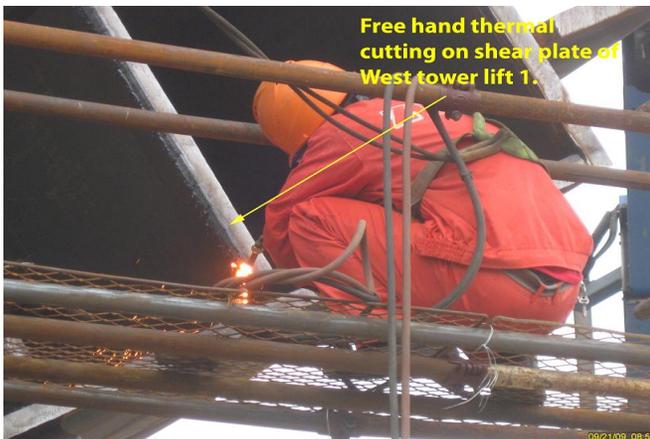
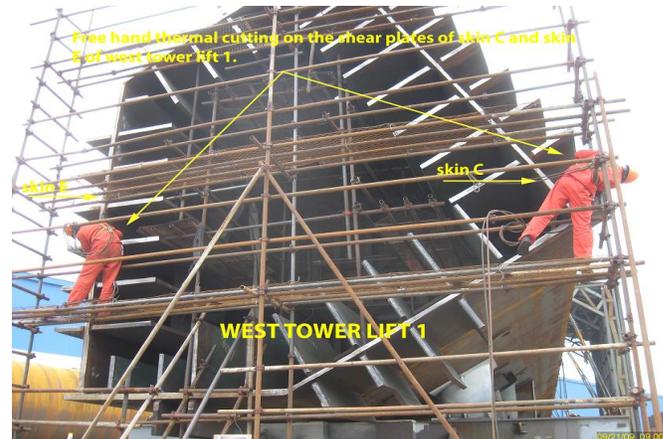
During in-process Visual Testing (VT) of West Tower, Lift 1, base-end bevel preparation, QA observed 'freehand thermal cutting' being carried out by ZPMC personnel. Access to the areas being cut were not restricted due to cross sectional geometry and or position in so far as mechanical guides could not be used.

AWS D1.5-2002, Section 3.2.3 - "Steel and weld metal may be thermally cut, provided a smooth and regular surface free from cracks and notches is secured, and provided that an accurate profile is secured by the use of a mechanical guide. Freehand thermal cutting shall be done only where approved by the Engineer."

Propose a resolution for the identified non-conformance, documenting that the affected plate edges have been brought in compliance with the contract requirements.

The ABFJV QCM has discussed the issue with the ZPMC QA department and the ZPMC QA department, in turn, has discussed this with ZPMC production. The surfaces in question will be ground smooth and the joint fit will be inspected by a CWI prior to welding.
