Contract #: 04-0120F4  
 Cty: SF/ALA Rte: 80 PM: 13.2/13.9  
 File #: 69.25B

## QUALITY ASSURANCE -- NON-CONFORMANCE REPORT

**Report No:** NCR-000542

**Reference Description:** Deviating from Approved HSR during Heat Straightening, L6W

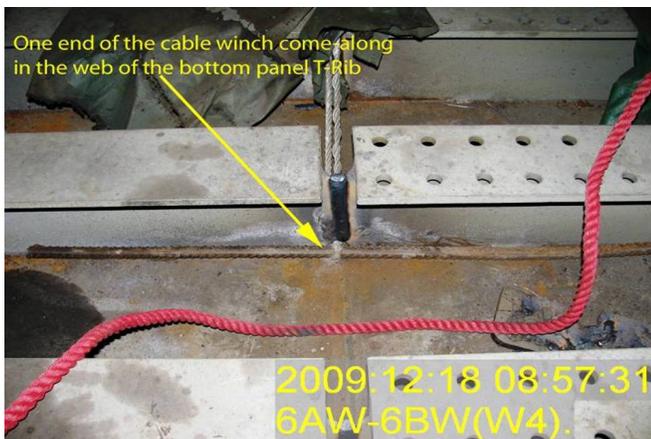
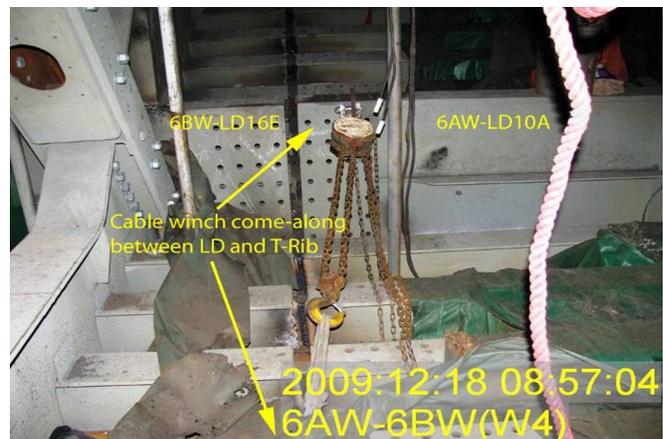
The Caltrans Quality Assurance (QA) Inspector observed ZPMC personnel aligning the Longitudinal Diaphragms (LD) 6AW (LD16E) to 6BW (LD10A) by utilizing an approved Heat Straightening Report (HSR). ZPMC personnel rigged a hand operated cable/chain winch (come-along mechanical device) at the flange of LD10A and anchored it behind the web of the T-Rib at the Bottom Panel (BP) of 6AW to 6BW. This equipment and methods were not described in ZPMC's internal HSR procedure. Additional information identifying this non-conformance issue is listed below.

- The LD's were located at 6AW to 6BW splice weld at W4.
- The 6AW LD is identified as: LD16E
- The 6BW LD is identified as: LD10A
- The HSR was identified as HSR1 (B)-7992 Rev. 0, dated 11th Dec. 2009.

submit the details of the deviation from the approved HSR for approval by the engineer. A response for the resolution of this issue is expected within 7 days.

Perform NDT required to verify weld quality.

Contractor submitted NDT reports verifying welds affected by heat straightening procedures are in conformance with Contract specifications.

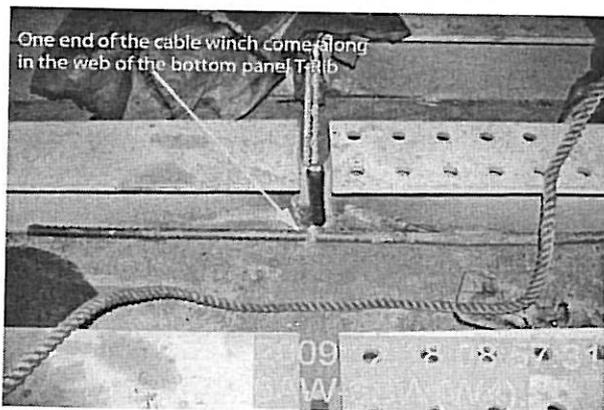
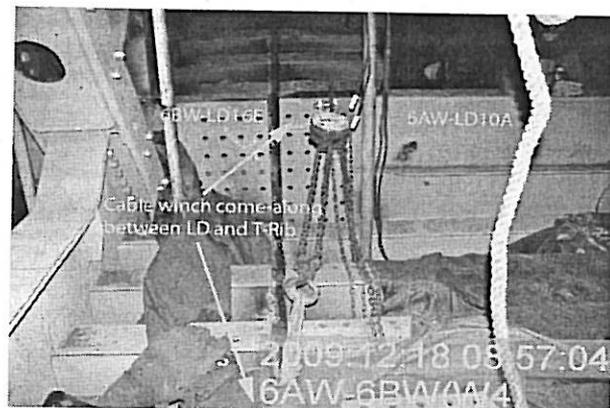
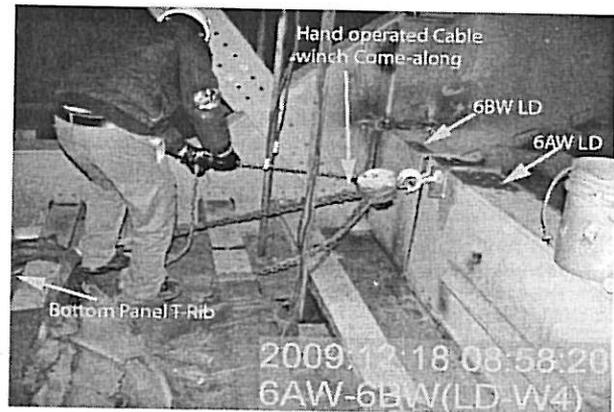
The Caltrans Quality Assurance (QA) Inspector observed ZPMC personnel aligning the Longitudinal Diaphragms (LD) 6AW (LD16E) to 6BW (LD10A) by utilizing an approved Heat Straightening Report (HSR). ZPMC personnel rigged a hand operated cable/chain winch (come-along mechanical device) at the flange of LD10A and anchored it behind the web of the T-Rib at the Bottom Panel (BP) of 6AW to 6BW. This equipment and methods were not described in ZPMC's internal HSR procedure. Additional information identifying this non-conformance issue is listed below.

-The LD's were located at 6AW to 6BW splice weld at W4.

-The 6AW LD is identified as: LD16E

-The 6BW LD is identified as: LD10A

-The HSR was identified as HSR1 (B)-7992 Rev. 0, dated 11th Dec. 2009.
