Contract #: 04-0120F4Cty: SF/ALA Rte: 80 PM: 13.2/13.9File #: 69.25B**QUALITY ASSURANCE -- NON-CONFORMANCE REPORT****Location:** Changxing Island, Shanghai, P.R. China**Report No:** NCR-000636**Prime Contractor:** American Bridge/Fluor Enterprises, a JV**Date:** 16-Jan-2010**Submitting Contractor:** Zhenhua Port Machinery Company, Ltd (ZPMC), Changxing Island**NCR #:** ZPMC-0609**Type of problem:****Welding****Concrete****Other****Welding****Curing****Procedural****Bridge No:** 34-0006**Joint fit-up****Coating****Other****Component:** Segment 7CE Deck Panel**Procedural****Procedural****Description:****Reference Description:** Freehand thermal cutting of 7CE Deck Panel without Engineer's approval**Description of Non-Conformance:**

**To:** AMERICAN BRIDGE/FLUOR, A JV **Date:** 20-Jan-2010  
 375 BURMA ROAD  
 OAKLAND CA 95607 **Contract No:** 04-0120F4  
 04-SF-80-13.2 / 13.9  
**Dear:** Mr. Charles Kanapicki **Job Name:** SAS Superstructure  
**Attention:** Mr. Thomas Nilsson Project/Fabrication Manager **Document No:** 05.03.06-000602  
**Subject:** NCR No. ZPMC-0609

**Reference Description:** Freehand thermal cutting of 7CE Deck Panel without Engineer's approval

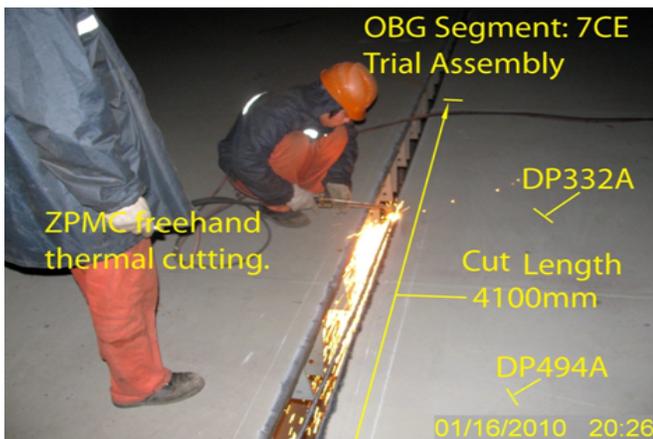
During Caltrans Quality Assurance (QA) Inspection of OBG 7CE, Trial Assembly, this QA inspector discovered the following issue:

- ZPMC performed freehand thermal cutting of 4100mm in length without the Engineer's approval.
- The OBG segment is identified as 7CE.
- The deck plates are identified as DP494A and DP332A.
- Material thickness; 14mm.
- Access to the area being cut was not restricted due to cross sectional geometry and or position, in so far as mechanical guides could not be used.
- ZPMC QC and ABF Representatives were not present during the time of the thermal cutting.

Preparation of Base Metal: Section 3, Para. 3.2.2 Freehand thermal cutting shall be done only where approved by the Engineer.

Get a procedure approved for subsequent cutting. Confirm the cutting is within the specified tolerance. A response for the resolution of this issue is expected within 7 days.

Grind area to meet the joint requirements of the approved WPS.

ZPMC Personnel has ground the area in question and Segment 7CE has been moved into the Trail Assembly are for fit-up.
