Contract #: 04-0120F4
 Cty: SF/ALA Rte: 80 PM: 13.2/13.9
 File #: 69.25B

QUALITY ASSURANCE -- NON-CONFORMANCE REPORT

Location: Changxing Island, Shanghai, P.R. China **Report No:** NCR-000865
Prime Contractor: American Bridge/Fluor Enterprises, a JV **Date:** 16-Oct-2010
Submitting Contractor: Zhenhua Port Machinery Company, Ltd (ZPMC), Changxing Island **NCR #:** ZPMC-0827

Reference Description: Lift 5: North Grillage Cover Plate dimension for Longitudinal Grillage plate do not match with Drawing

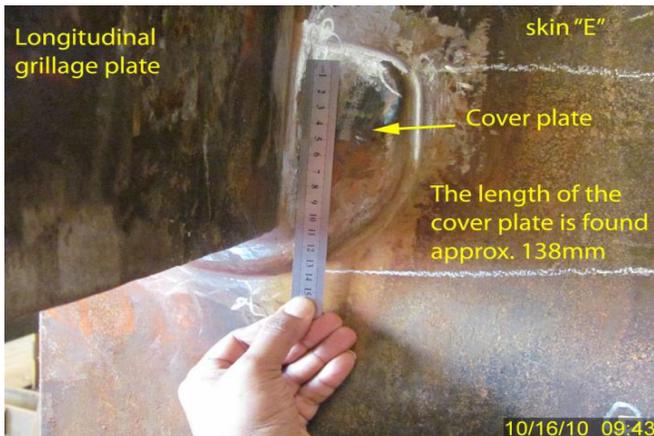
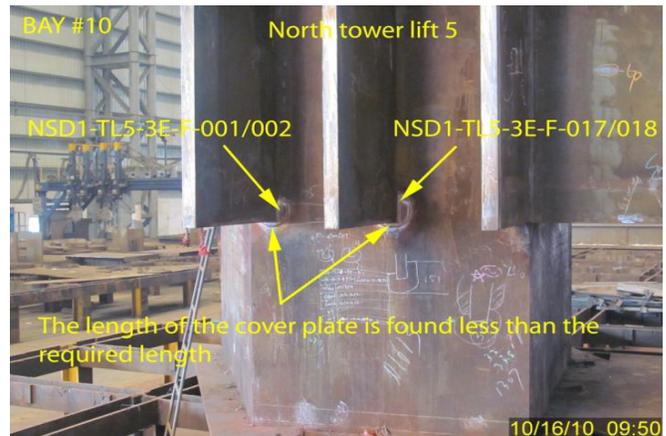
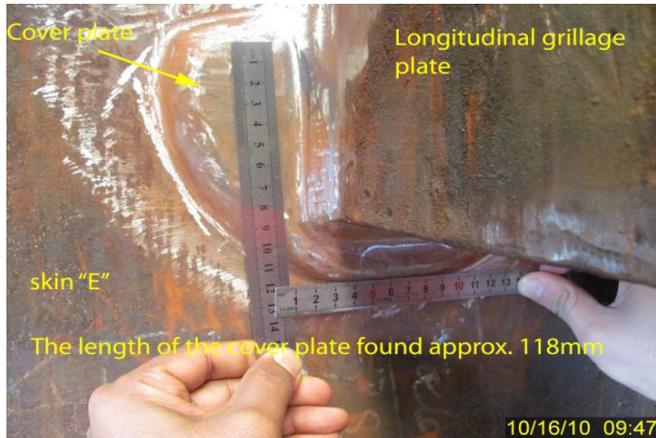
During the Quality Assurance Visual Testing (VT) verification of welds located on Cover Plate for the Longitudinal Grillage plate of North Tower lift 5, this Quality Assurance (QA) Inspector discovered the following issues:

- The dimensions of Cover Plate do not match the approved shop drawings.
- As per shop drawing the required length of the Cover Plate is 151.4mm.
- Cover Plate weld # NSD1-TL5-3E/F-001/002, the length of the Cover Plate was measured as 138mm.
- Cover Plate weld # NSD1-TL5-3E/F-017/018, the length of the Cover Plate was measured as 118mm and 143mm.
- These welds are fillet welds, joining the Cover Plate to the Skin Plate and Longitudinal Grillage plate.
- The member is located in Bay 10.

The Notice of Witness Inspection Number (NWIT) is 06975. These areas have been previously tested and accepted by ZPMC Quality Control (QC) personnel.

-Attached photographs provide additional location details.

Contractor will submit revised shop drawing as per the as built for Engineer's approval. Ensure in future to communicate with CT before any modification works are performed.

Contractor has revised the shop drawing and submitted for Engineer's approval. The revised drawing has been accepted and the cover plate left as- built.

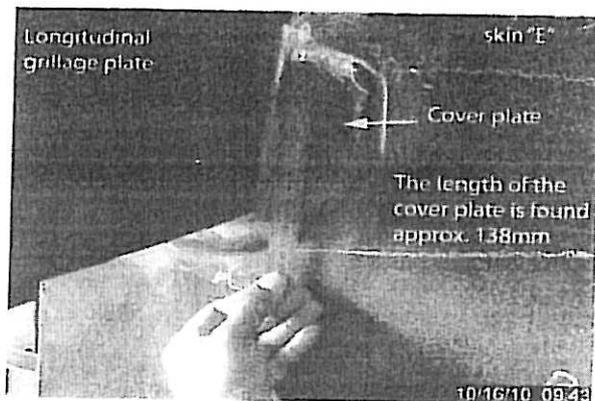
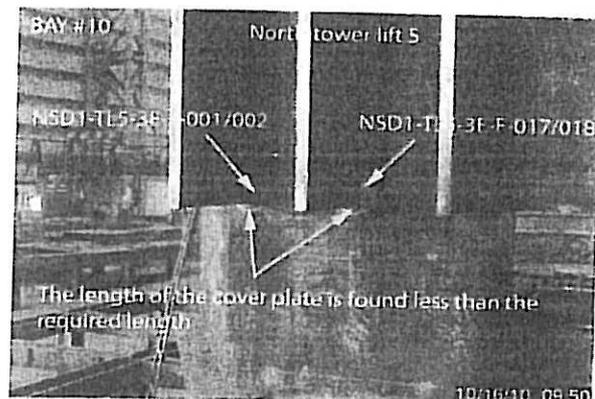
During the Quality Assurance Visual Testing (VT) verification of welds located on Cover Plate for the Longitudinal Grillage plate of North Tower lift 5, this Quality Assurance (QA) Inspector discovered the following issues:

- The dimensions of Cover Plate do not match the approved shop drawings.
- As per shop drawing the required length of the Cover Plate is 151.4mm.
- Cover Plate weld # NSD1-TL5-3E/F-001/002, the length of the Cover Plate was measured as 138mm.
- Cover Plate weld # NSD1-TL5-3E/F-017/018, the length of the Cover Plate was measured as 118mm and 143mm.
- These welds are fillet welds, joining the Cover Plate to the Skin Plate and Longitudinal Grillage plate.
- The member is located in Bay 10.

The Notice of Witness Inspection Number (NWIT) is 06975. These areas have been previously tested and accepted by ZPMC Quality Control (QC) personnel.

-Attached photographs provide additional location details.

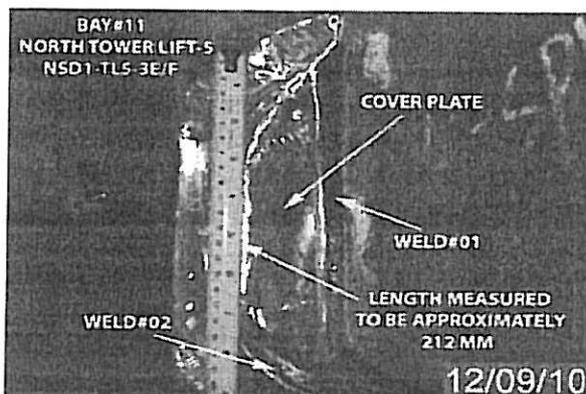
During the Caltrans Quality Assurance (QA) in-process observation on North Tower Lift 5 Cover plate, this QA Inspector discovered the following issue:

- ZPMC fabrication personnel removed 2 cover plates involving a total four (4) Non-SPCM fillet welds without notifying the Engineer .
- ZPMC re-welded with new cover plates, where the dimension of the cover plates does not comply with the approved drawings.
- As per the shop drawing the required length of the cover plate is 151.4 mm. The length measured was approximately 212 mm.
- Welds are fillet welds joining cover plate to skin 'E'.
- The weld designations are NSD1-TL5-3E/F#01; 02; 17; 18.
- This component located at fabrication Bay#11.
- NCR ZPMC-827 had been issued on 10/19/2010 for the two non-conforming cover plates that were removed. Response to this NCR is still outstanding todate.

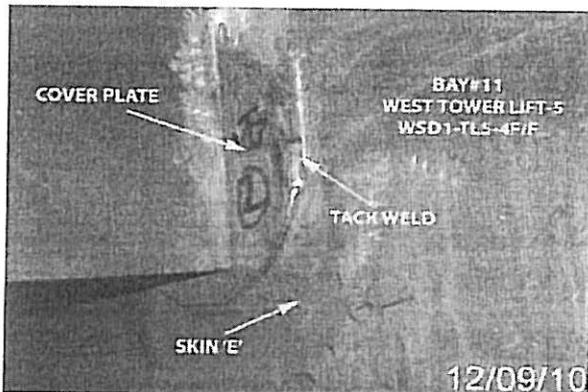
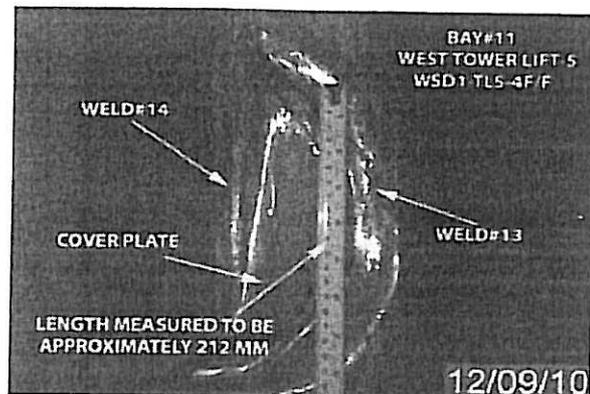
During the Caltrans Quality Assurance (QA) in-process observation on West tower lift-5 Cover plate, this QA Inspector discovered the following issue:

- ZPMC fabrication personnel removed 2 cover plates involving a total four (4) Non-SPCM fillet welds without notifying the Engineer.
- ZPMC re-welded with new cover plates, where the dimensions of the cover plates do not comply with the approved drawings.
- As per the shop drawing the required length of the cover plate is 151.4 mm. The length measured was approximately 212 mm.
- Welds are fillet welds joining cover plate to skin 'E'.
- The weld designations are WSD1-TL5-4F/F#13; 14; 15; 16.
- This component located at fabrication Bay#11.
- NCR ZPMC-827 had been issued on 10/19/2010 for the two non-conforming cover plates that were removed. Response to this NCR is still outstanding today.
