Contract #: 04-0120F4Cty: SF/ALA Rte: 80 PM: 13.2/13.9File #: 69.25B**QUALITY ASSURANCE -- NON-CONFORMANCE REPORT****Location:** Changxing Island, Shanghai, P.R. China**Report No:** NCR-000915**Prime Contractor:** American Bridge/Fluor Enterprises, a JV**Date:** 23-Nov-2010**Submitting Contractor:** Zhenhua Port Machinery Company, Ltd (ZPMC), Changxing Island**NCR #:** ZPMC-0877**Type of problem:****Welding****Concrete****Other****Welding****Curing****Procedural****Bridge No:** 34-0006**Joint fit-up****Coating****Other****Component:** Bikepath BK004C2-024**Procedural****Procedural****Description:**

Reference Description: ZPMC performed fabrication without following the "Weld Procedure Requirements for New Welds" by Rager/McQuaid

Job Name: SAS Superstructure

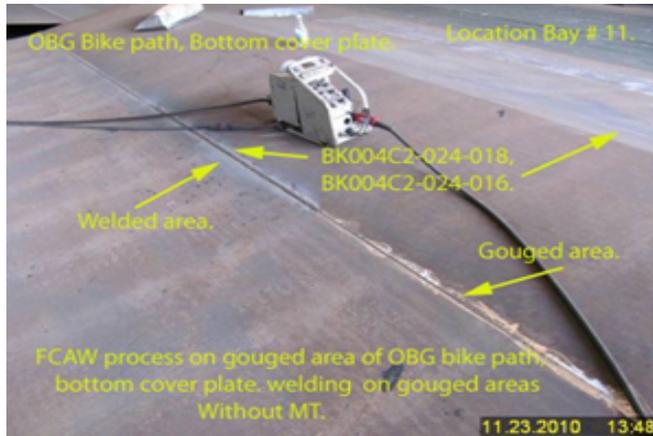
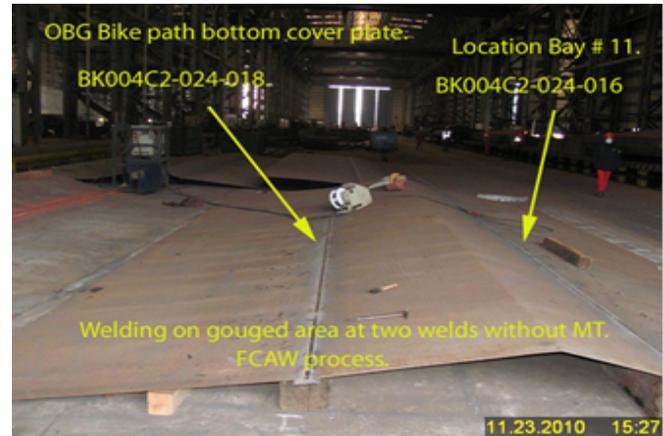
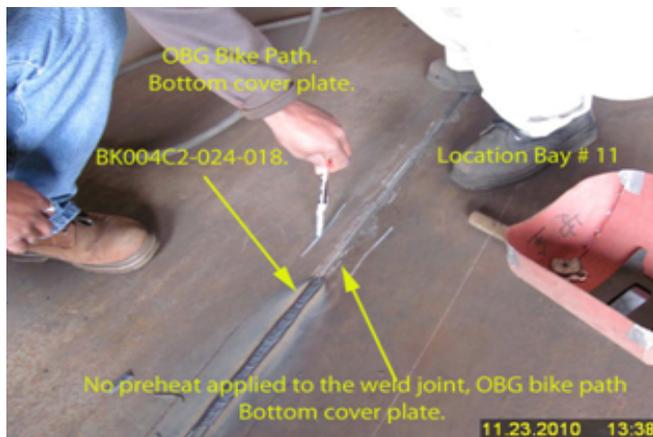
-The weld is identified as BK004C2-024-018, 016.

-The welding process used was Flux Core Arc Welding (FCAW).

-The area was being not preheated to 165 degrees.

-ZPMC personnel did not inspect 100% VT and MT of backgouged area before welding began from the second side.

-The weld is a Completed joint Penetration, (CJP) joining 6mm plate to 6mm plate.

-OBG Bike path, Bottom cover plate is located in Bay # 11.

CT acknowledges contractor's response. However, successful NDT will close this NCR.

Normal NCR closure package with NDT reports shall be submitted with the NPR to close out the NCR.

Contractor provided the NDT report. The report proves the weld is acceptable.

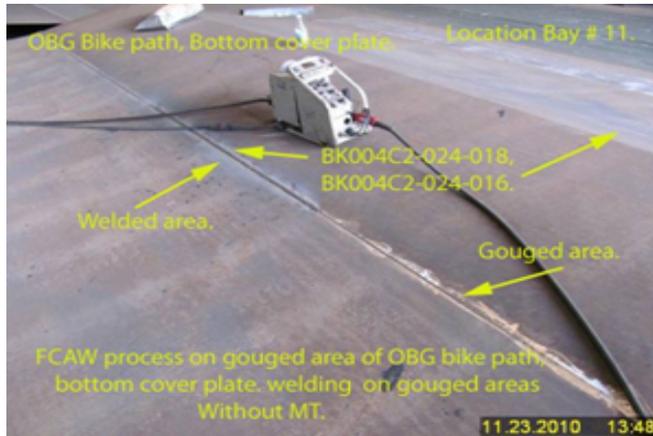
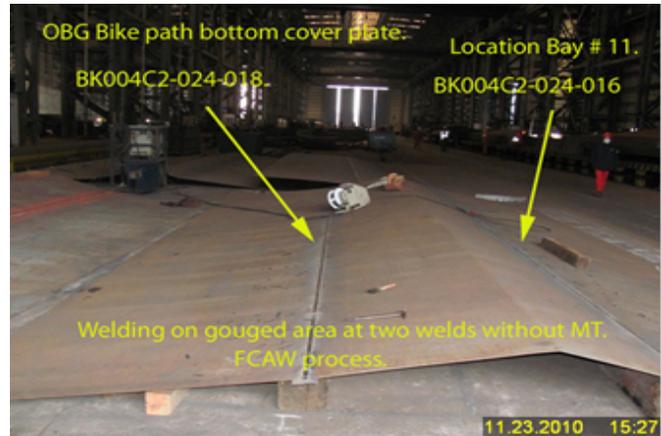
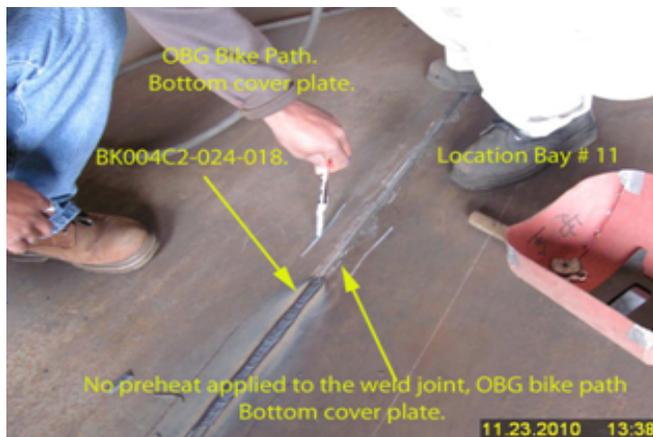
-The weld is identified as BK004C2-024-018, 016.

-The welding process used was Flux Core Arc Welding (FCAW).

-The area was being not preheated to 165 degrees.

-ZPMC personnel did not inspect 100% VT and MT of backgouged area before welding began from the second side.

-The weld is a Completed joint Penetration, (CJP) joining 6mm plate to 6mm plate.

-OBG Bike path, Bottom cover plate is located in Bay # 11.

Contractor will provide the NDT report to prove the weld is acceptable.
