Contract #: 04-0120F4Cty: SF/ALA Rte: 80 PM: 13.2/13.9File #: 69.25B**QUALITY ASSURANCE -- NON-CONFORMANCE REPORT****Location:** Changxing Island, Shanghai, P.R. China**Report No:** NCR-000963**Prime Contractor:** American Bridge/Fluor Enterprises, a JV**Date:** 05-Jan-2011**Submitting Contractor:** Zhenhua Port Machinery Company, Ltd (ZPMC), Changxing Island**NCR #:** ZPMC-0922**Type of problem:**

Reference Description: QA Inspector observed handling paint damages on the OBG steel barriers after they were loaded on the ship.

Job Name: SAS Superstructure
Document No: 05.03.06-000920

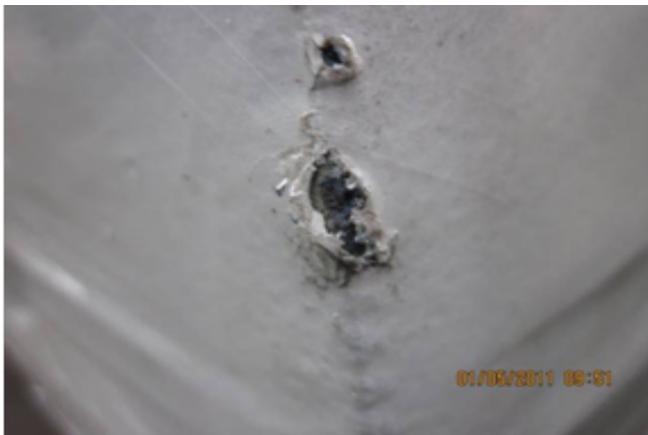
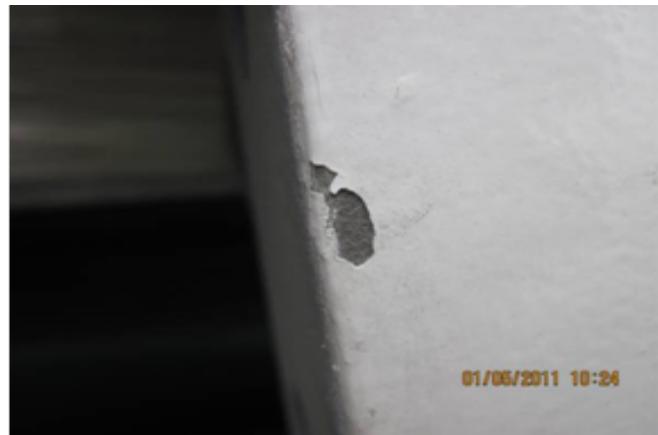
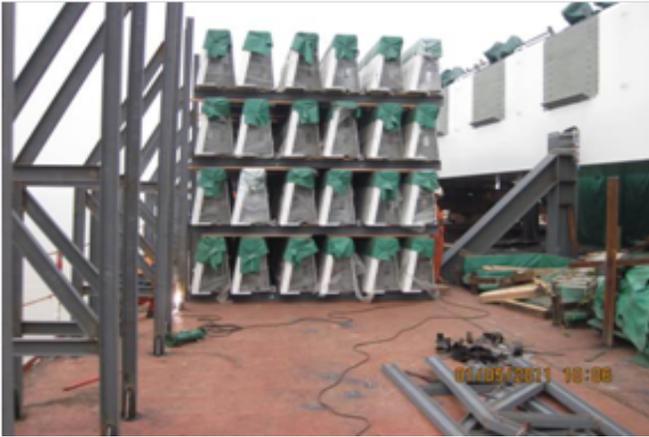
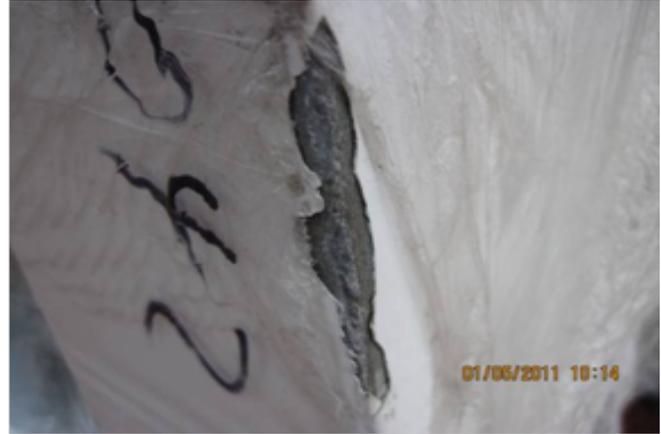
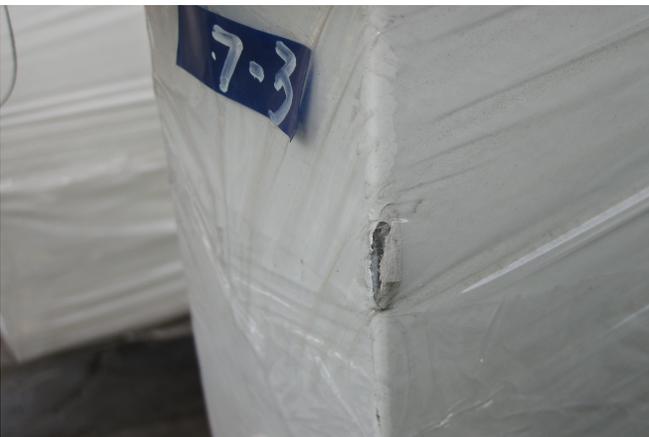
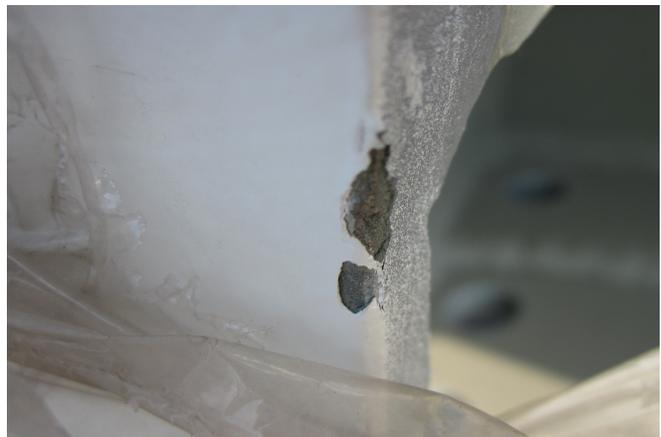
During random in-process visual inspection of OBG Steel Barriers, Caltrans Quality Assurance (QA) Inspector discovered the following issues:

-Paint damages were observed on the following steel barriers: W2-SB9-041 for Panel Point (PP) 78-78.5, W5-SB2-006 for PP55-55.5, W5-SB1-042 for PP50-50.5 and W5-SB2-007 for 53-53.5.

-These barriers were loaded onto ZPMC Ship 18.

-Prior to transporting these steel barriers away from the paint shop onto the ship, the paint quality on these steel barriers were inspected and accepted.

-The observed paint damages are handling damages.

-Additional paint damages were found on some other steel barriers on this ship (which are not mentioned above). This is due to the limited access to the steel barriers.

ZPMC has repaired the damaged painted areas accessible at this time, acceptance of the damaged coating for W5-SB1-042 PP50-50.5 and W5-SB2-007 PP53-53.5 is documented in the attached notice of inspection. The remaining two barriers will be repaired when they are unpacked in the US. Based on this ZPMC requests that this NCR be approved, with action pending.

This proposed resolution is accepted with action pending. This NCR will be considered closed pending paint repairs on the inaccessible steel barriers including, but not limited to W5-SB2-006, and W2-SB9-041.

Contractor proposes to repair the paint damaged Steel Barriers which are accessible on the ship. For those Steel Barriers not accessible for repair, Contractor will perform the paint repair in Oakland. The repair work will be tracked by the punchlist for Voyage 7 under item O-117.

Contractor performed the paint repair of two of the four identified Steel Barriers which were accessible and submitted documentation showing the repair was acceptable. For the two inaccessible, Contractor will perform the work in Oakland, and tracked by the punchlist of Voyage 7 under item O-117.

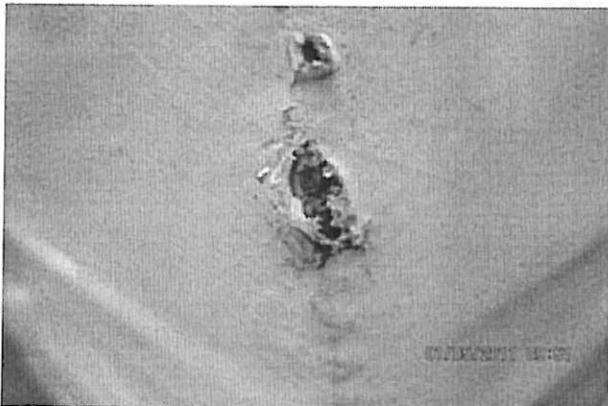
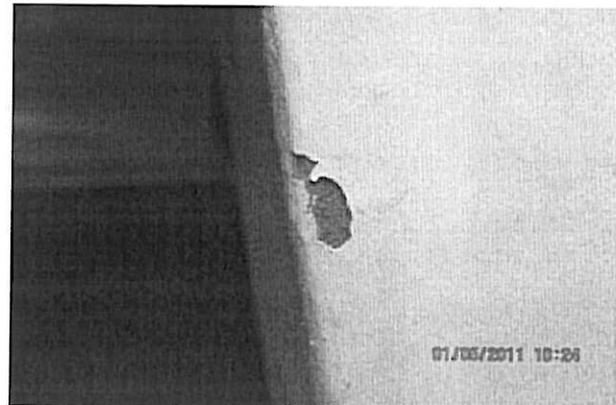
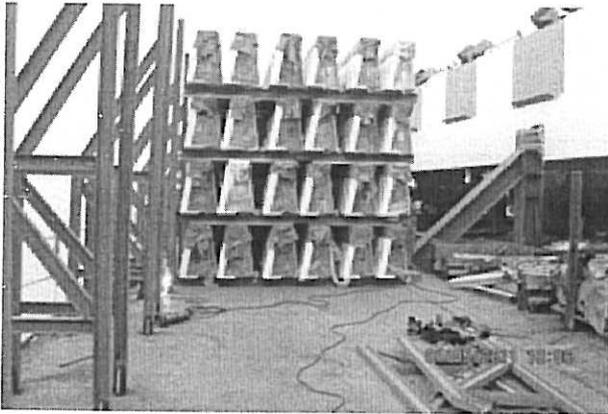
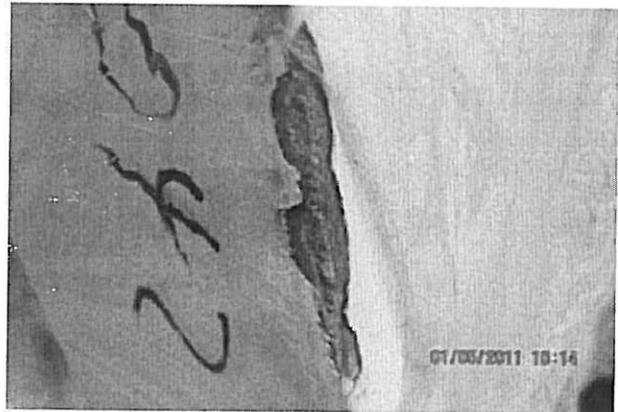
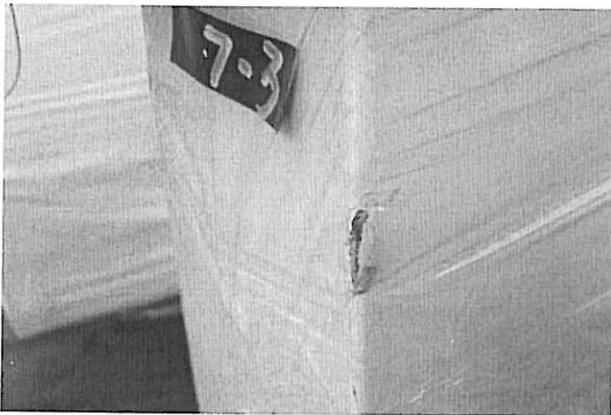
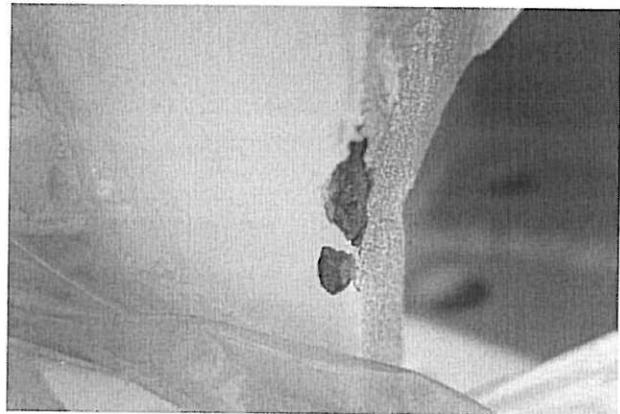
During random in-process visual inspection of OBG Steel Barriers, Caltrans Quality Assurance (QA) Inspector discovered the following issues:

- Paint damages were observed on the following steel barriers: W2-SB9-041 for Panel Point (PP) 78-78.5, W5-SB2-006 for PP55-55.5, W5-SB1-042 for PP50-50.5 and W5-SB2-007 for 53-53.5.
- These barriers were loaded onto ZPMC Ship 18.
- Prior to transporting these steel barriers away from the paint shop onto the ship, the paint quality on these steel barriers were inspected and accepted.
- The observed paint damages are handling damages.
- Additional paint damages were found on some other steel barriers on this ship (which are not mentioned above). This is due to the limited access to the steel barriers.
