## QUALITY ASSURANCE -- NON-CONFORMANCE REPORT

**Report No:** NCR-000469

**Reference Description:** Unapproved freehand thermal cutting on North Tower, Lift 1

**Job Name:** SAS Superstructure  
**Document No:** 05.03.06-000432

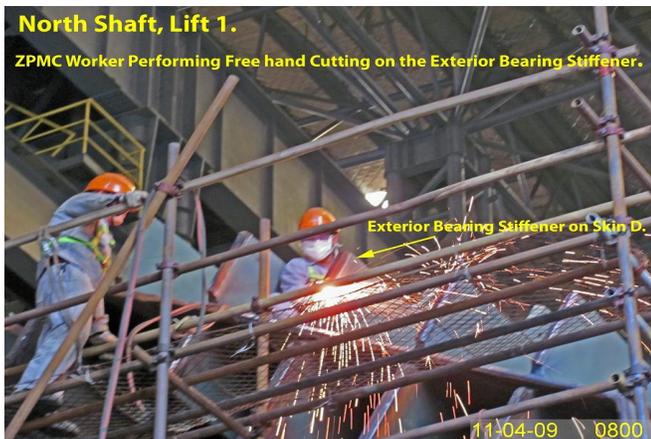
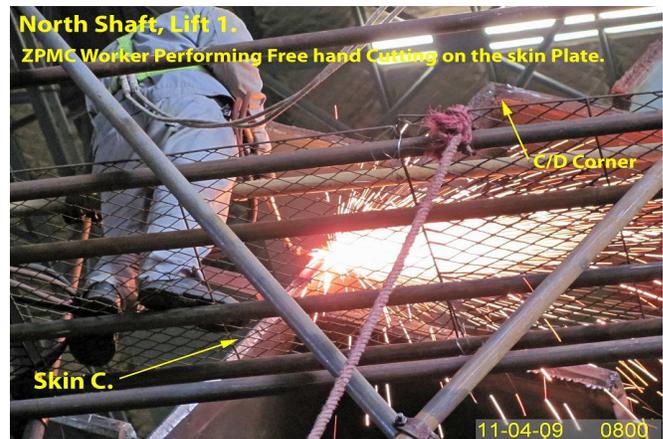
During Visual Testing (VT) of North Tower, Lift 1, exterior bearing stiffeners, QA observed 'freehand thermal cutting' being carried out by ZPMC personnel without Engineer approval.

AWS D1.5-2002, Section 3.2.3 - "Steel and weld metal may be thermally cut, provided a smooth and regular surface free from cracks and notches is secured, and provided that an accurate profile is secured by the use of a mechanical guide. Freehand thermal cutting shall be done only where approved by the Engineer."

Propose a resolution for the identified non-conformance, documenting that the affected plate edges have been brought in compliance with the contract requirements.

ZPMC has resolved the discrepancy between their internal procedure and AWS D1.5 and understands that Engineer approval is required for free hand thermal cutting. A CVI will monitor free hand thermal cutting in the future to prevent this non conformance. ZPMC has provided their internal free hand thermal procedure which was used in the documented NCR. Enclosed are photos of the final condition of the free hand cut. Based on this ZPMC requests closure of this NCR.

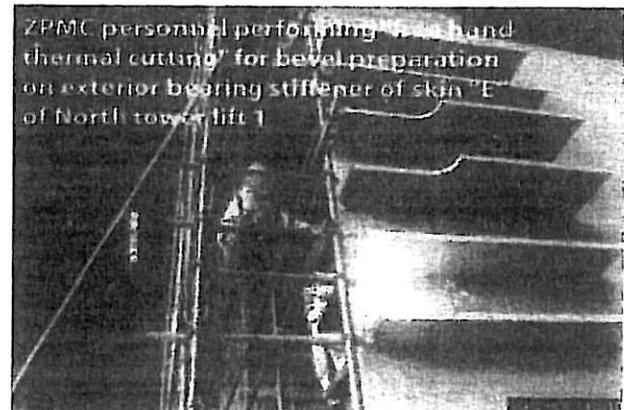
During Visual Testing (VT) of North Tower, Lift 1, Skin E exterior bearing stiffeners, QA observed 'free hand thermal cutting' for bevel preparation being carried out by ZPMC personnel without approval by the Engineer.

AWS D1.5-2002, Section 3.2.3 - "Steel and weld metal may be thermally cut, provided a smooth and regular surface free from cracks and notches is secured, and provided that an accurate profile is secured by the use of a mechanical guide. Freehand thermal cutting shall be done only where approved by the Engineer."

Propose a resolution for this systematic non-conformance, documenting that the affected plate edges have been brought in compliance with the contract requirements.

In addition, to the material/workmanship non-conformance, propose a resolution for this systematic non-conformance that addresses the failure of Quality Control to identify the deficiency. NPR ZPMC-391 and NPR ZPMC-412 addressed the same type of non-conformance, ABFJV stated in part, "ZPMC understands and acknowledges that free hand thermal cutting is not permitting without prior Engineer approval and in the future ZPMC CWIs monitor thermal cutting activities closer to ensure that it is in compliance". Please also address the apparent failure of the internal communication within ZPMC that caused this now systematic failure. In the event of another repeated incident of this type, address what steps/ actions will be taken by ABFJV.

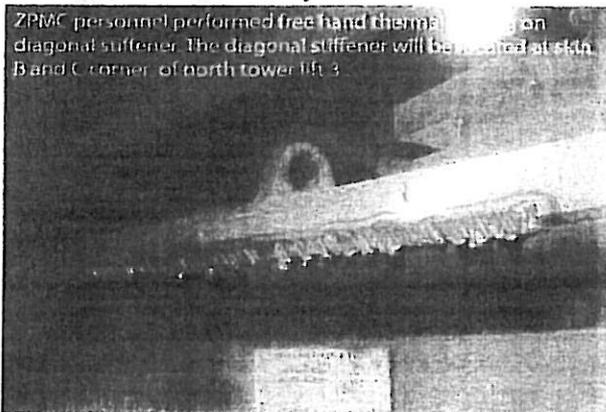
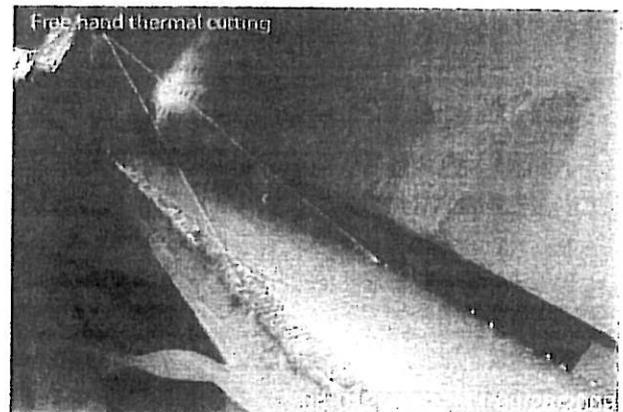
QA observed ZPMC personnel perform free hand thermal cutting on North Tower, Lift 3, BC Diagonal Stiffener, between the 85m and 89m Diaphragms. The length of the cut was approximately 850mm.

AWS D1.5-2002, Section 3.2.3 - "Steel and weld metal may be thermally cut, provided a smooth and regular surface free from cracks and notches is secured, and provided that an accurate profile is secured by the use of a mechanical guide. Freehand thermal cutting shall be done only where approved by the Engineer."

Propose a resolution for the identified non-conformance, documenting that the affected plate edges have been brought in compliance with the contract requirements.

In addition, to the material/workmanship non-conformance, propose a resolution for the identified non-conformance that addresses the failure of Quality Control to identify the deficiency.

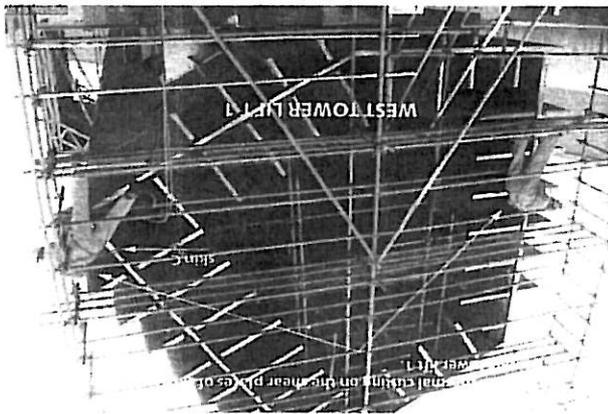
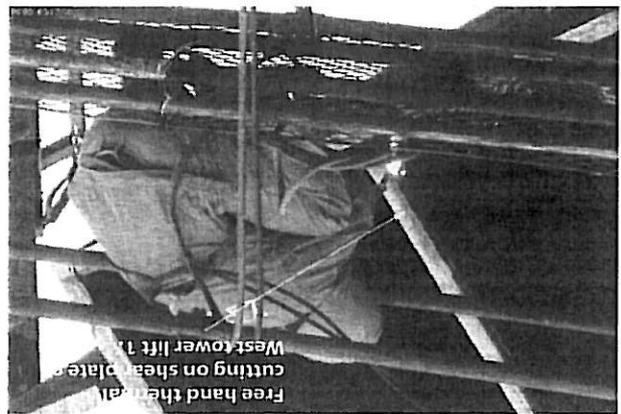
During in-process Visual Testing (VT) of West Tower, Lift 1, base-end bevel preparation, QA observed 'freehand thermal cutting' being carried out by ZPMC personnel. Access to the areas being cut were not restricted due to cross sectional geometry and or position in so far as mechanical guides could not be used.

AWS D1.5-2002, Section 3.2.3 - "Steel and weld metal may be thermally cut, provided a smooth and regular surface free from cracks and notches is secured, and provided that an accurate profile is secured by the use of a mechanical guide. Freehand thermal cutting shall be done only where approved by the Engineer."

In addition, to the material/workmanship non-conformance, propose a resolution for the identified non-conformance that addresses the failure of Quality Control to indentify the deficiency.

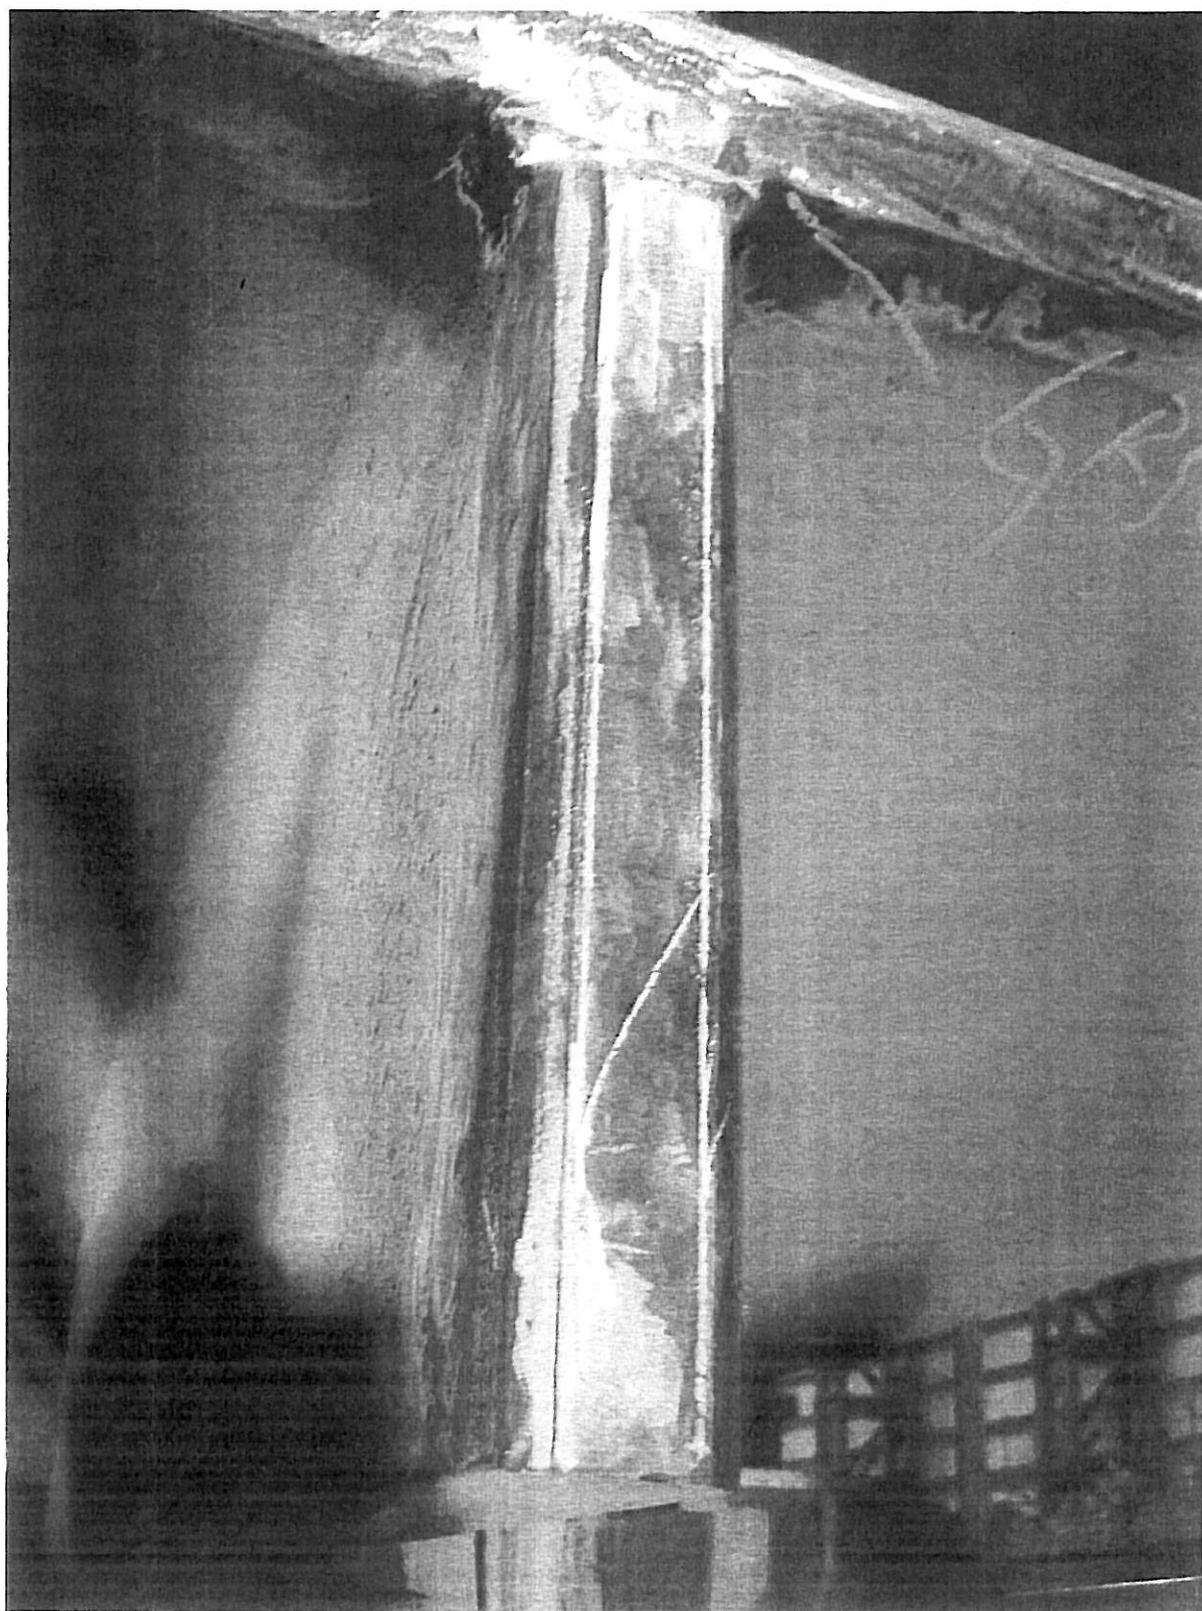
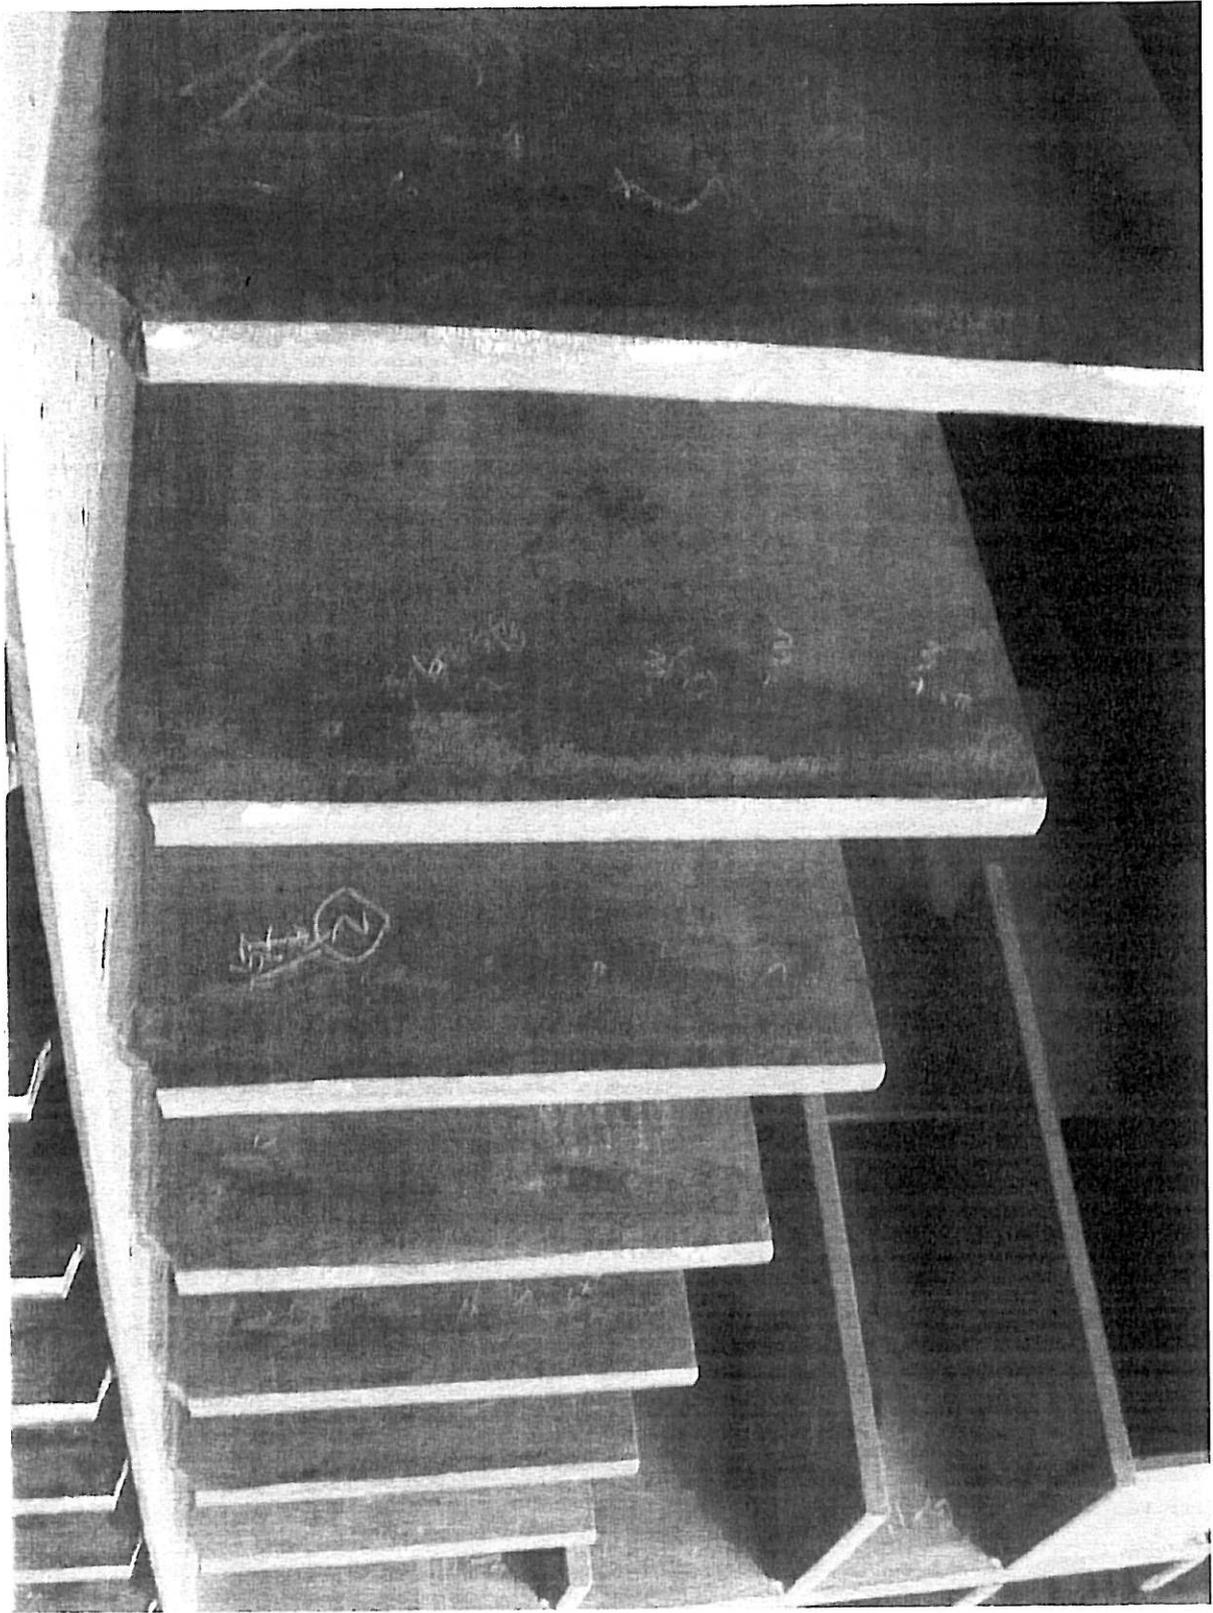
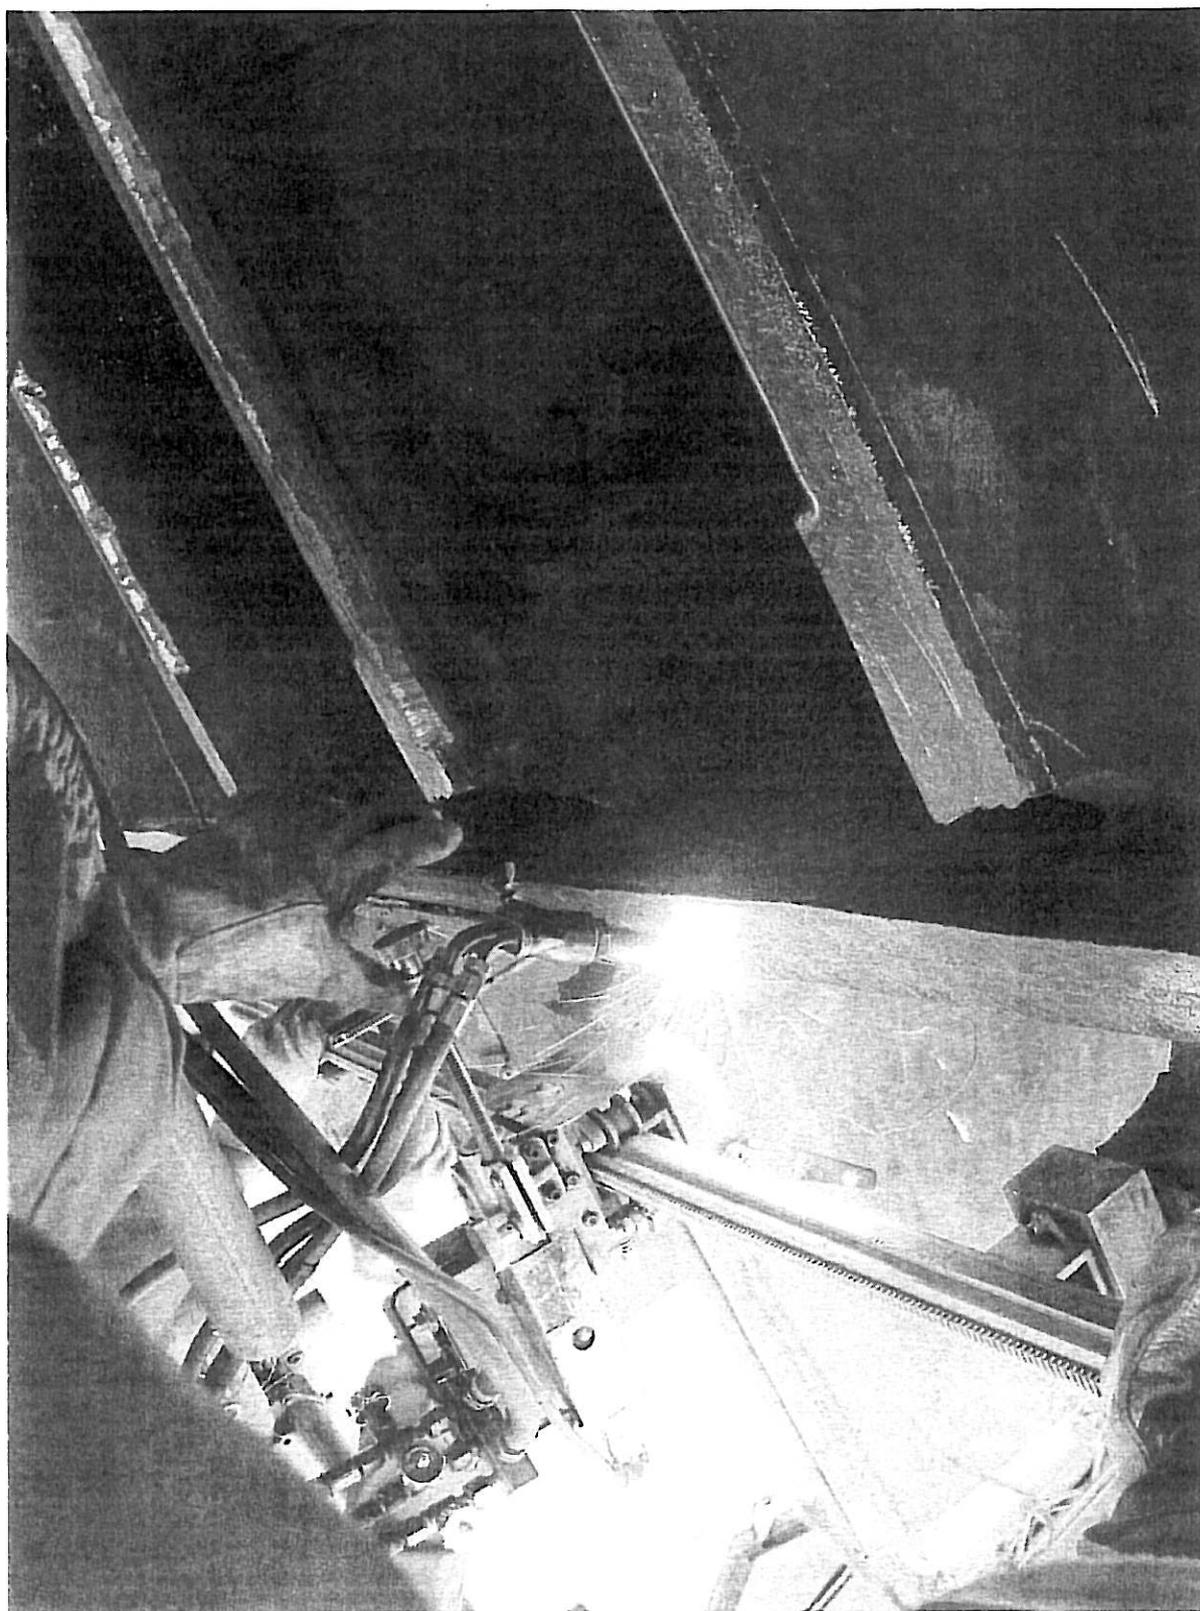
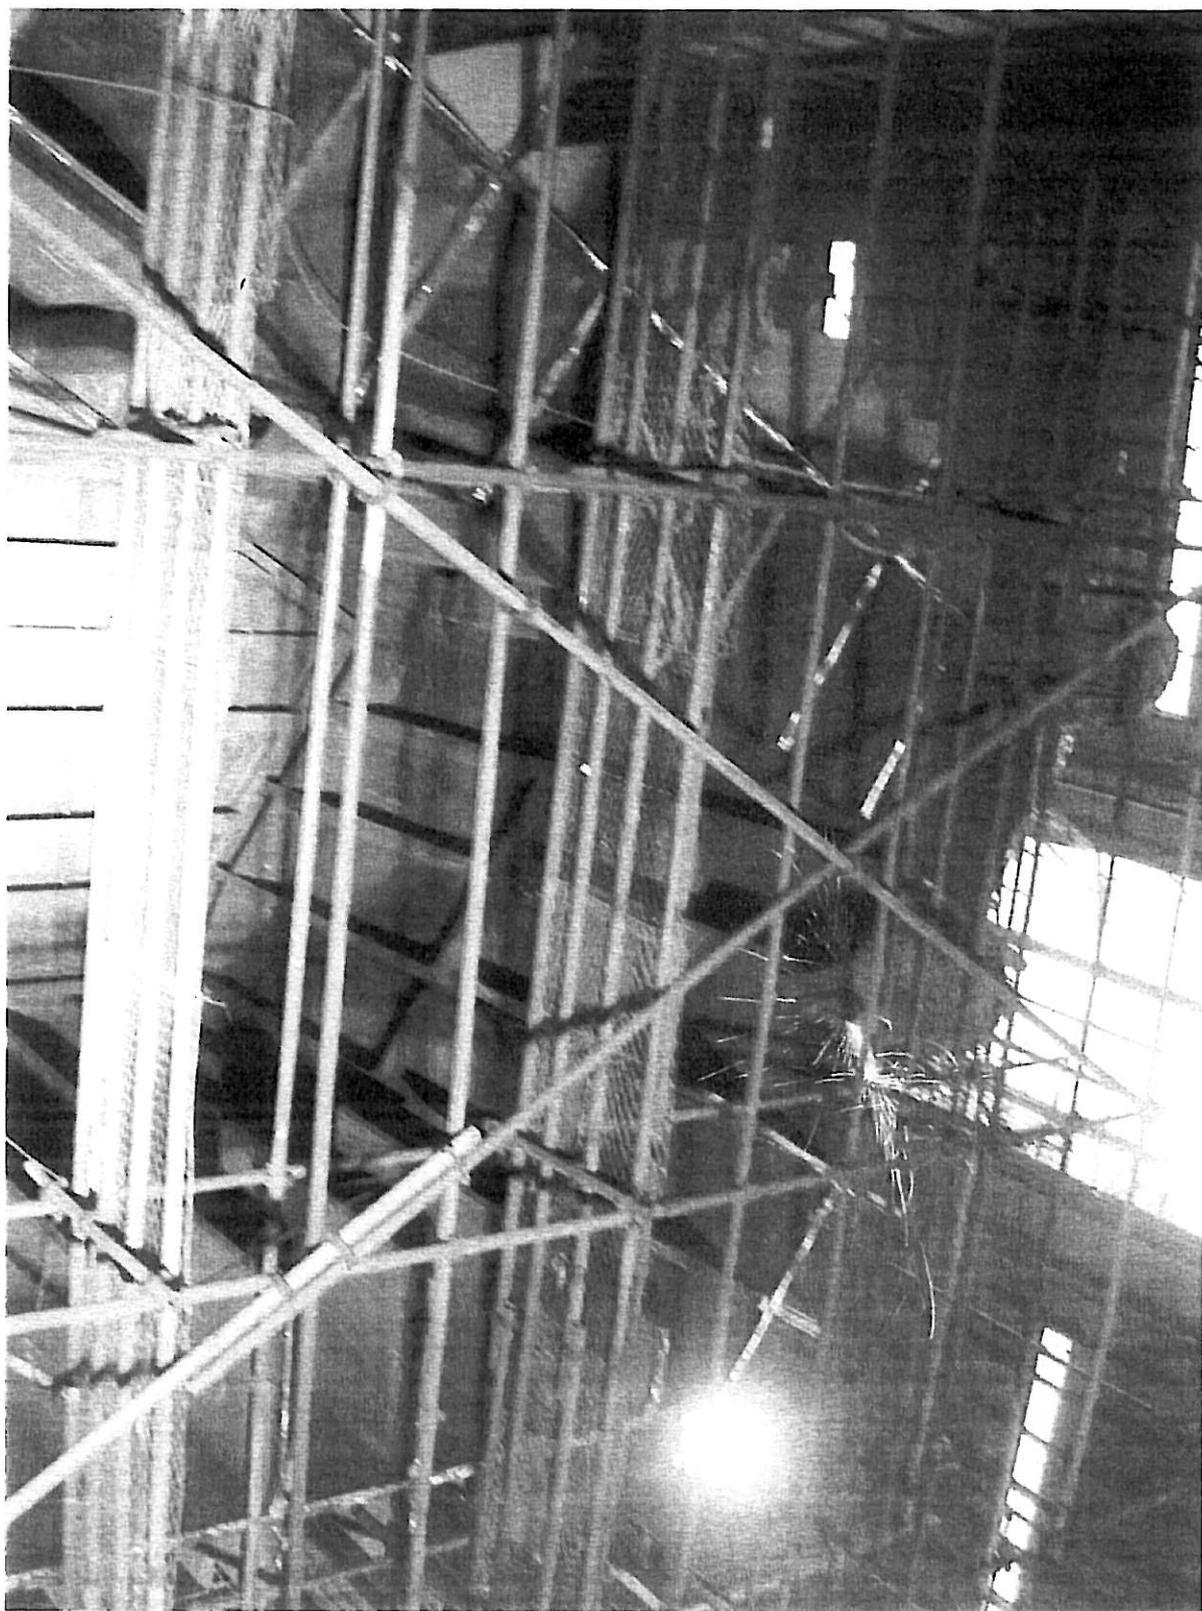
4 Relative Pictures After Bevel Preparation

Freehand flame cutting procedure may be performed in areas where it is impractical to use machine flame cutting or a mechanical guide. Freehand flame cutting should follow this procedure unless otherwise approved by Engineer.

1. Mark the cutting line on steel plate.
2. Carefully freehand flame cut to approximately 3mm above the cutting line.
3. Grind the remaining 3mm to the cutting line.
4. Occasional notches or gouges deeper than the cutting line, which are not subsequently welded, should be removed by fairing to the material edge with a slope not steep than 1:10 and with grinding marks parallel to the material surfaces. The repair should not remove more than 2% of the nominal section.
5. Maximum roughness for the flame cut surface should meet the requirements in AWS D1.5.
6. Sharp corners that are not to be incorporated into a weld shall be removed by chamfering the edge.

So ZPMC provided the internal cutting procedure and the pictures of final condition of the joint freehand cut, hoping Caltrans could take a review and consider close these NCR. If it's necessary to use the freehand flame cutting, ZPMC will ask for Engineer's approval in the future.
