**DEPARTMENT OF TRANSPORTATION**

Contract #: 04-0120F4Cty: SF/ALA Rte: 80 PM: 13.2/13.9File #: 69.25B**QUALITY ASSURANCE -- NON-CONFORMANCE REPORT****Location:** Changxing Island, Shanghai, China**Report No:** NCR-000931**Prime Contractor:** American Bridge/Fluor Enterprises, a JV**Date:** 08-Dec-2010**Submitting Contractor:** Zhenhua Port Machinery Company, Ltd (ZPMC), Changxing Island**NCR #:** ZPMC-0892**Type of problem:**

**Reference Description:** CCO#077 - Quality Assurance Green Tagging Procedure Not Followed**Description of Non-Conformance:**

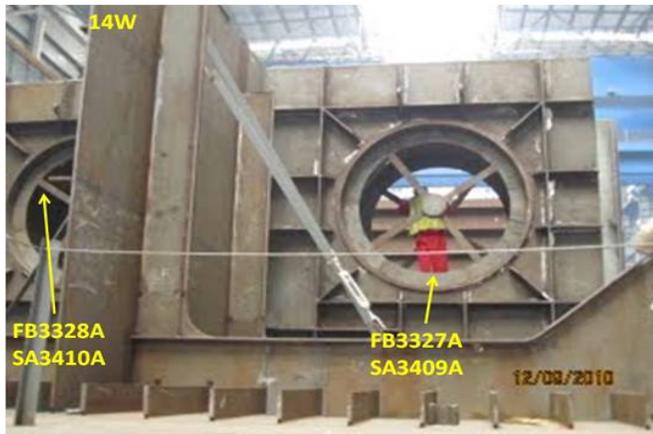
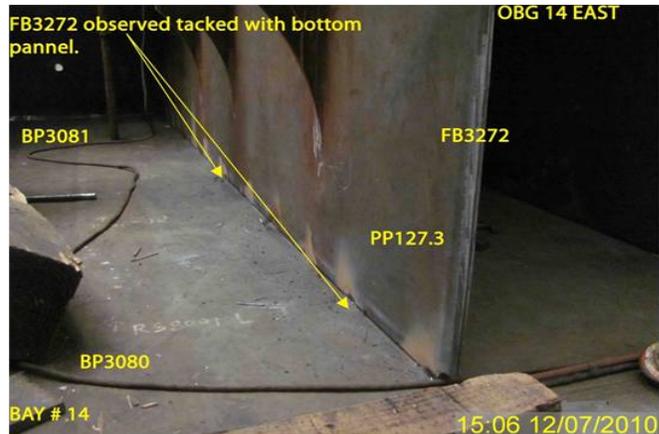
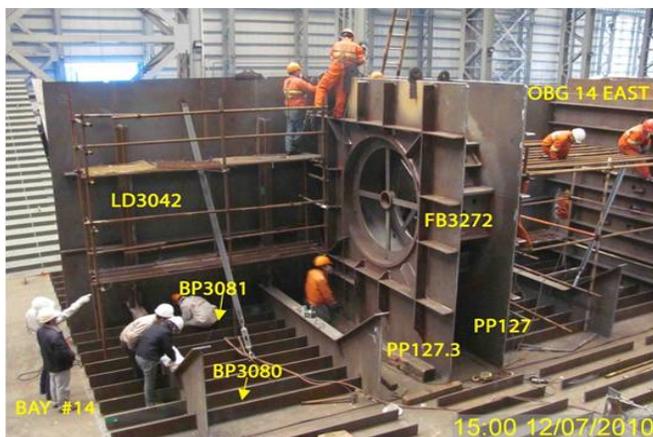
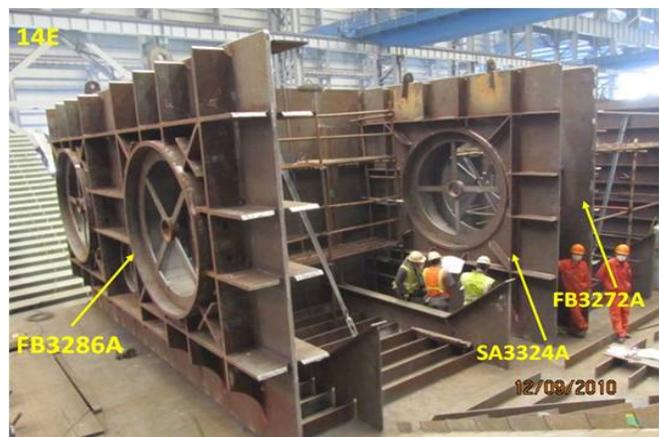
During the Quality Assurance (QA) random in-process observations of the fabrication of OBG Lift 14 in Bay # 14, this Caltrans QA Inspector observed the following on Hinge A Pipe Sleeve Bulkheads:

- Floorbeam FB3272A and Sub Assembly SA3324A were observed to be erected/assembled prior to completion of inspection and testing on 12/7/10.
- Floorbeam FB3286A was observed to be erected/ assembled prior completion of inspection and testing on 12/8/10.
- Floorbeams FB3327A, FB3328A and Sub Assemblies SA3409A, SA3410A were observed to be erected/ assembled prior completion of inspection and testing on 12/8/10.
- The inspection requirements for these components were not fulfilled as per contract documents.
- The Green Tag has been not issued for this component for further assembly/ erection.
- The Hinge Plates are located between PP127 and 128.3
- Hinge Plates were observed tacked to Bottom Plates in Bay #14 for Lifts 14 East and West

See attached photographs for additional detail.

The sub assemblies referenced in the NCR have been inspected by the Department and found to be acceptable, signature of the green tag form is pending closure of this NCR. Whenever possible subassemblies will be complete green tagged prior to movement in the future. Based on this, ZPMC requests closure of this NCR.

Contractor will request for Department's QA inspection of the sub-assemblies. The green tag form will be signed off subject to closure of this NCR. In future, where practicable sub-assemblies will be inspected, green tagged prior to movement.

Contractor requested for QA inspection, inspection subsequently completed. Green tag application submitted and signing off of Green Tag pending closure of this NCR.
